Roundhouse Railroad Museum

CHS Preservation Team Projects

April 2006

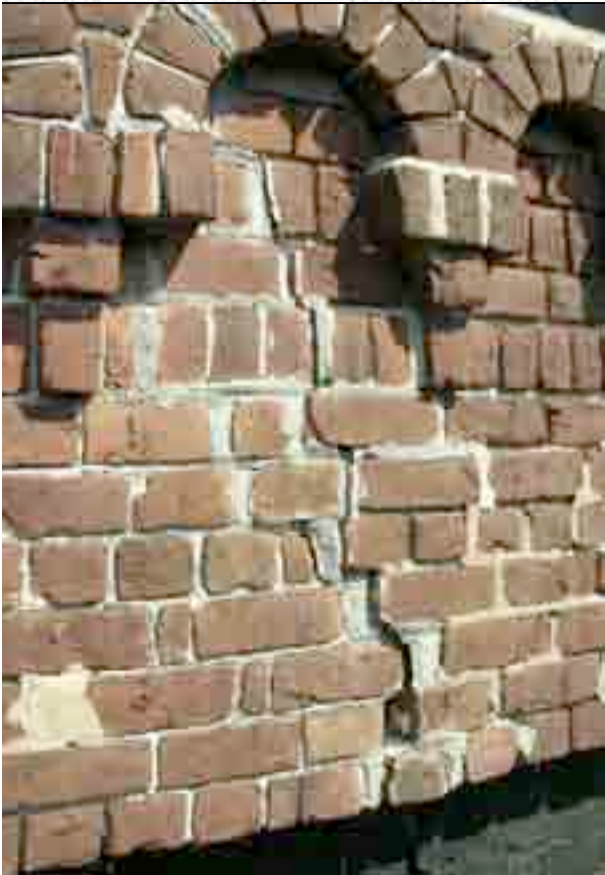
A large crack has formed in the eastern wall of the Boiler House.

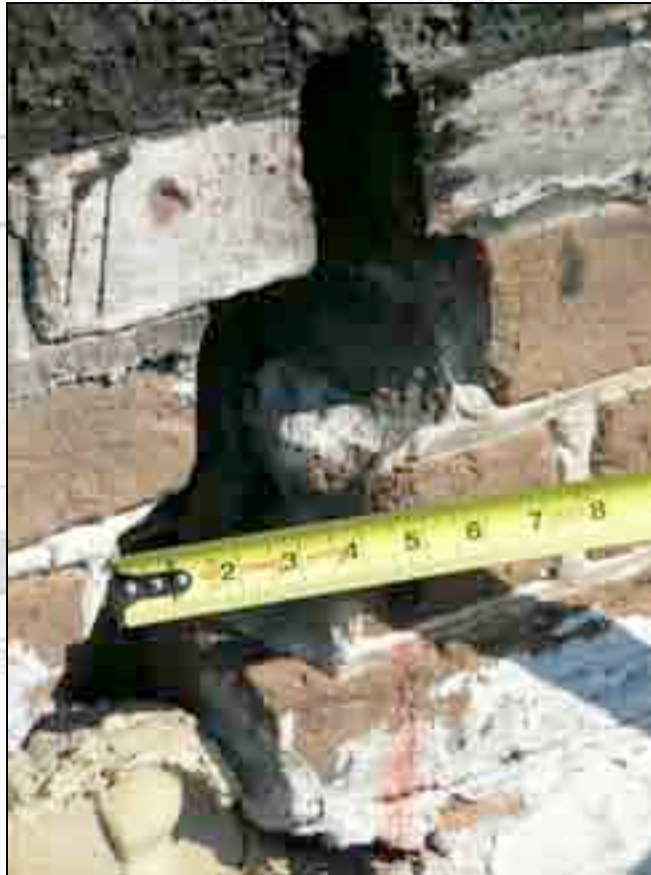
One point in the crack is measured at four inches.

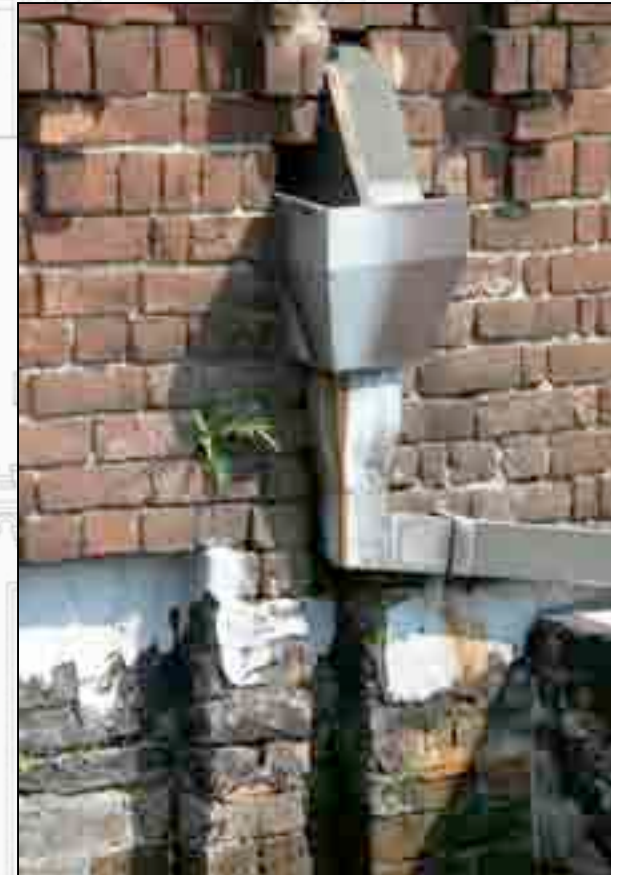
A faulty gutter system contributes to the mortar deterioration and wood rot along the edges of the Boiler House and Compressor Room.

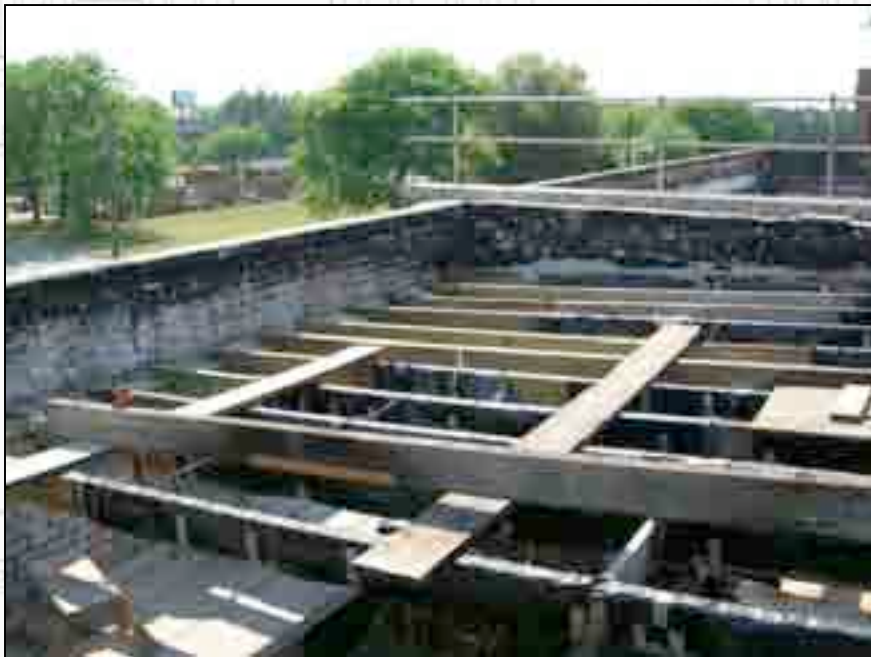
The CHS Preservation Team wrapped damaged boards to keep further rot from occurring. A Dutchman repair can be seen on the bottom of the rafter in the foreground.

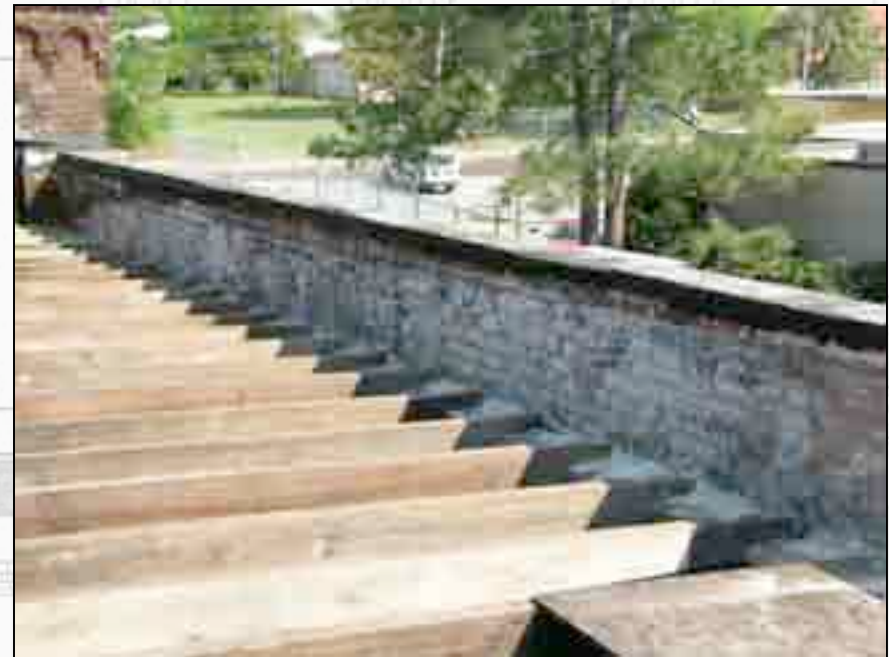
View of original rafters located below the cricket roof before major epoxy repairs and scarf-jointed replacement boards are inserted.

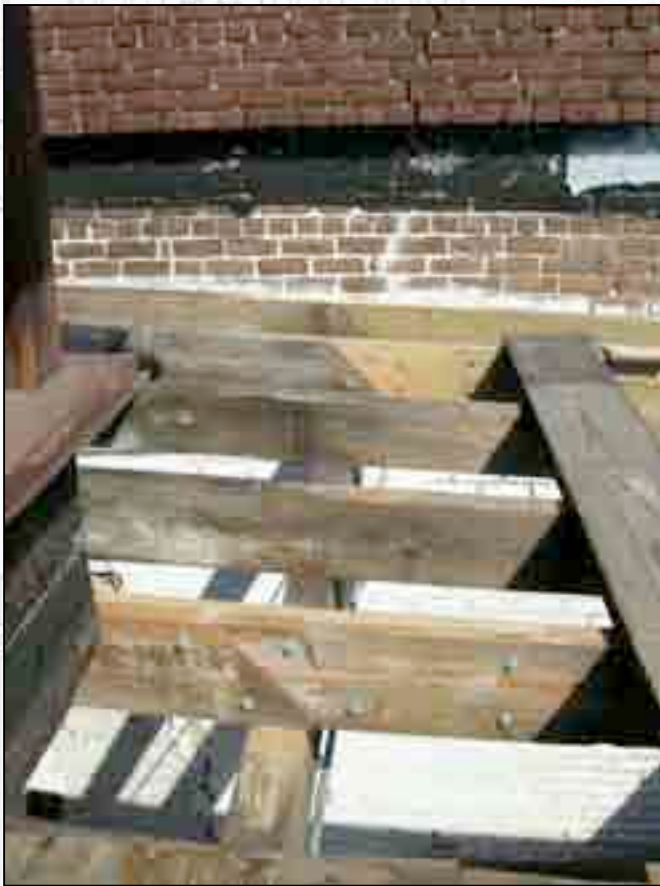
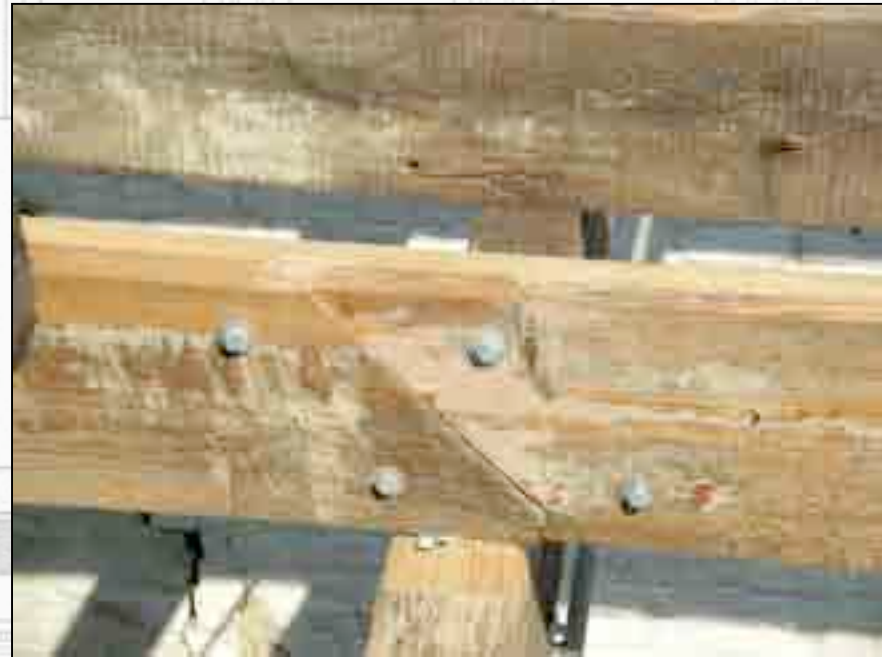
Close-up view of one of the scarf joint repairs. Another board was sistered to the scarf-jointed rafter for additional support.

The CHS Preservation Team has made scarf-joint repairs to the rafters.

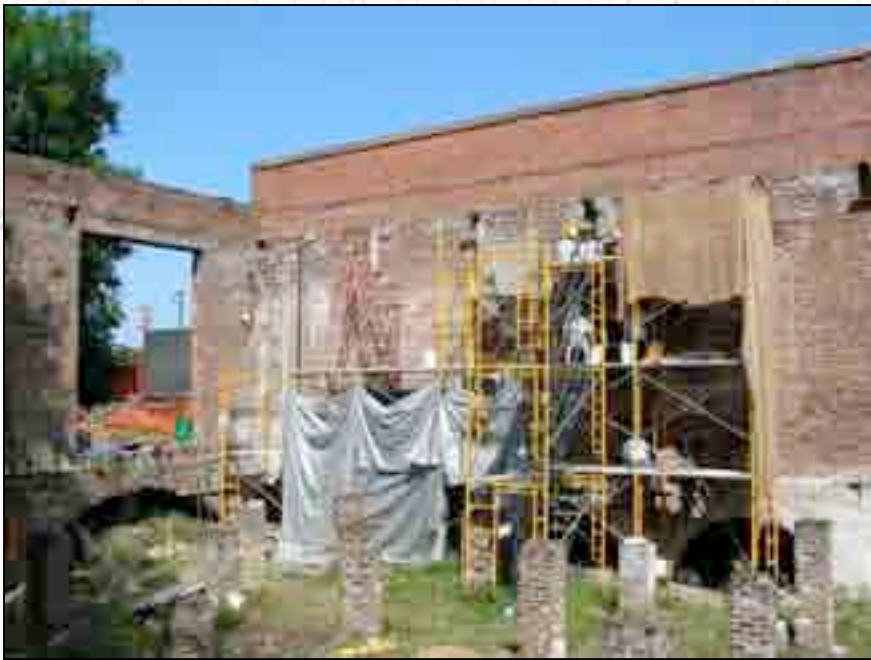
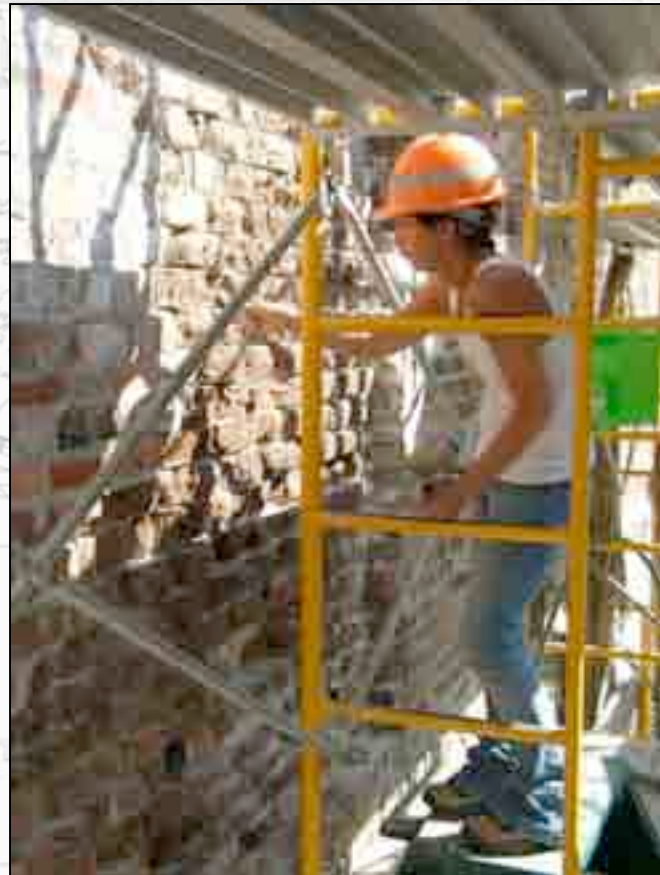
Carpentry Shop

The north end of the carpentry shop wall is currently being repointed.

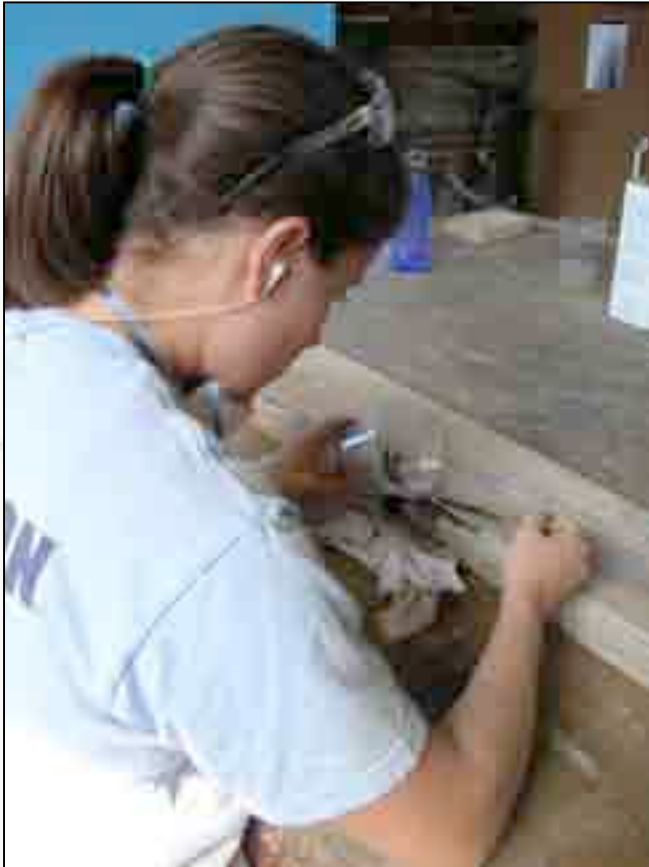
Jess King applies epoxy to one of the Paint Shop doors that is currently being restored.

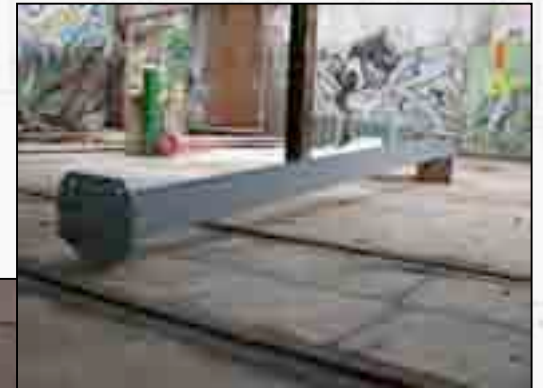
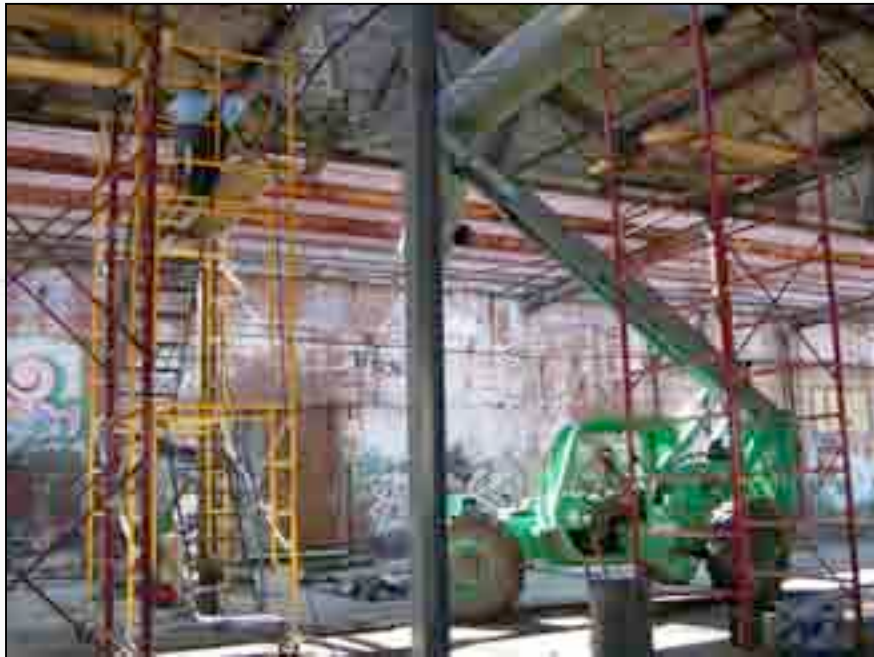
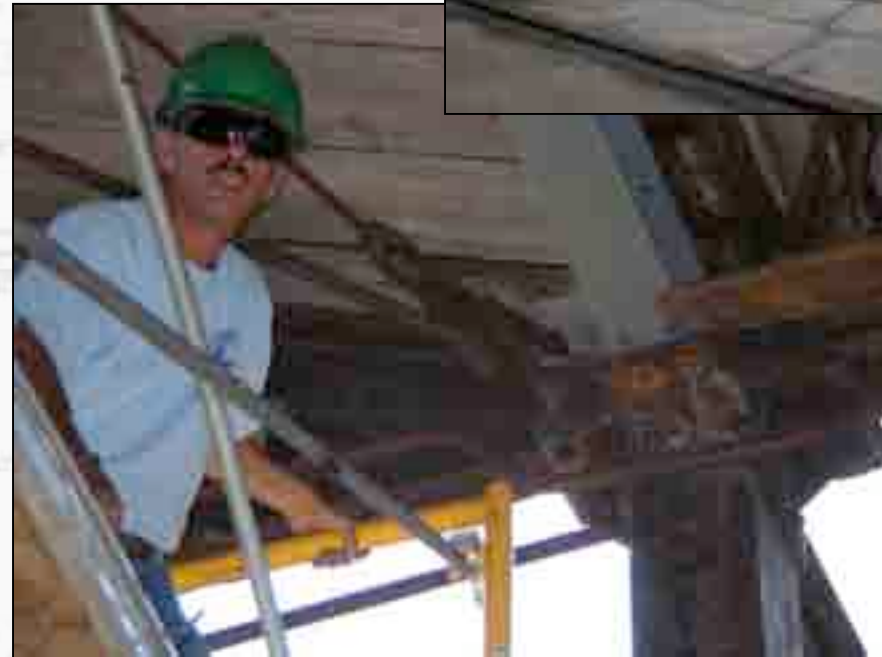
The CHS Preservation Team continues making steel repairs to the Paint Shop.

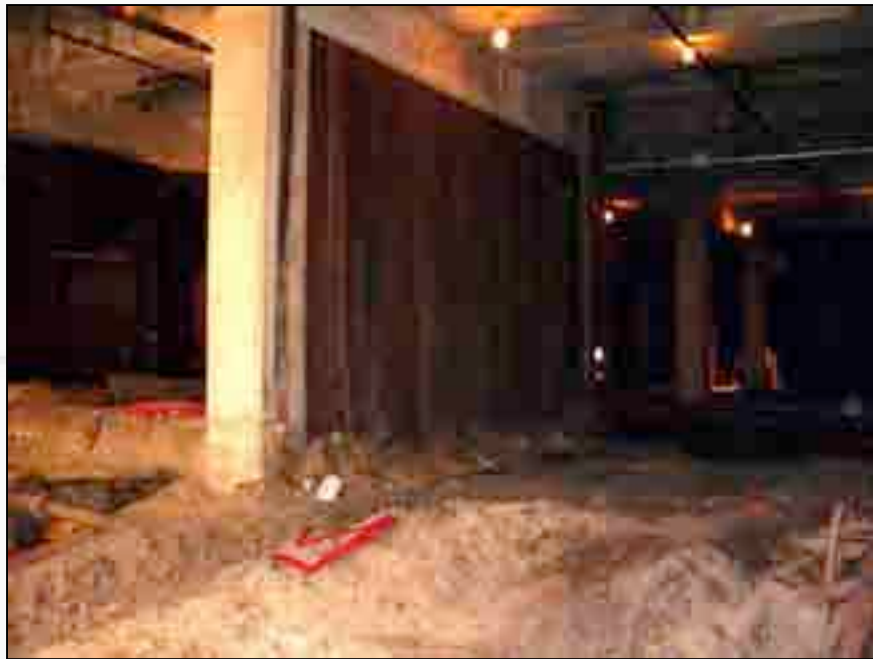
View of the wall before it was removed.

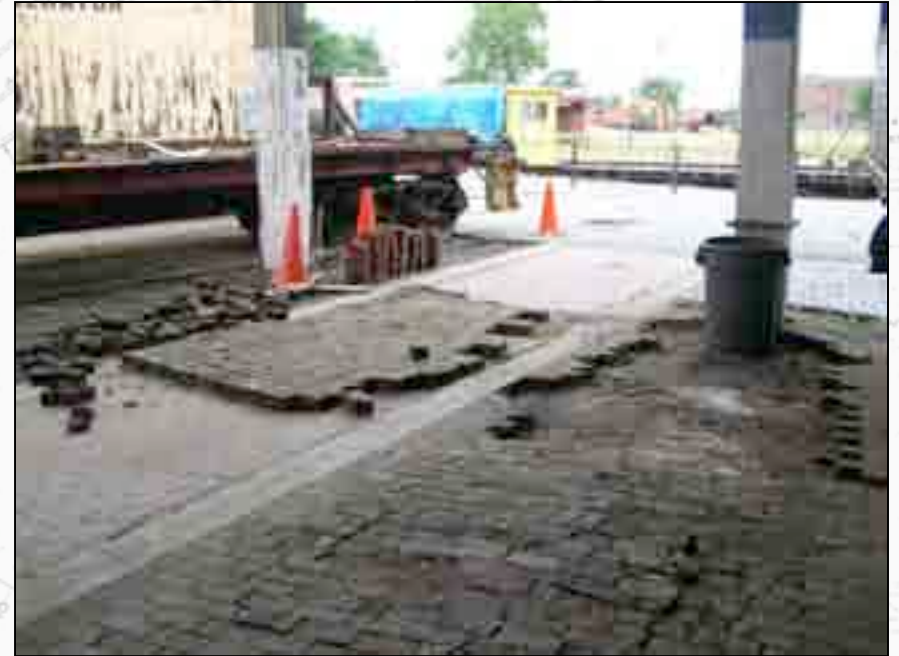
Present woodblocks are removed to make test patches before the full restoration process begins. Various mastics and sealers are being tested.

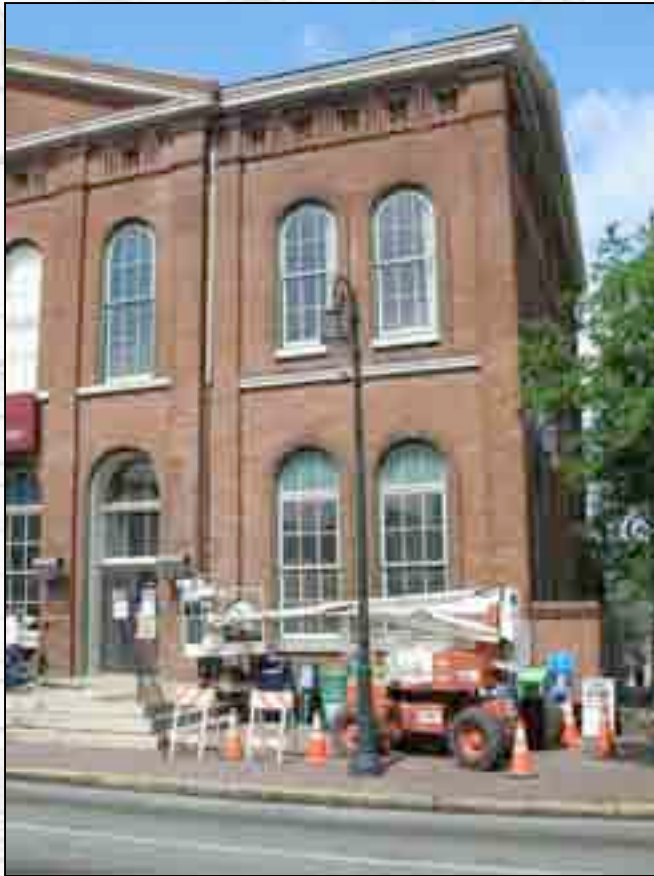
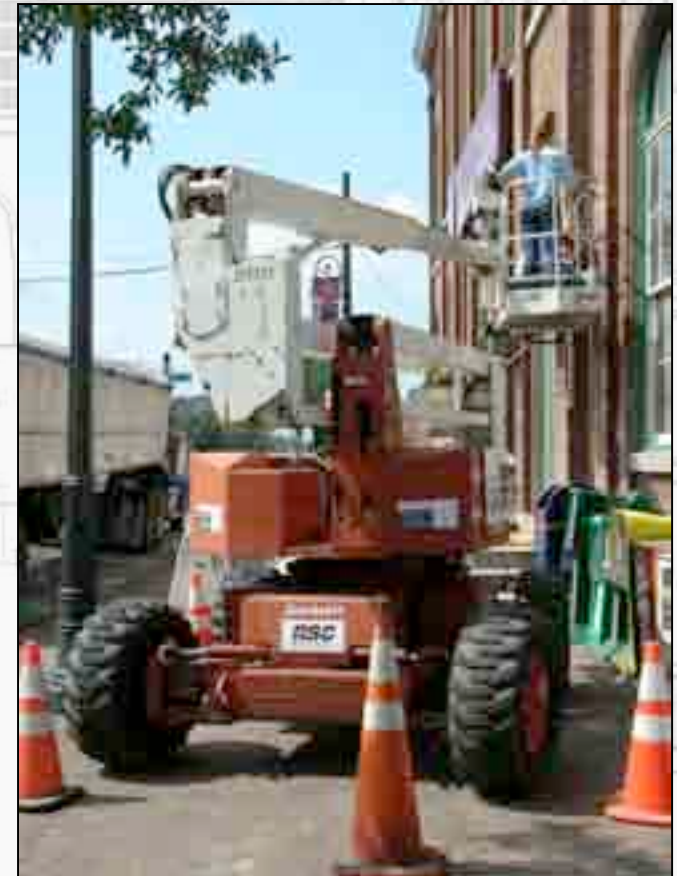
The interior plaster wall of the Visitors Center was cracking and delaminating due to moisture from the downspout. Travis Brown and Jeanne Fullam repointed areas behind the downspout and repaired seams of the gutter.

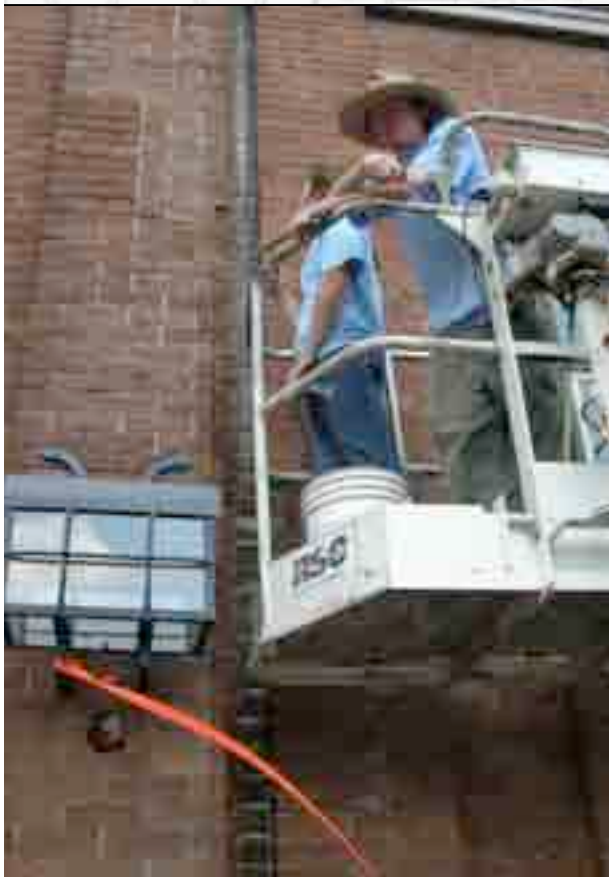
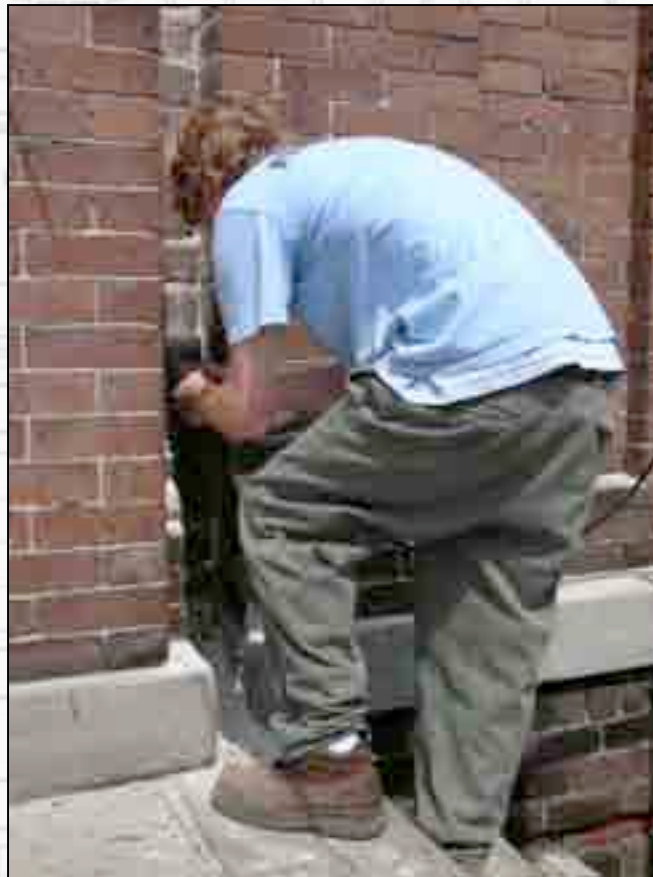
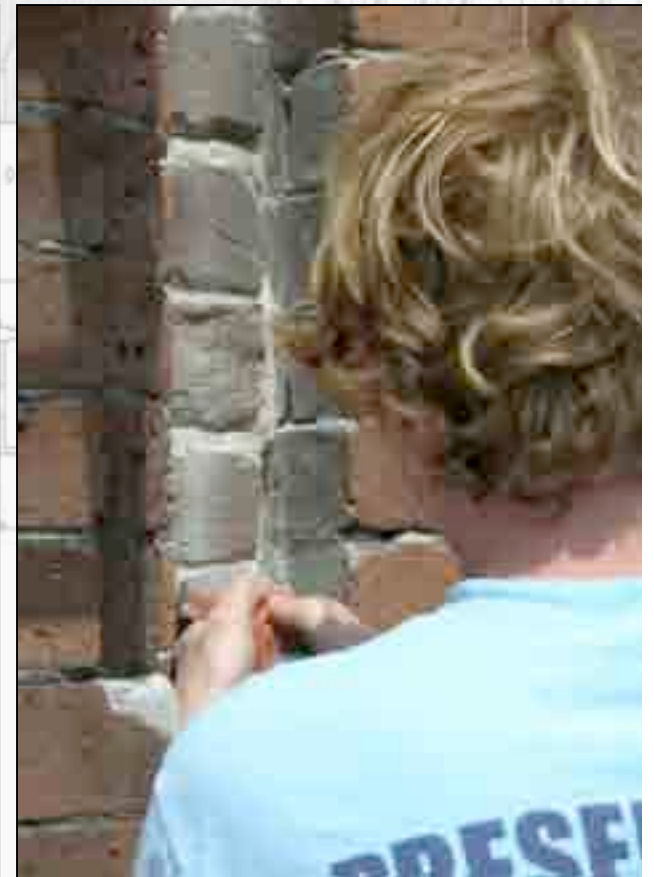
More views of the area behind the downspout that Travis and Jeanne repointed.
