Roundhouse Railroad Museum

CHS Preservation Team Projects

May 2006

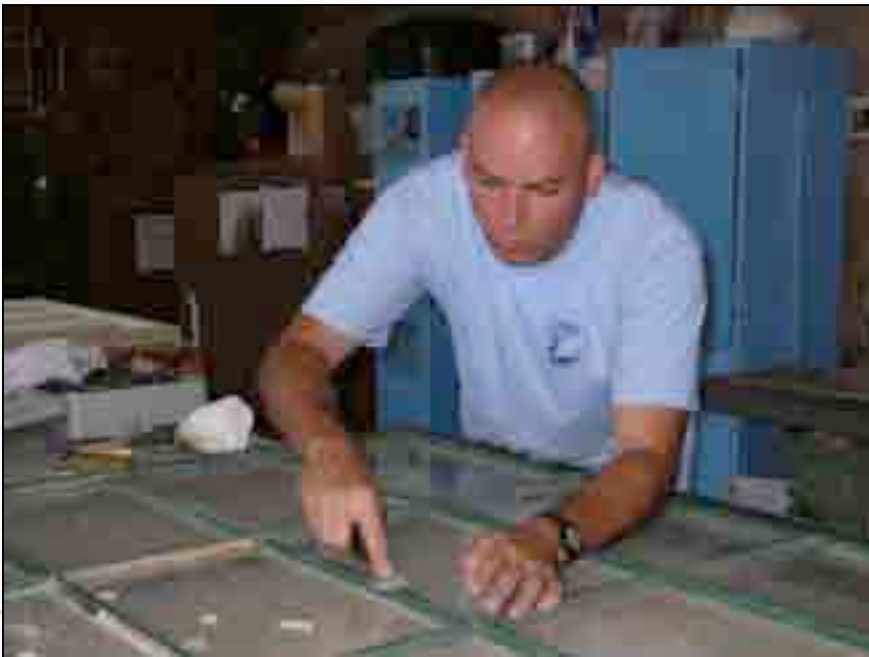
Kurt removes the deteriorated glazing on a window from the first floor of the Tender Frame Shop.

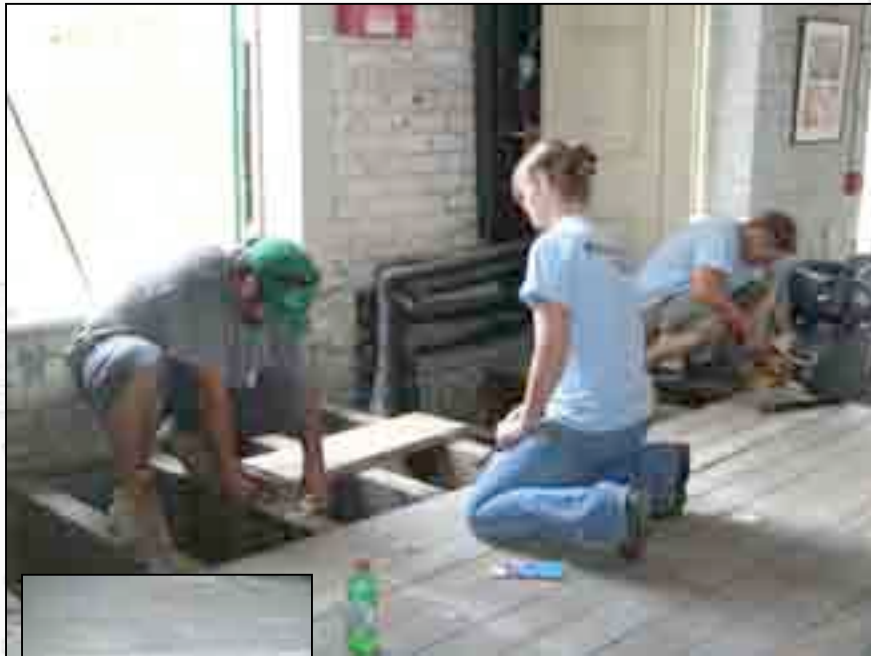
Chris, Jeanne, and Ryan remove the floorboards of the first floor of the Tender Frame Shop to access the rotted and termite damaged floor joists.

The CHS Preservation Team is repairing the joists that can be saved and replacing the others in kind. The floor boards were numbered so they can be reinstalled in the same order as they were taken out.

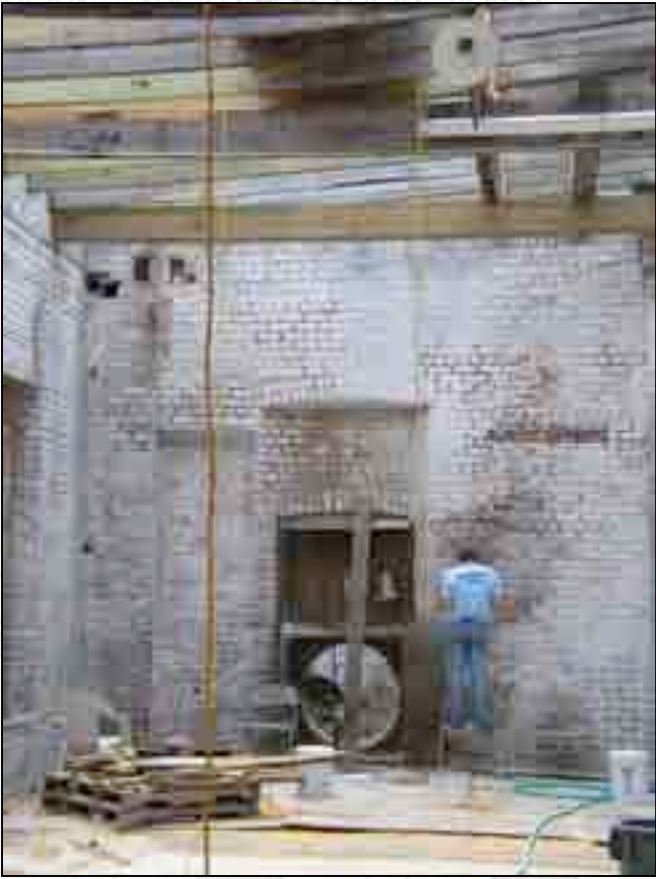
West wall

The CHS Preservation Team continues to repoint all walls of the Compressor Room.

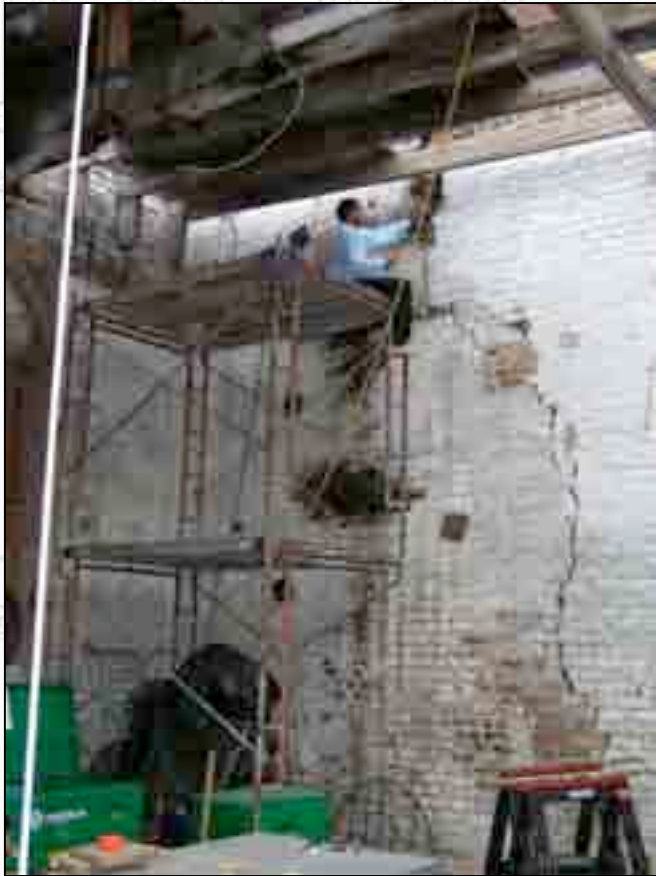
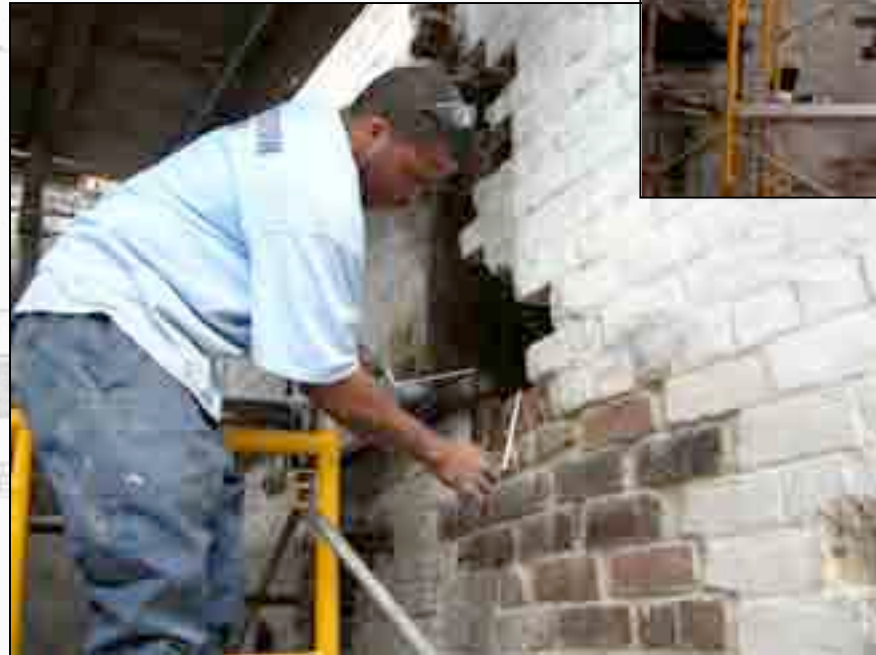
Extensive repointing is taking place along a major crack in the east wall of the Compressor Room.

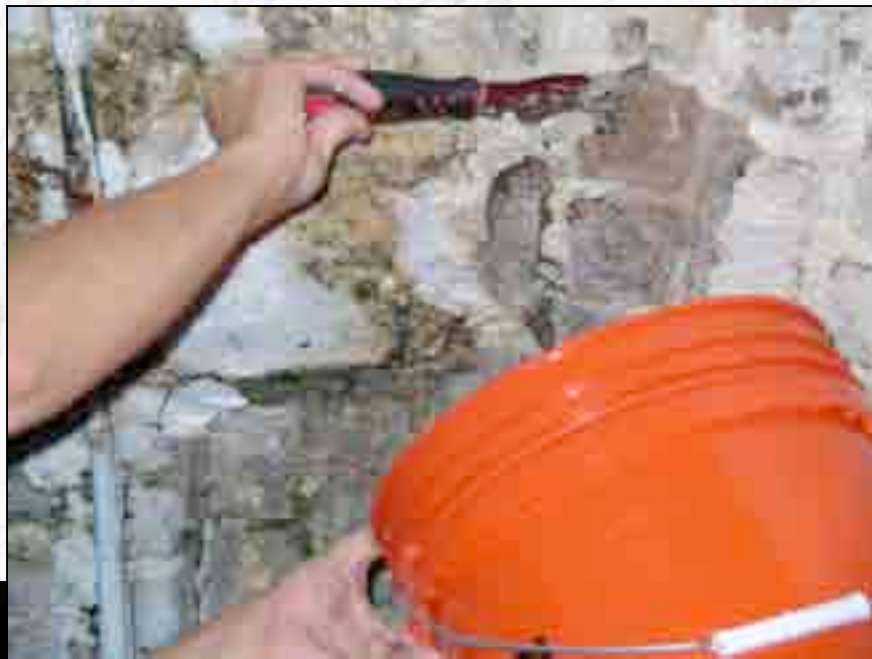
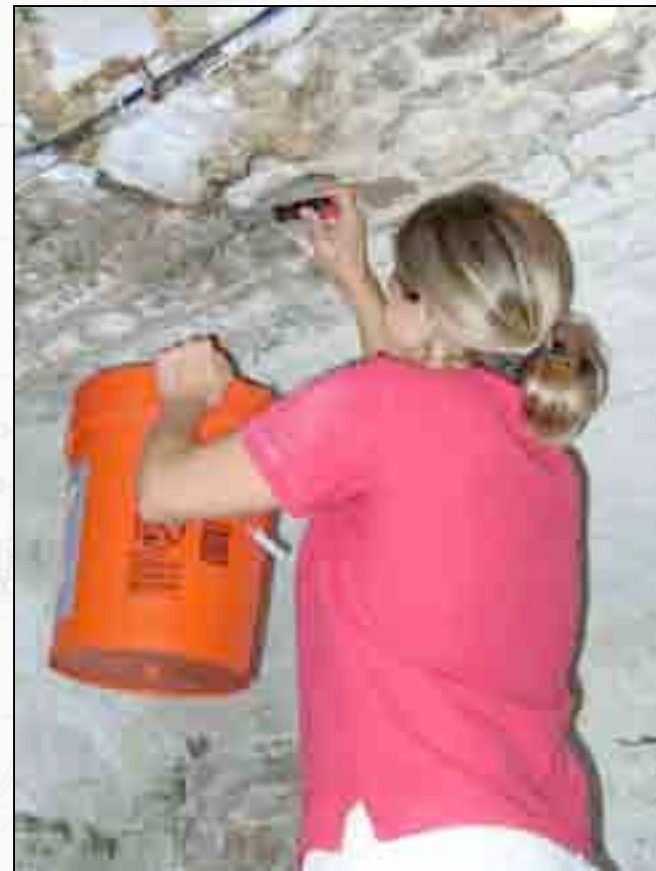
Close-up view of removed substance

Krystal removes a mixture of salts and mold from the ceiling of one of the casemates, using a 5-in-1 tool to gently remove the substance and a bucket to catch it.

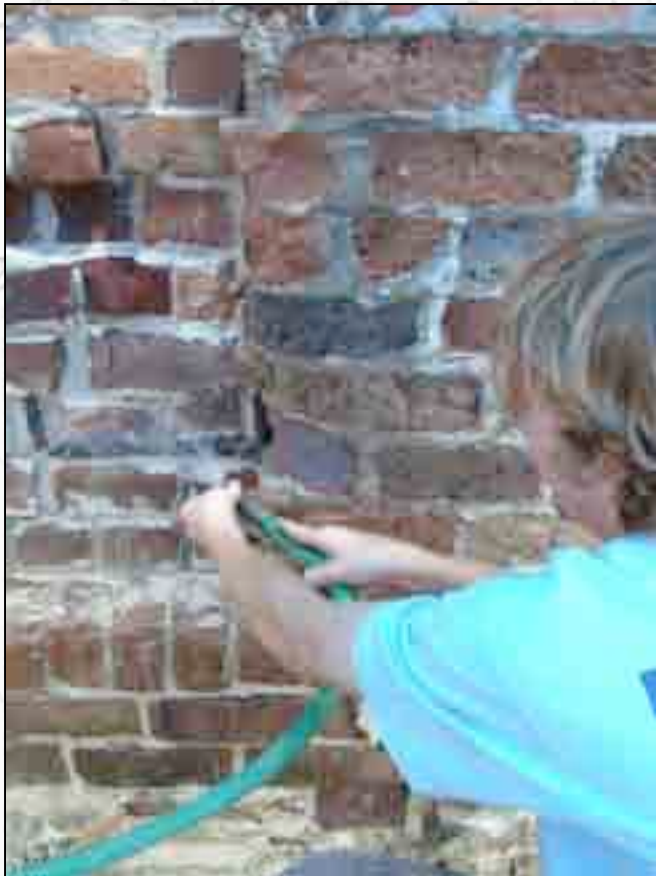
Travis and Kevin are currently removing rust from a metal member within the Carpentry Shop wall using a technique that incorporates a low-voltage electrical charge.

First, Travis and Kevin dampened the area surrounding the rusted metal.

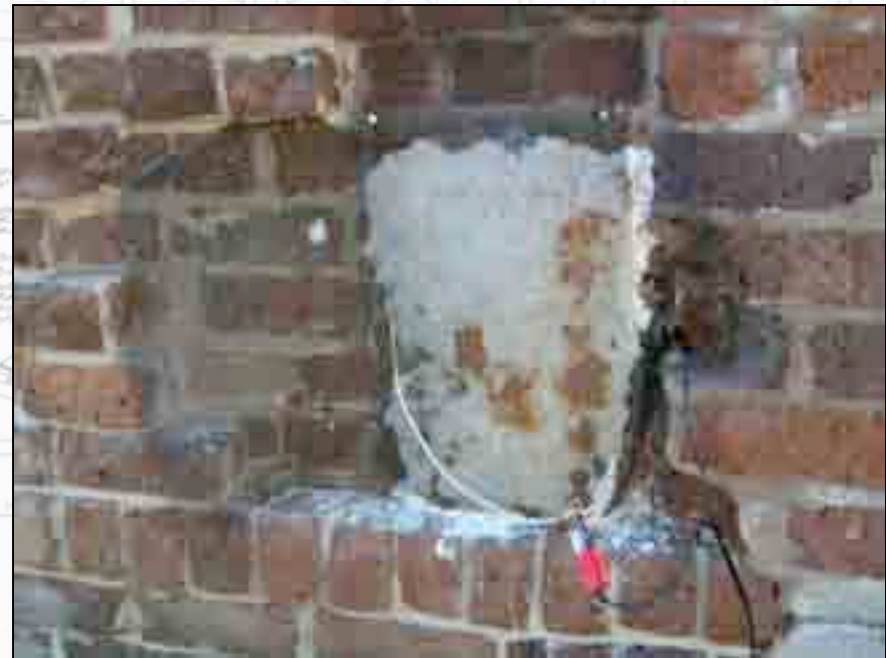
After 24 hours, the treated area is already showing signs of rust removal as oxygen is being transferred from the metal to the tissue through magnetic attraction.

A low-voltage electrical charge was then applied to the area.

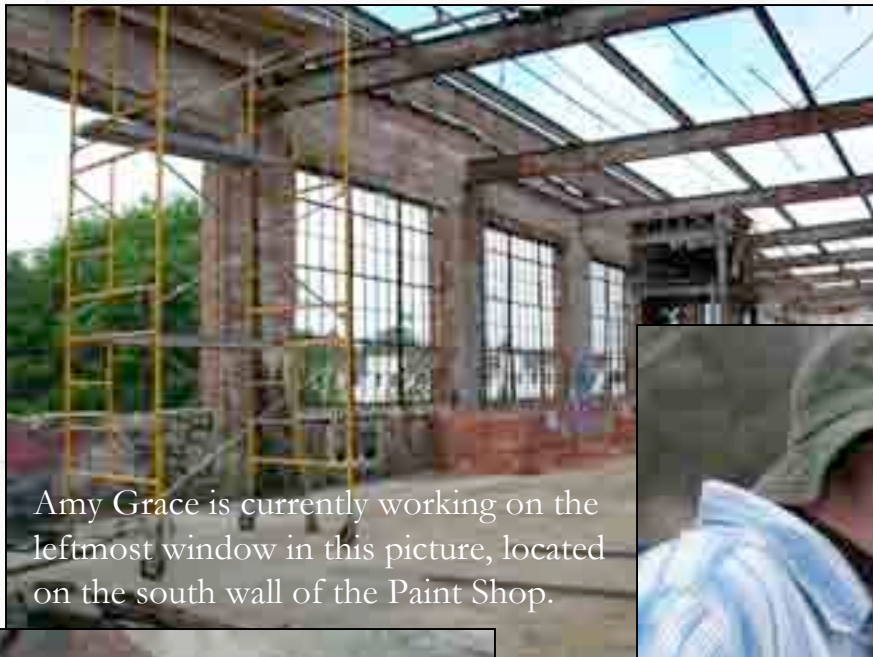
Amy Grace is currently working on the leftmost window in this picture, located on the south wall of the Paint Shop.

Amy Grace is removing a portion of the concrete sill where rust jacking has occurred in the window frames of the Paint Shop. The rebar will be removed and replaced, and Jahn concrete repair will be used to fill the remaining hole.

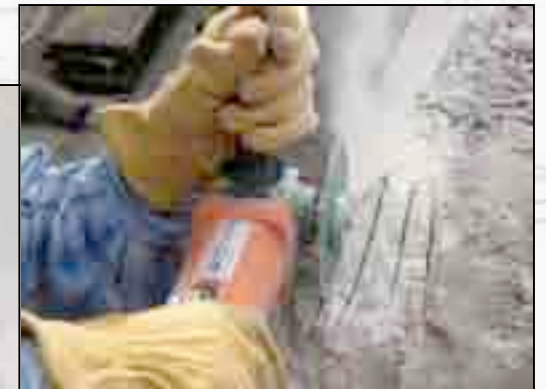
Amy Grace cuts hatch marks into the concrete sill in order to remove areas of rust jacking.

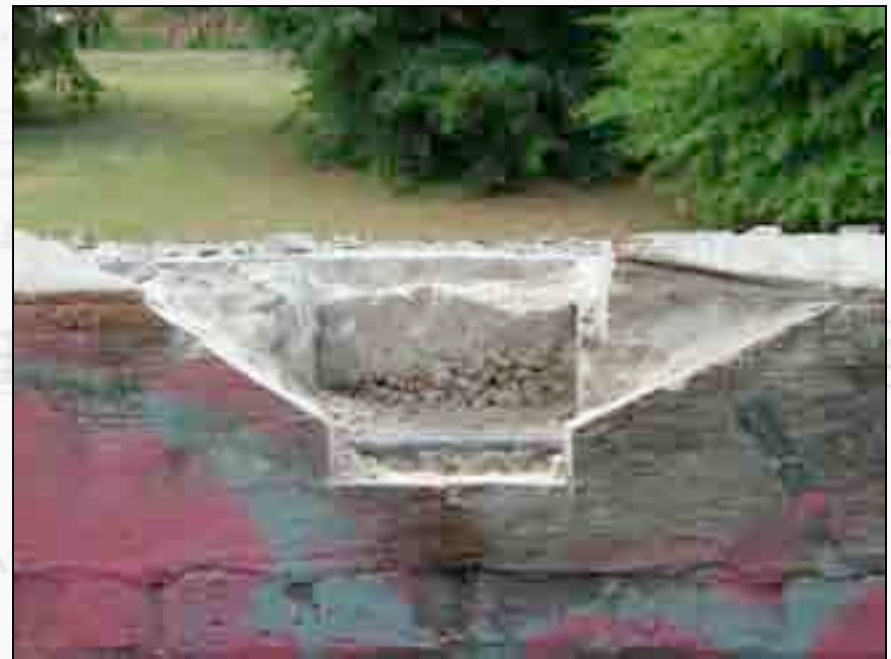
Close-up view of area where rebar will be replaced and Jahn concrete repair will fill the void.
