Coastal Heritage Society

April 2007

Carpentry Shop 1853

Stabilization

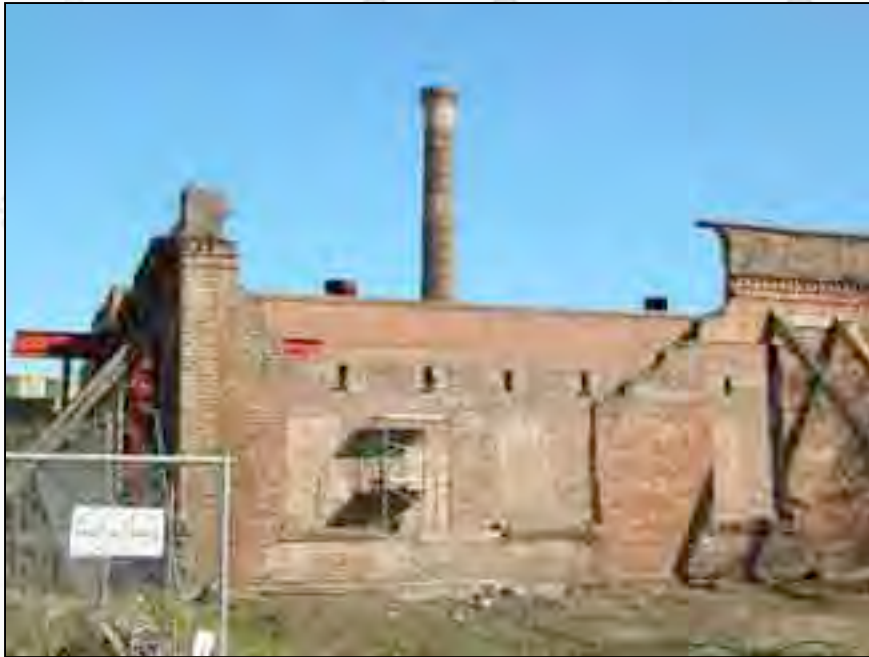
Southern Preservation Systems is currently rebuilding the west wall of the Carpentry Shop.

View of west wall before repairs.

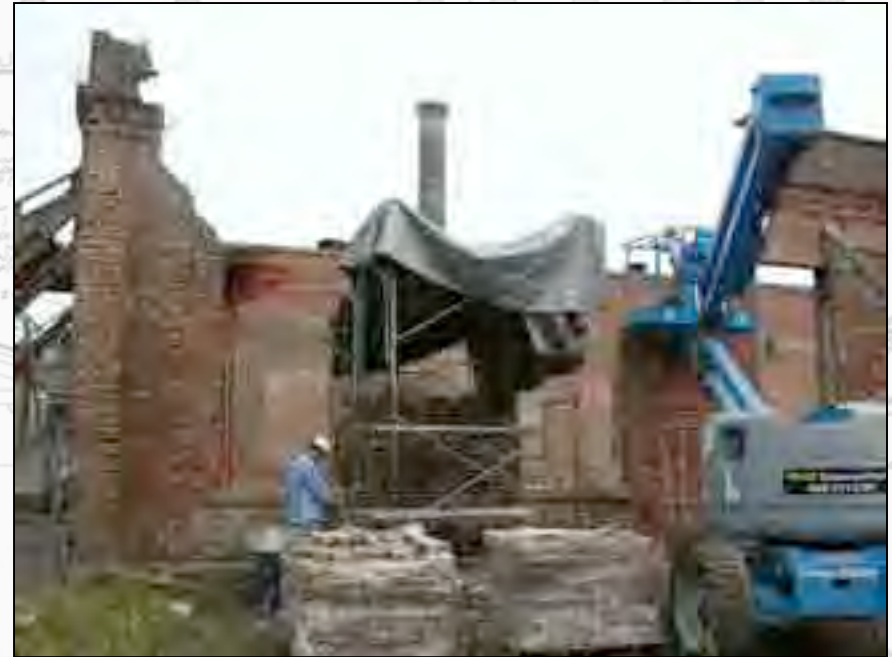
Rebuilding in progress.

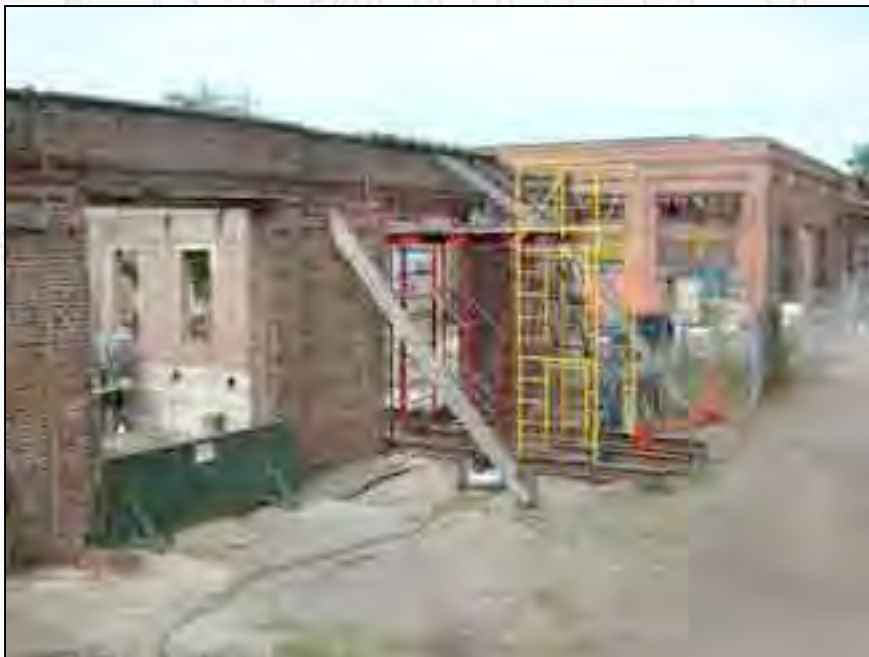
Steel repairs are currently being made to reinforce the north wall of the Carpentry Shop. Before this could happen, the masonry crew had to remove the bricks surrounding the steel lintels.

Masonry around the door lintels on the north facade was recently removed to facilitate steel reinforcements to the wall.

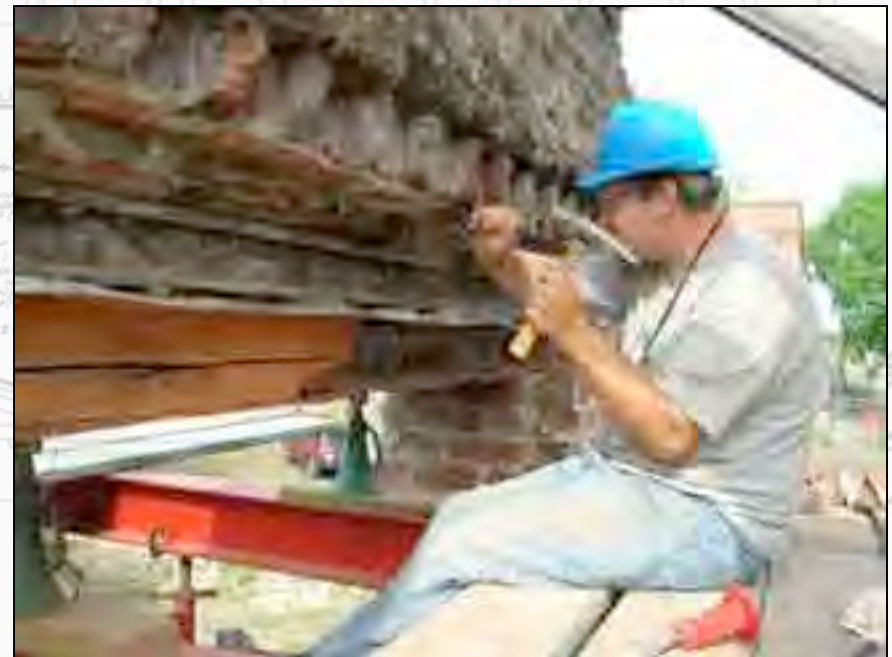
Gary Thorne chips away portland cement to remove masonry surrounding the lintel.

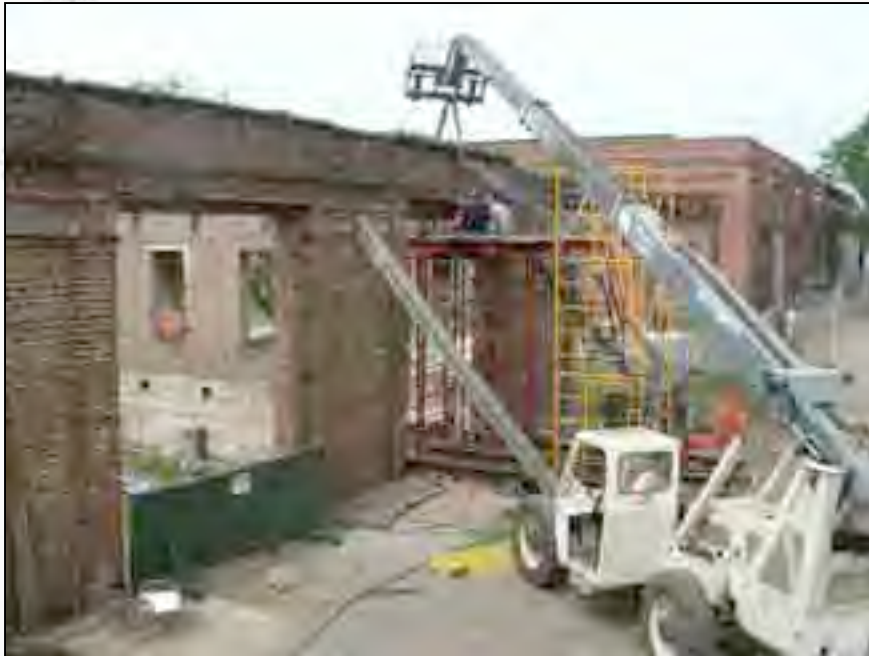
The steel crew is currently installing steel reinforcements in the north wall of the Carpentry Shop.

A forklift keeps the wall secure while the steel crew works on the lintel.

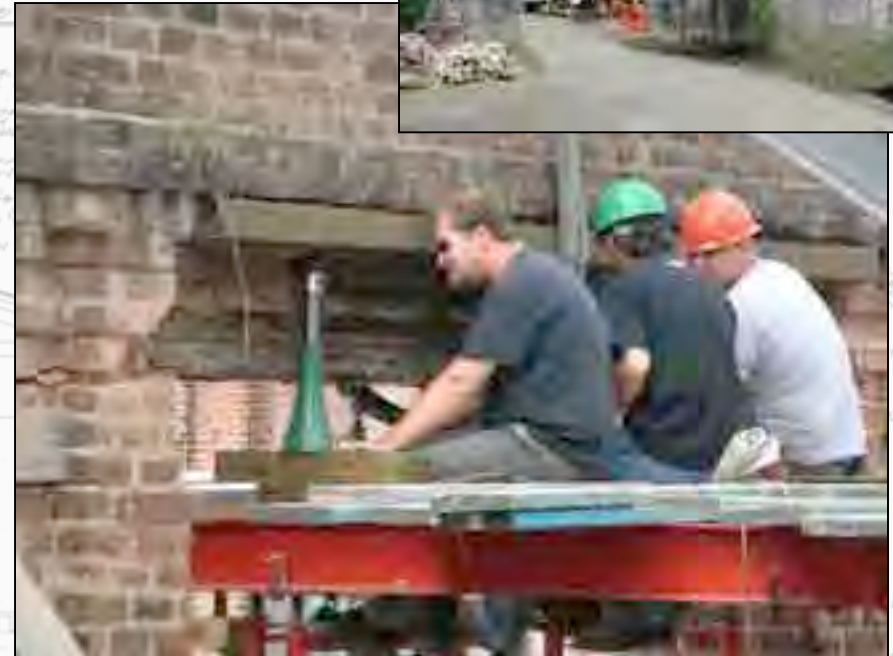
Justin Rowles, Bryan Law, and Project Manager Terry Koller (l-r) use a screw jack to hold the temporary lintel firm while they secure it in place.

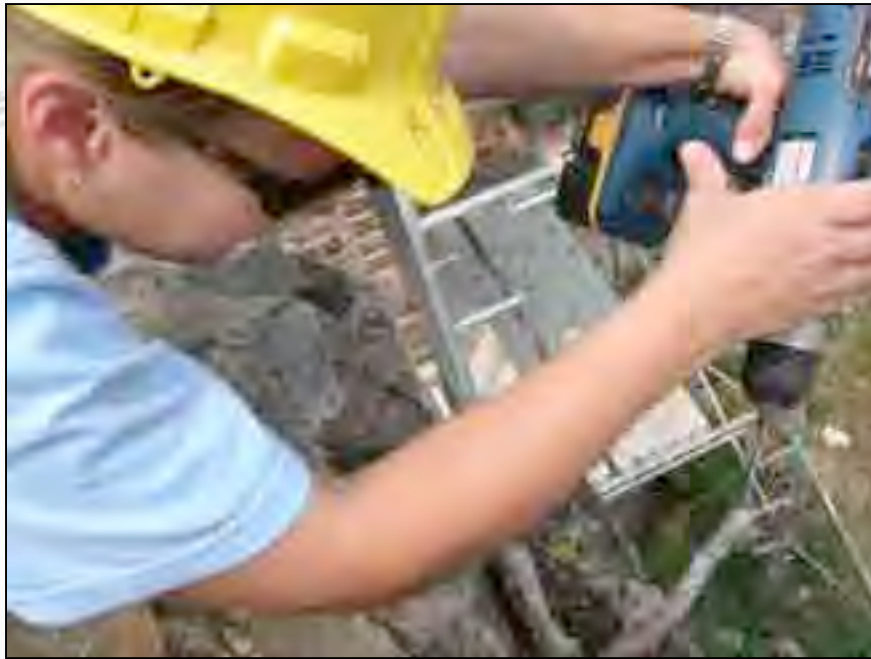
Project Manager Patricia Davenport has been killing vegetation on the west wall of the Carpentry Shop as part of her vegetation maintenance plan for the site.

For large outcroppings of plant growth, Patricia drills holes into woody stems.

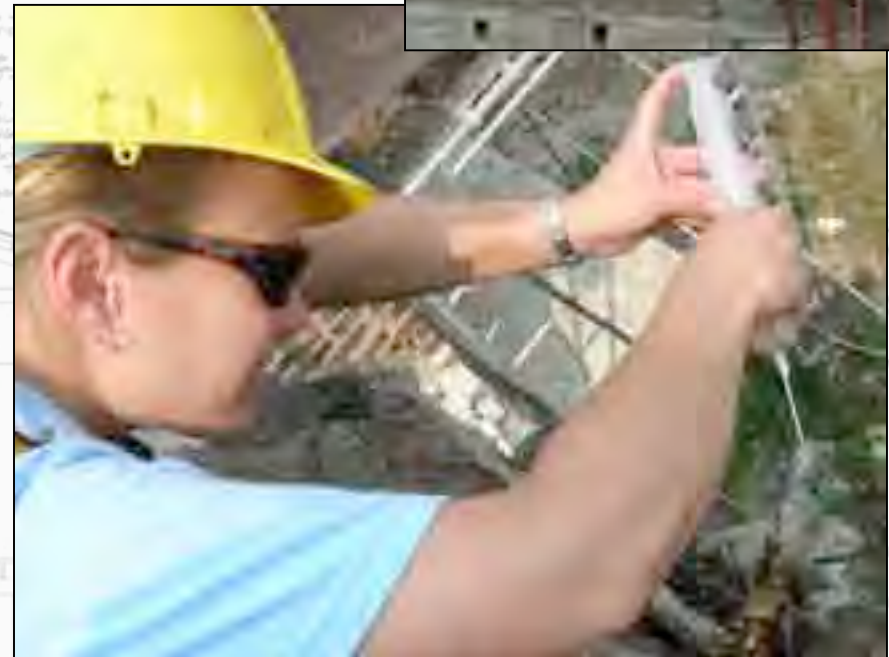
Then she injects the stem with an herbicidal solution that will kill the plant without harming the building.

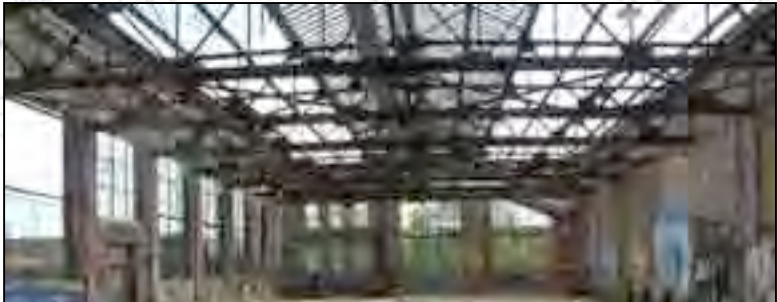
All of the original severely deteriorated window sashes in the Coach Shop have been removed in order to restore or replace them in kind.

Interior of Coach Shop before windows were removed.

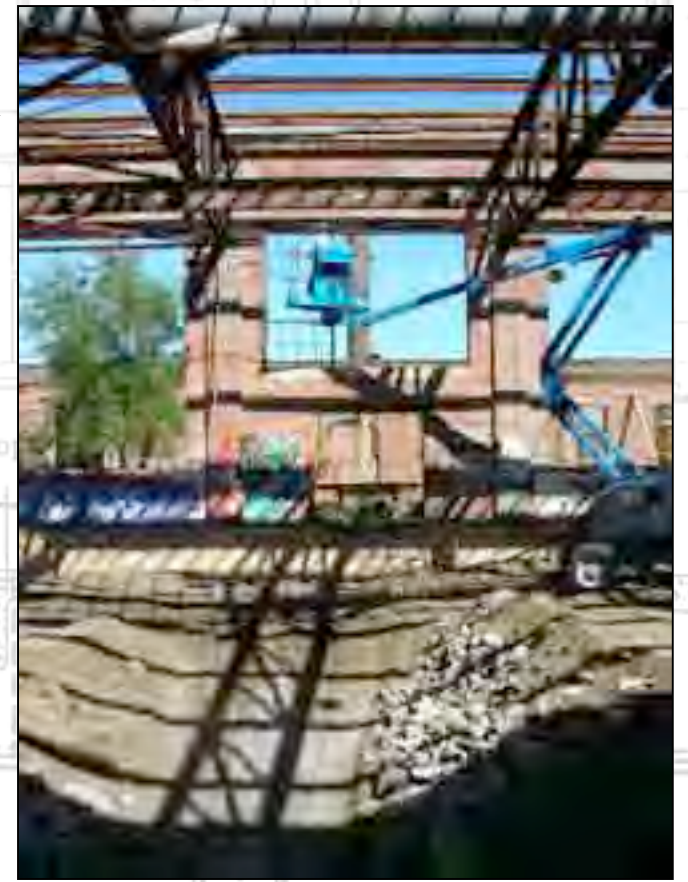
Current view of west wall. All windows have been removed.

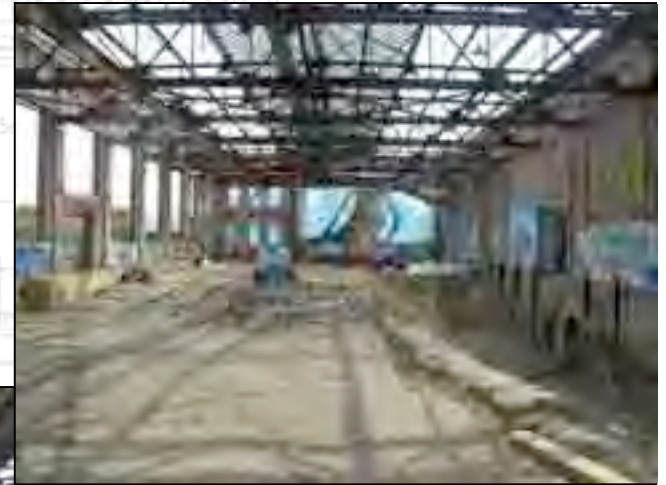
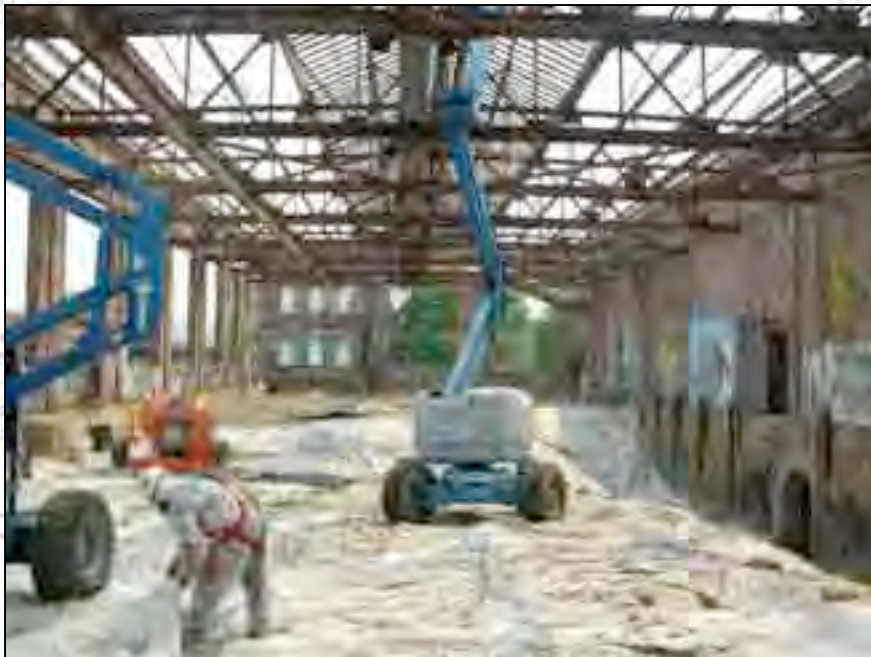
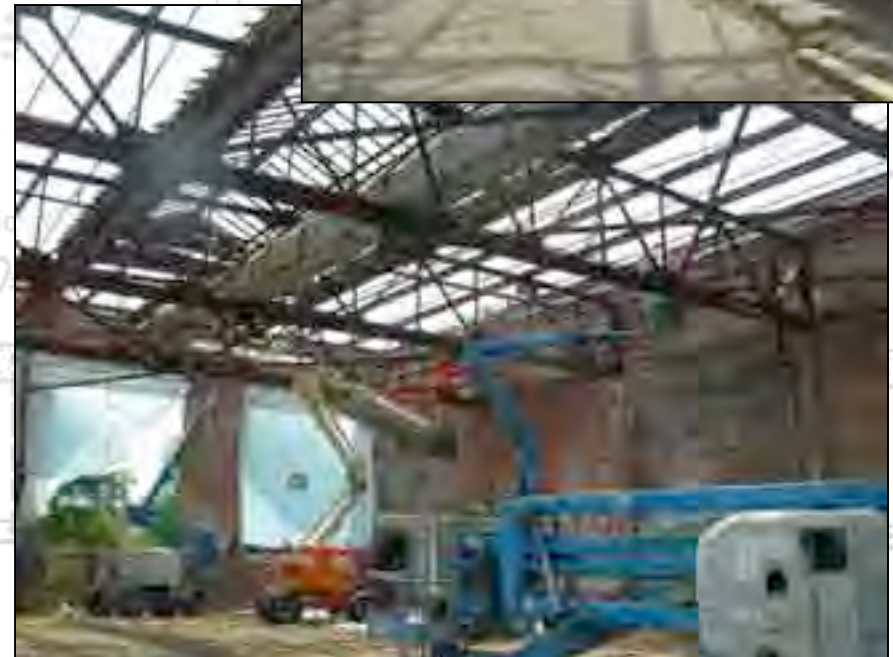
The interior of the Coach Shop is currently undergoing remediation of lead dust on the steel roof structure. Winter Construction is heading up this project. Once complete, the remediation will provide a safe environment for CHS crew and contractors to safely begin repairs to the steel roof structure and skylight.

Interior views of Coach Shop during remediation.

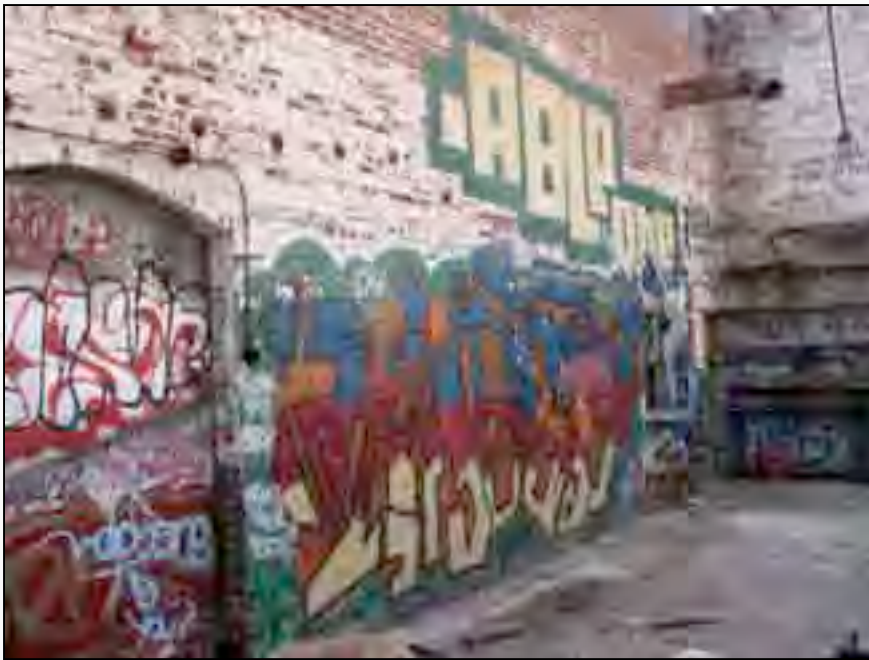
Graffiti has been applied to the building within the past 25 years, prior to the City of Savannah's ownership of the property. CHS Preservation Team member Jason Cobb has been removing graffiti from various areas in the Paint Shop.

East wall of the Paint Storage Room located on the main floor before graffiti was removed.

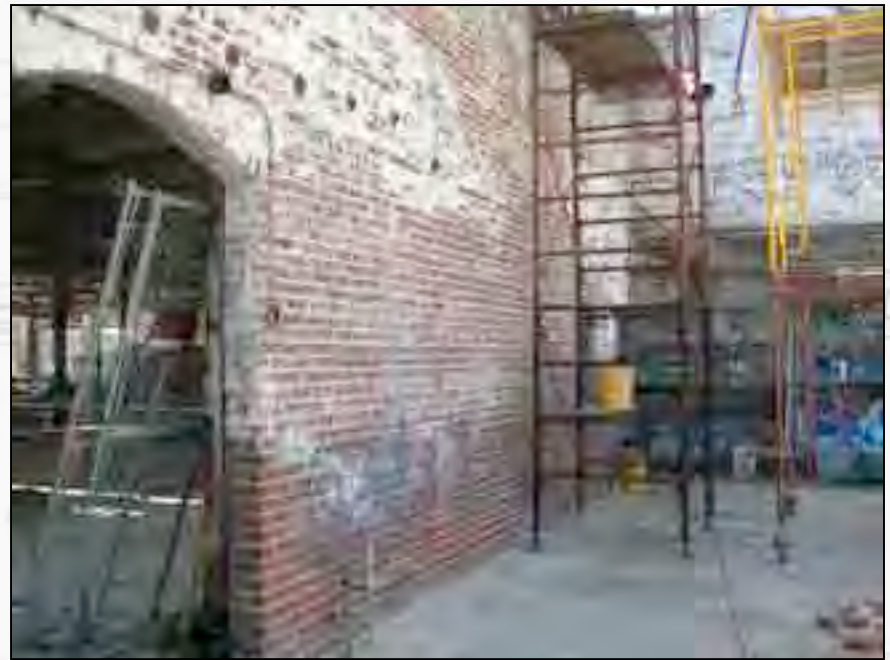
Current view after graffiti was removed.

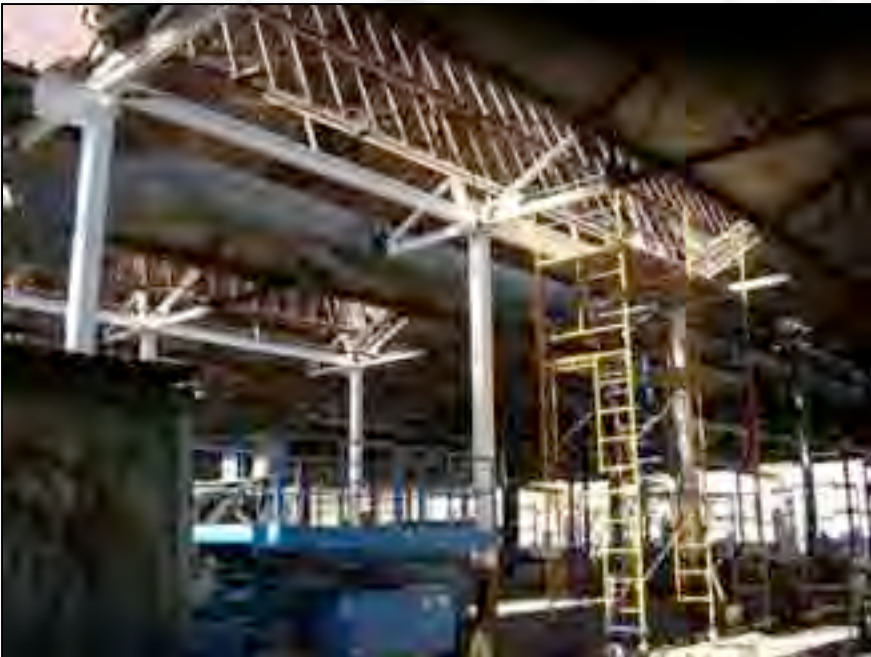
The CHS Preservation Team continues to make repairs to the sawtooth roof.

View of two northernmost sawtooth roof valleys shortly after project began.

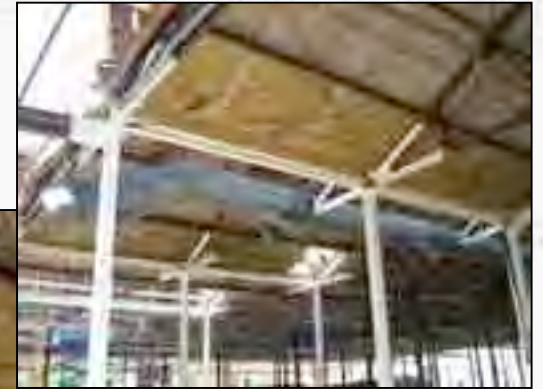
Current views with two repaired valleys.

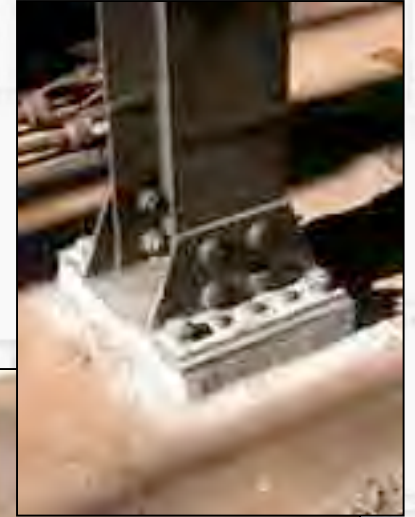
Finished column base

After the steel columns were repaired and restored, Preservation Team members painted and grouted the bases.

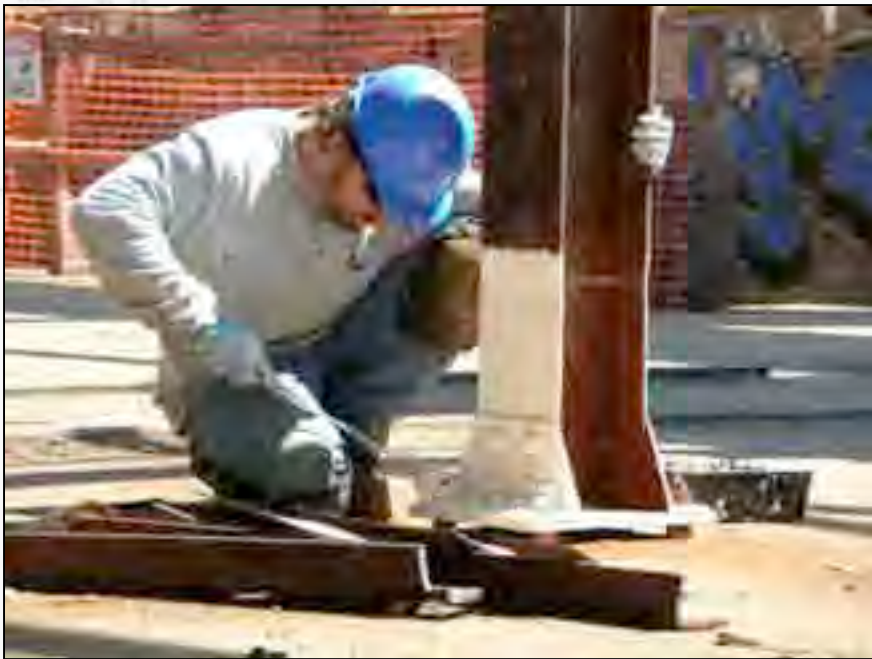
Kevin MacMillan primes the base of the column before painting it Central of Georgia bottle green.

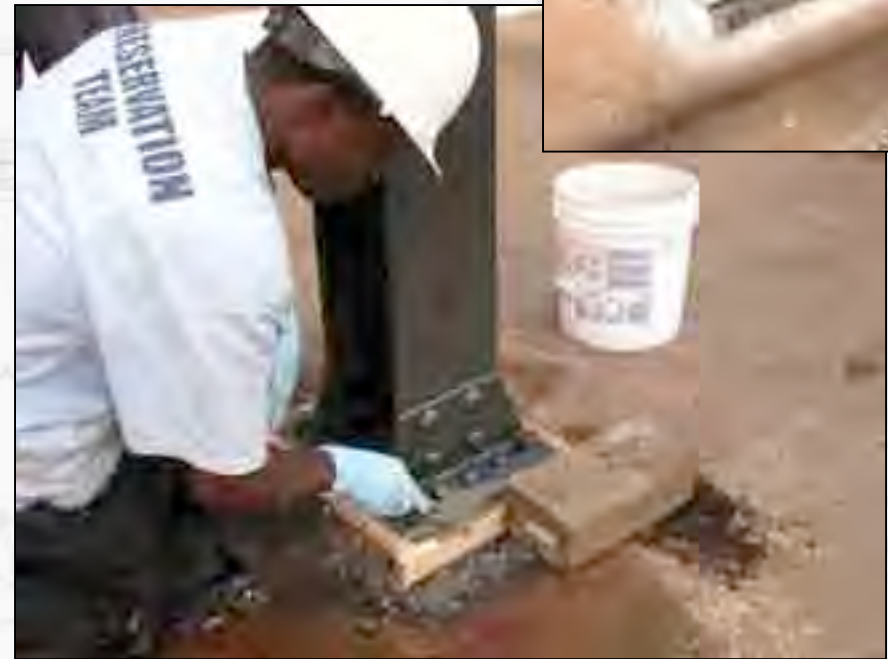
Using a wood form, James Jackson grouts the space between the column and floor with concrete.

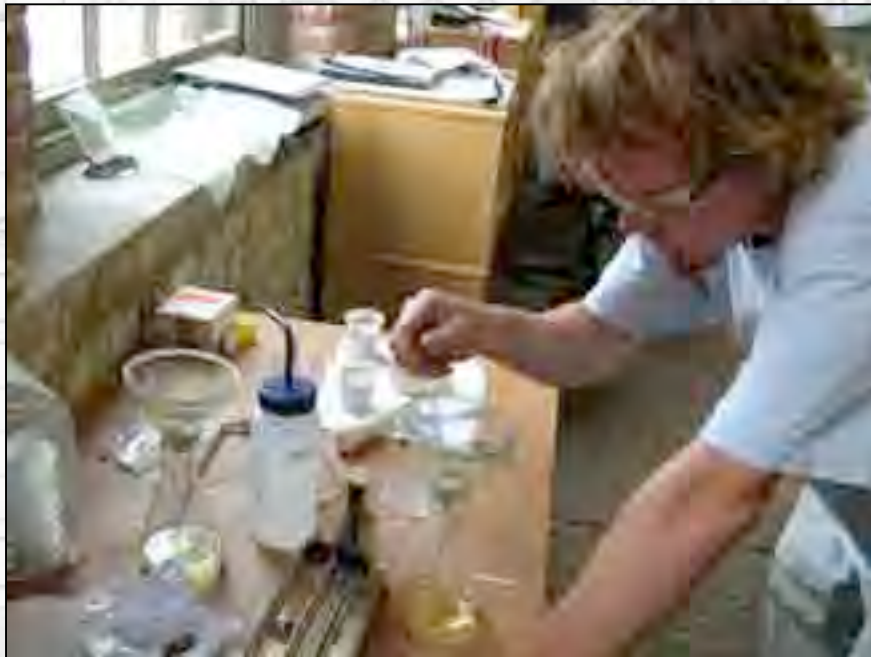
The first step in accurately restoring masonry is to perform a mortar analysis to determine the basic characteristics of sand in the original mortar. This information allows preservationists to match new mortar as close as possible to that used in the original construction.

After mortar samples are taken for analysis, Project Manager/Preservation Masonry Foreman Travis Brown separates the sand from the mortar by applying a strong acid to the composition.

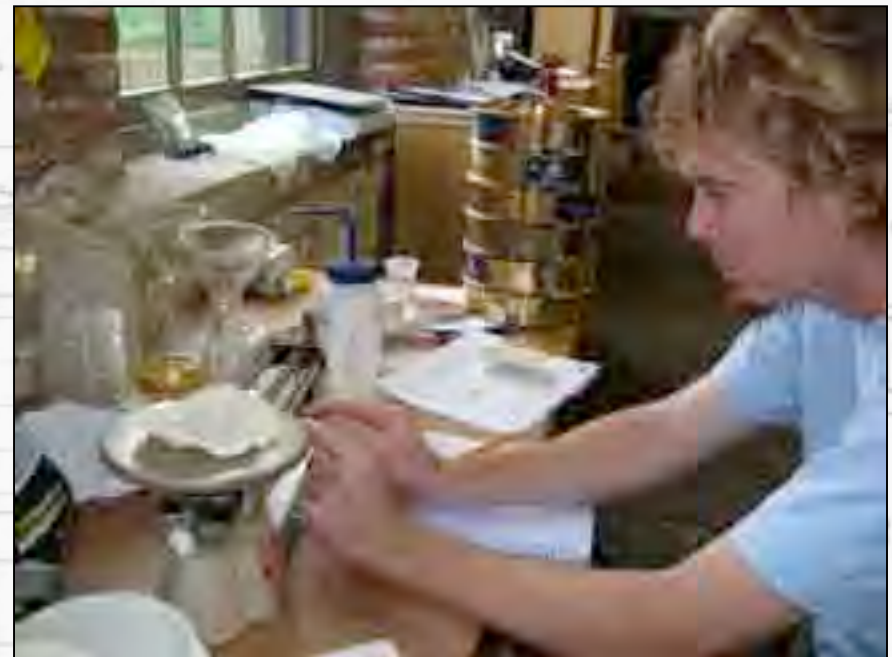
Then Travis weighs the sand that was lifted from the chemical reaction.

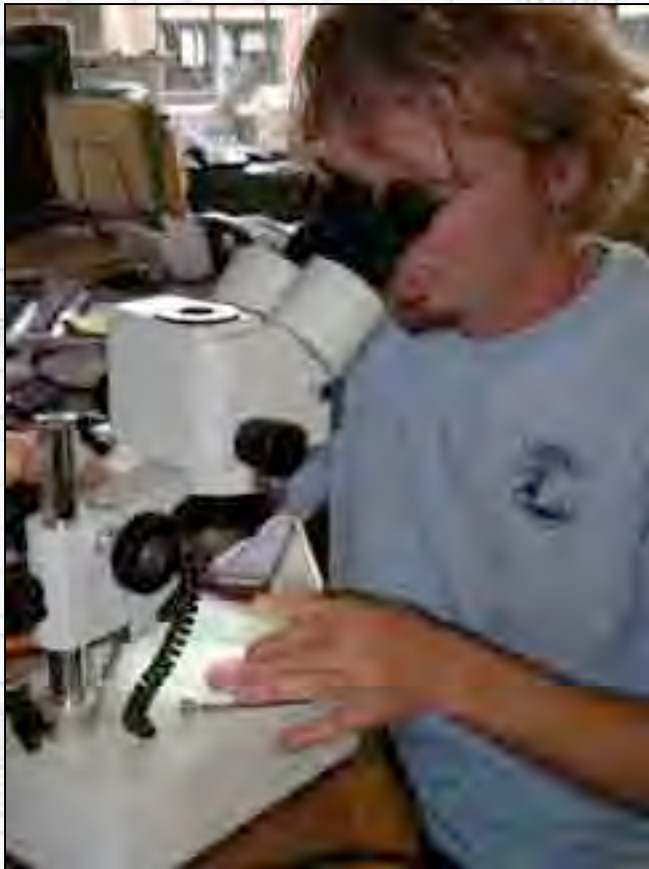
Using a microscope, Travis closely examines the color and shape of the sand.

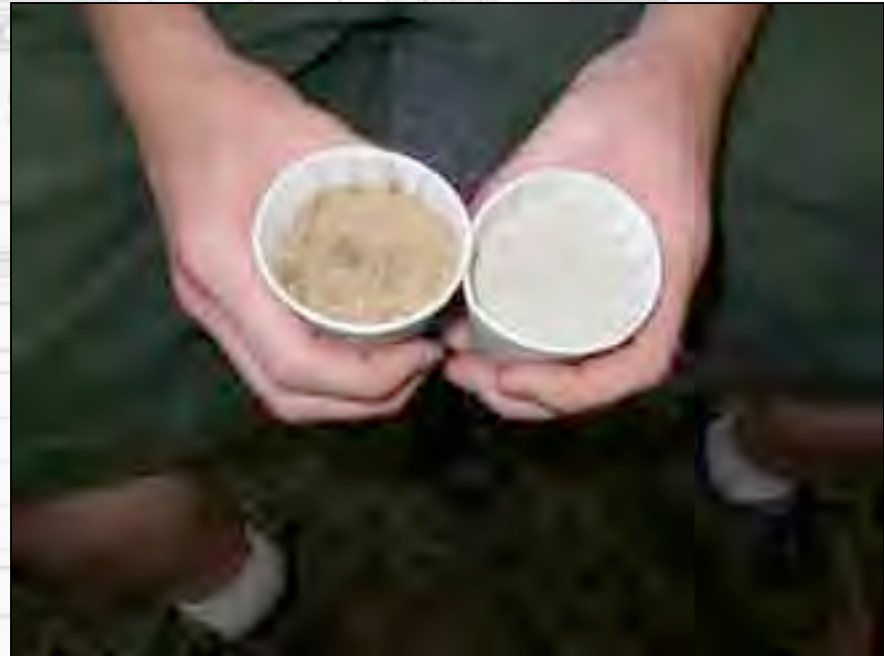
The mortar analysis shows that Savannah River sand (left) was historically used on most of the buildings in the repair shops complex; however, a finer sand with less color was originally used on the passenger station.

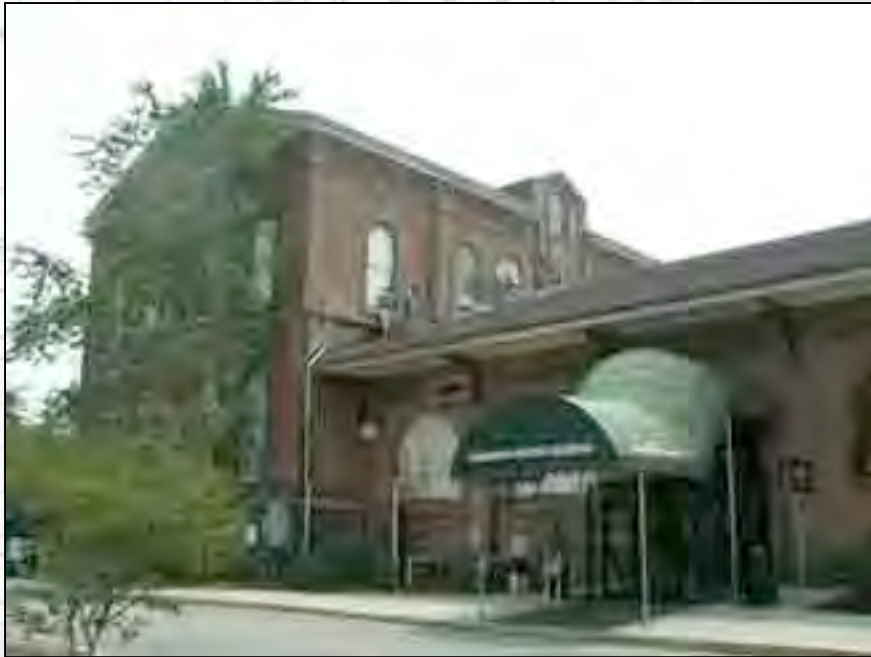
Exterior view of CHS offices and Savannah History Museum. Preservation Team members remove deteriorated mortar while Project Manager Eric Davenport assesses the windows.

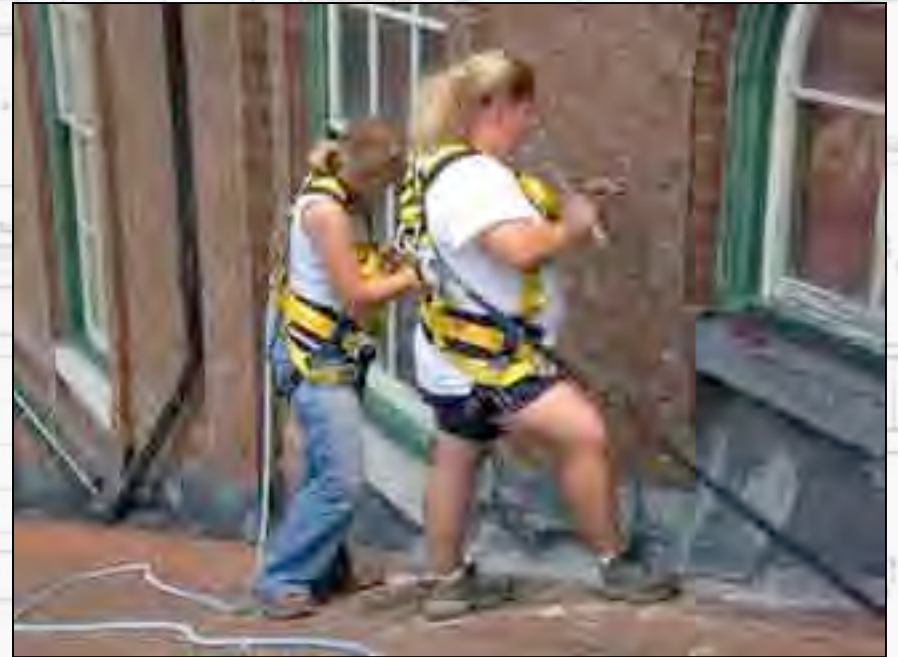
Attached to harnesses on top of the roof, Preservation Team members Tarin Erickson and Candice Leite investigate the condition of the mortar from the second story west façade of the Visitors Center.

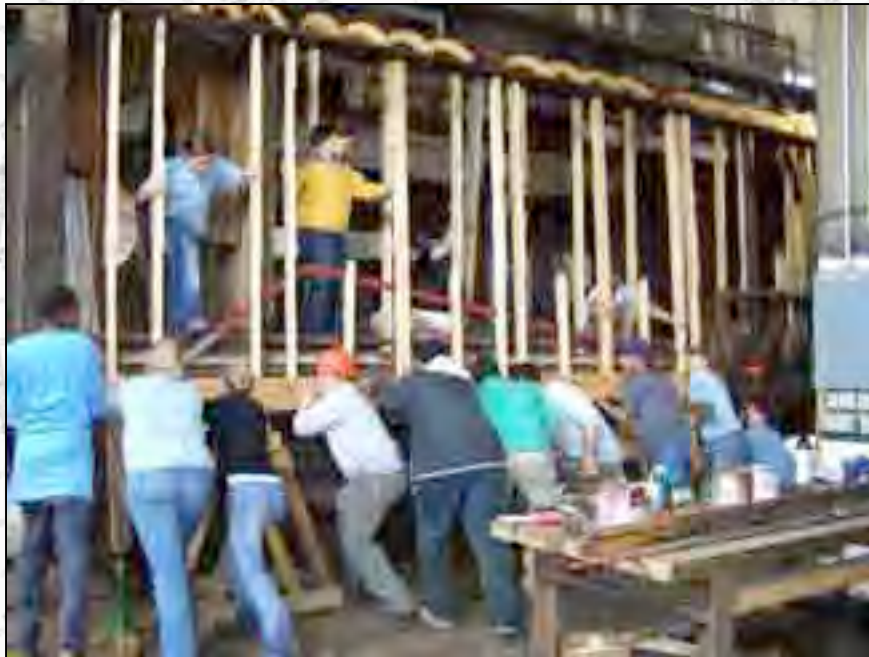
The Railroad Operations team is currently stabilizing the Thronateeska, a combination car that held baggage and passengers, and replacing components of the historic construction as needed.

Teamwork at its best! Preservation and Rail Ops members pitch in to change out a deteriorated wall section of the Thronateeska with a new one.

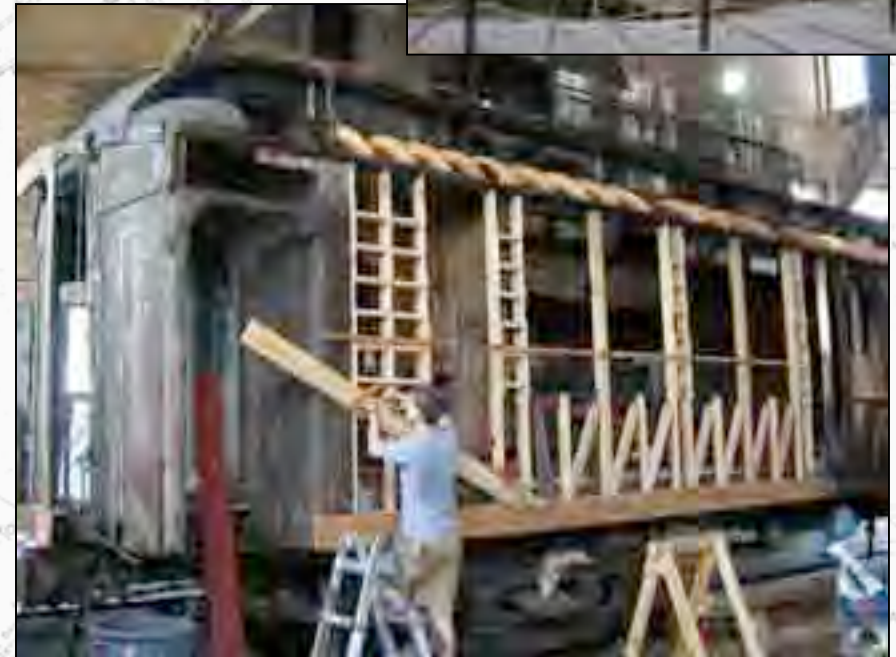
Ian Ashenfelter replaces deteriorated wood framing members that could not be reused.
