Coastal Heritage Society

Visitors Center • Roundhouse Railroad Museum • Old Fort Jackson

Preservation Team • Railroad Operations • Archaeology

August-September 2006

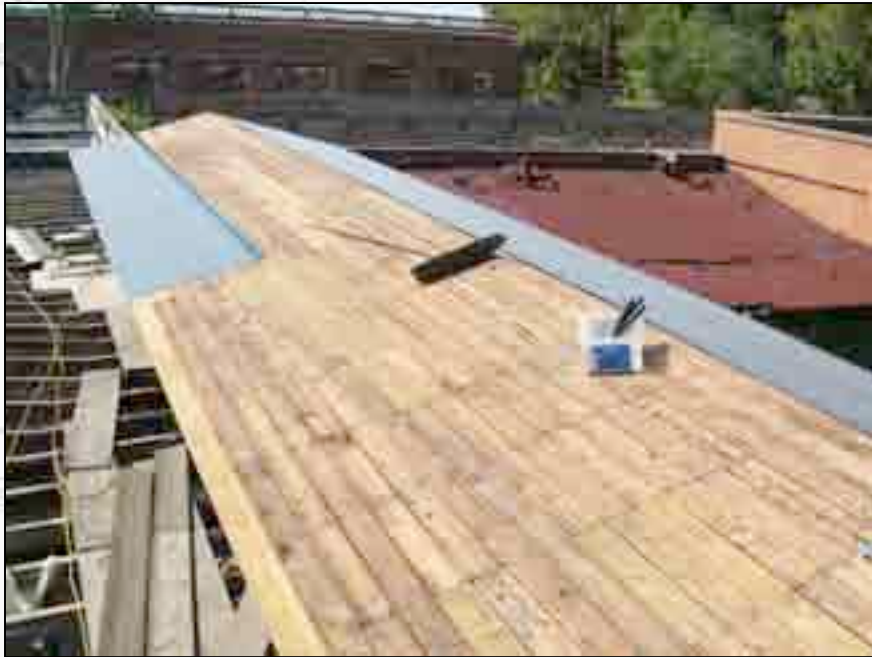
View of the roof decking as it is being repaired. The Preservation Team was able to reuse most of the existing deck boards, replacing only a few.

CHS Preservation Team members, Ian Ashenfelter, Nathan Harris, and Jack Tyson work to rebuild the monitor roof of the Compressor Room.

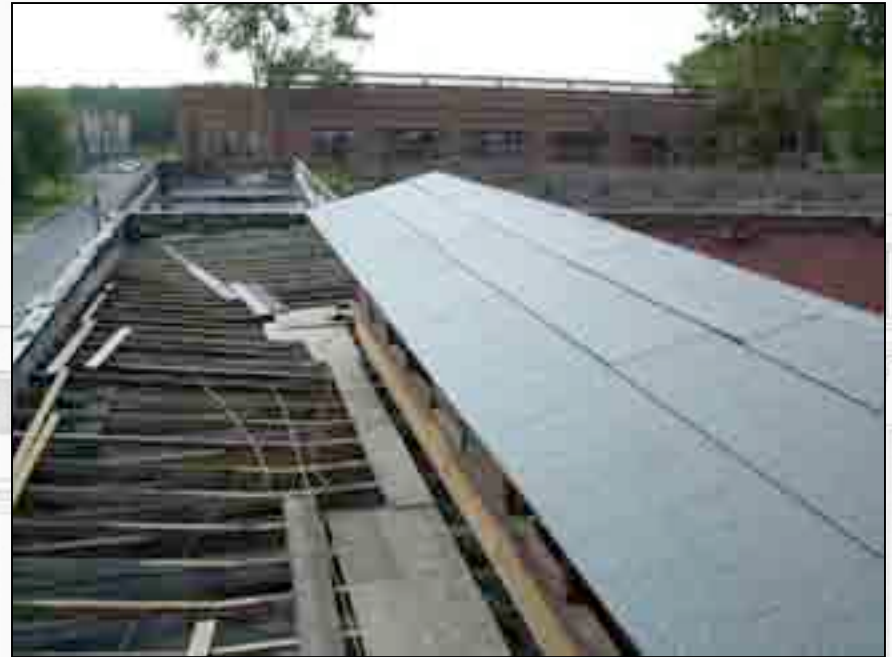
Current view of monitor with new decking and primary water proofing membrane.

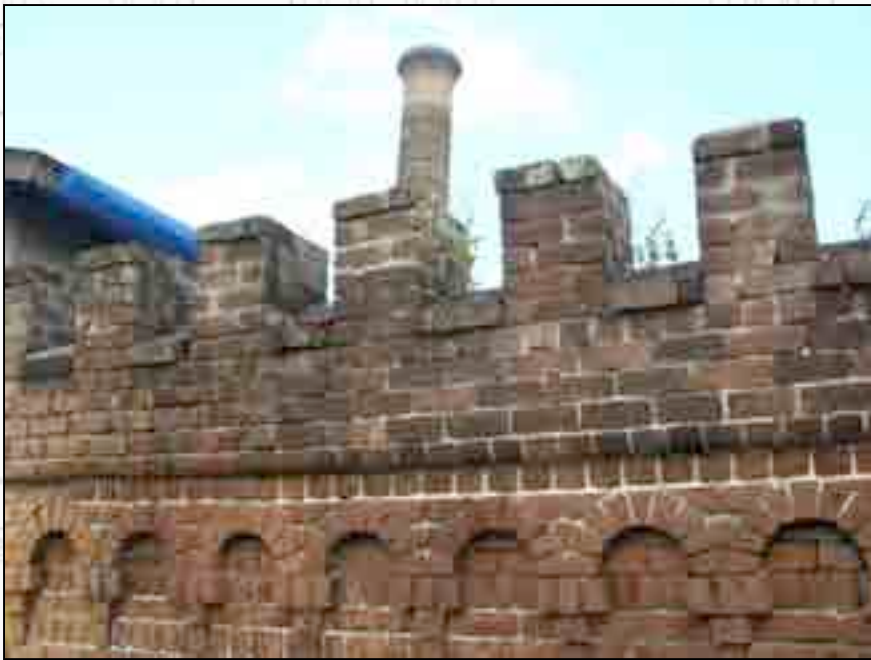
Mortar joints on the Boiler House are severely deteriorated. Repointing has started on the west façade of the building.

Close-up view of deteriorated mortar joints

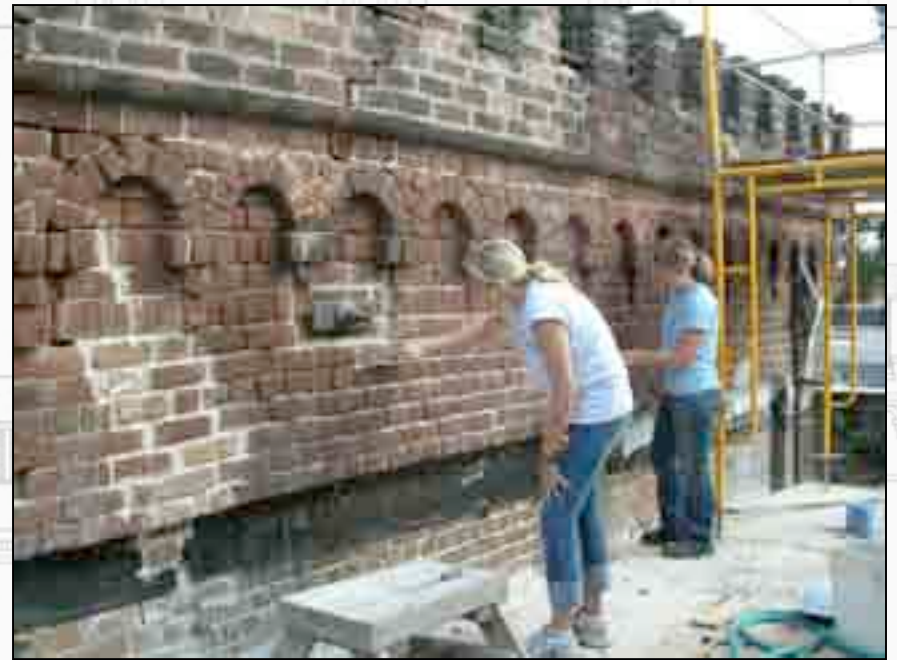
Newcomers, Brittany Barton and Tarin Erickson, take out deteriorating mortar from masonry joints.

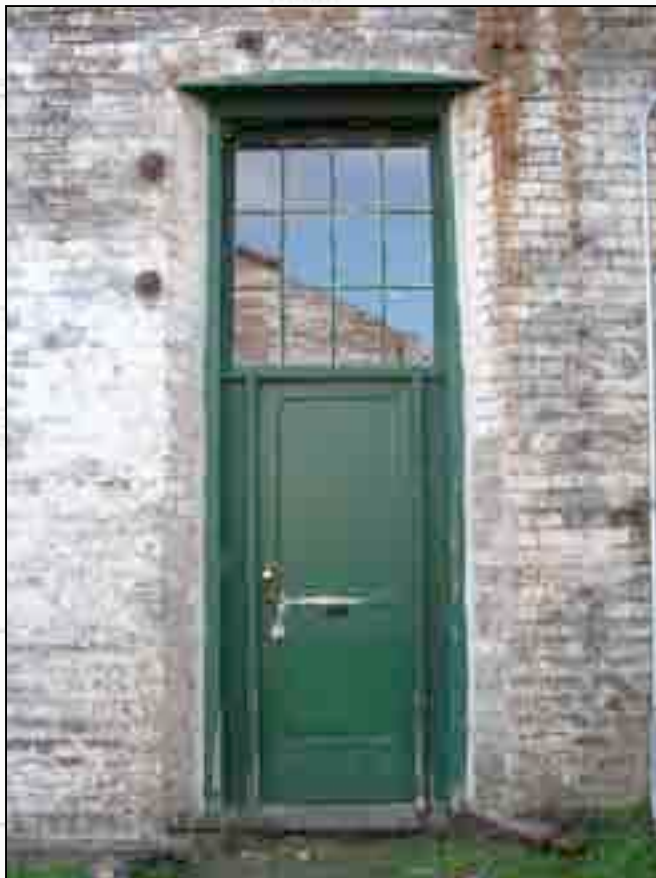
The temporary door on the west façade was falling apart and needed replacing. Since the door was a modern addition, it was replaced with one inspired by historic doors on the Paint Shop.

View of temporary door that was not original to the building.

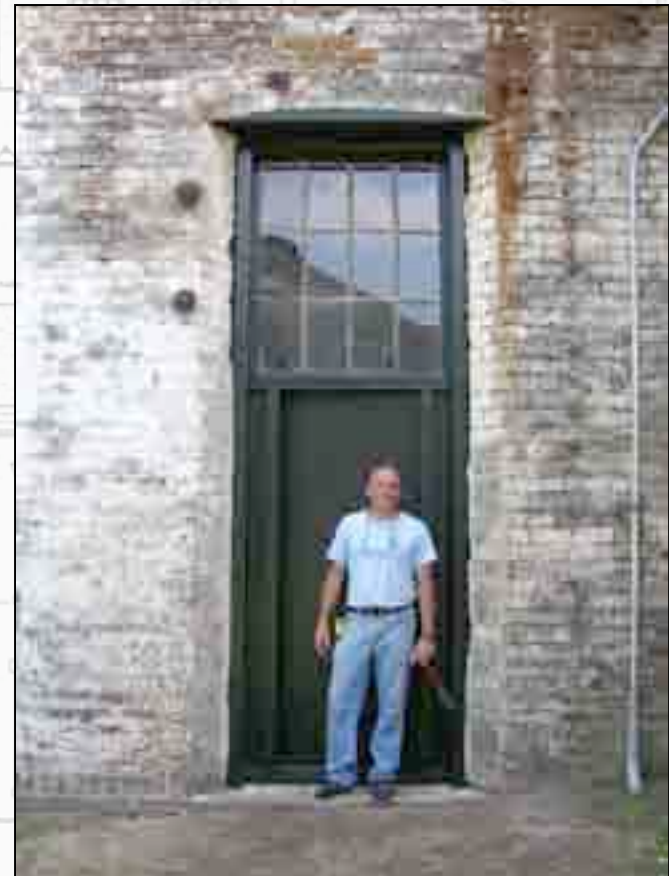
Kurt Benton stands in front of the door he constructed.

CHS Preservation Team member Kurt Benton built a door for the west façade of the Tender Frame Shop. There was no historic documentation for the appearance of the original door, so the design of the door was inspired by the original Paint Shop doors.

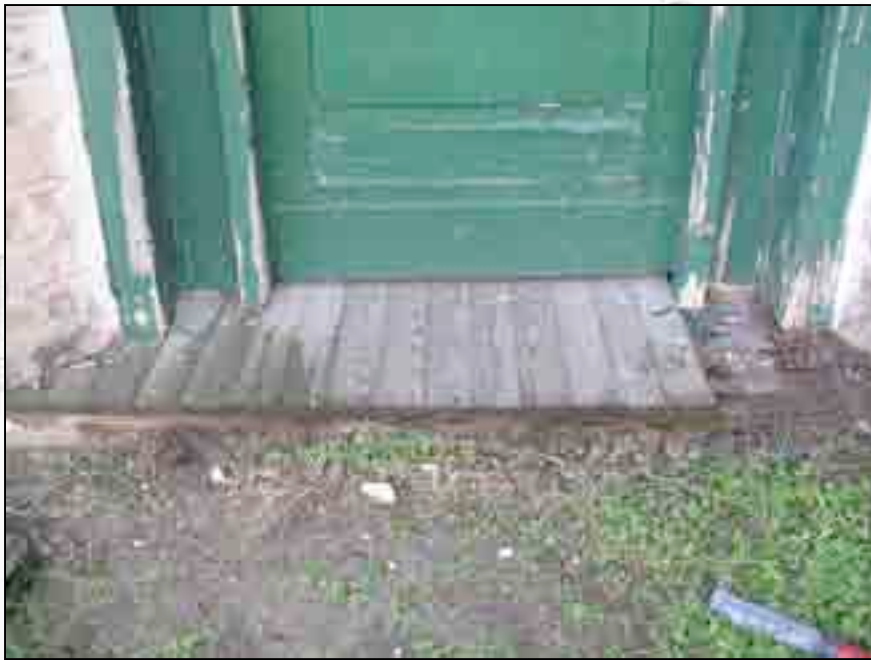
The west façade door sill was suffering from termite damage and rot. CHS Preservation Team members repaired and replaced the threshold.

View of threshold before work began.

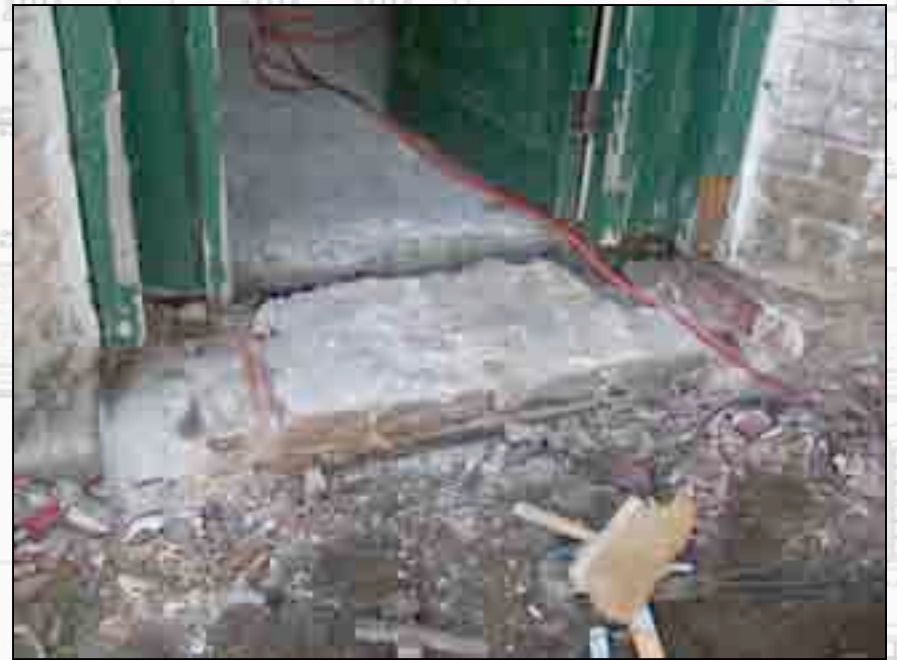
View of masonry found under rotted wood.

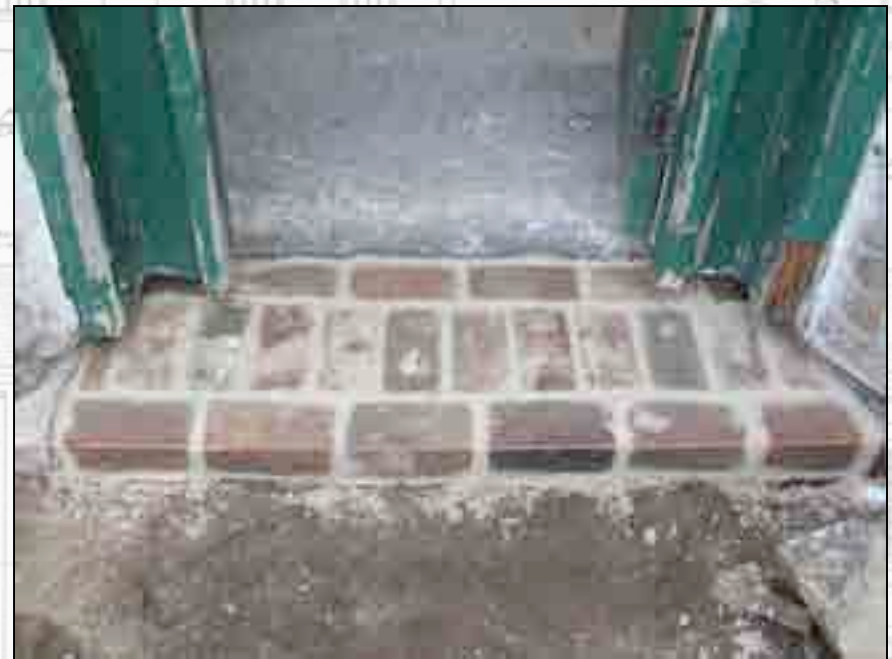
Finished view.

Under the guidance of Travis Brown, Masonry Foreman, Loraine Rodriguez repaired and replaced the threshold.

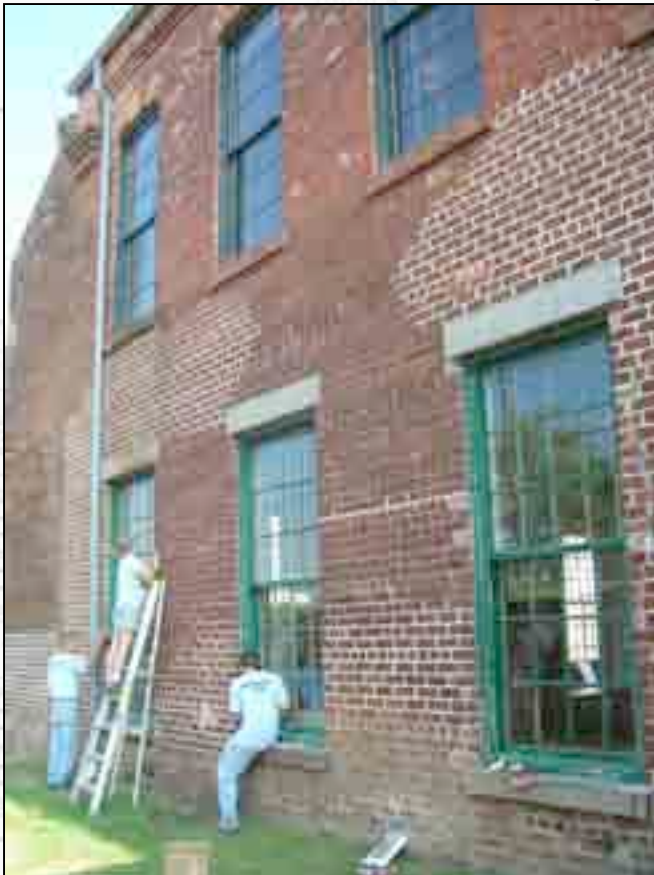
Charles, Amy, and Eric scrape and sand the window frames before repainting.

The windows on the first floor of the Tender Frame Shop are currently being restored by Charles Atkins, Eric Pettingill, and Amy Ver Beek.

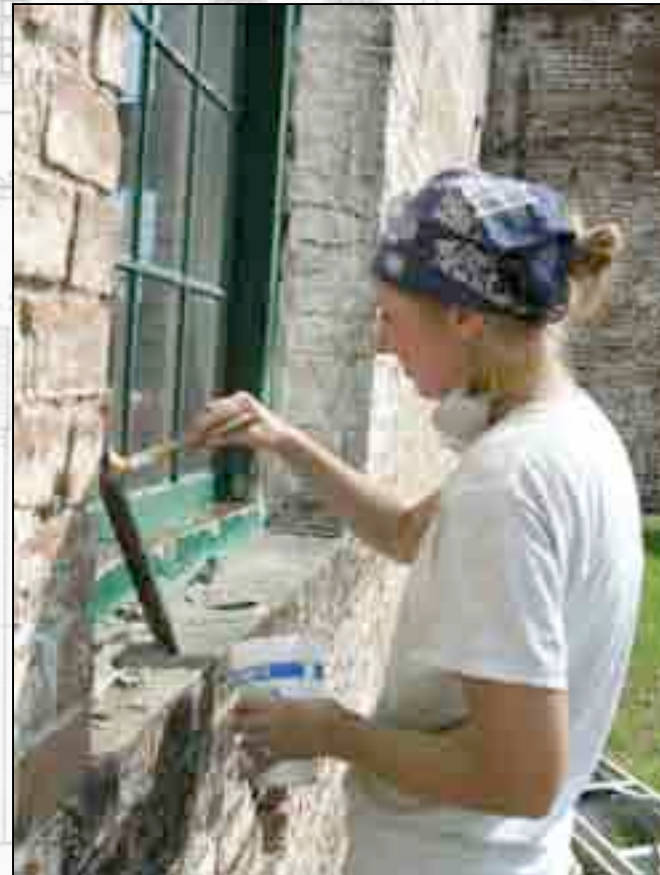
Amy applies Boracare to a Dutchman repair on the window frame. The application prevents termites and biological growth from damaging the wood.

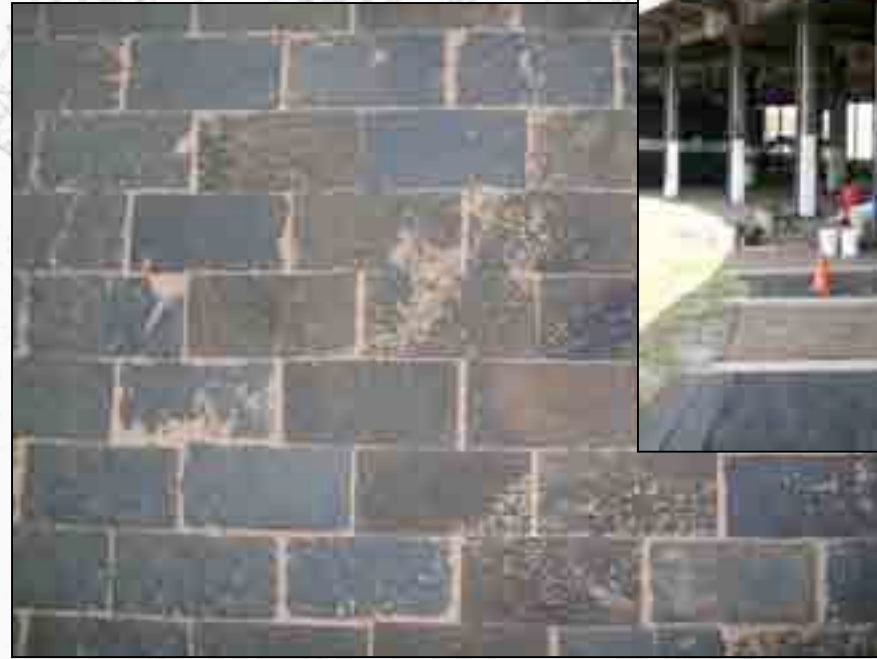
View of restored woodblock floor before a sealant is applied. Original woodblocks were used when possible.

The woodblock floors in the Overnight Shed are currently being restored.

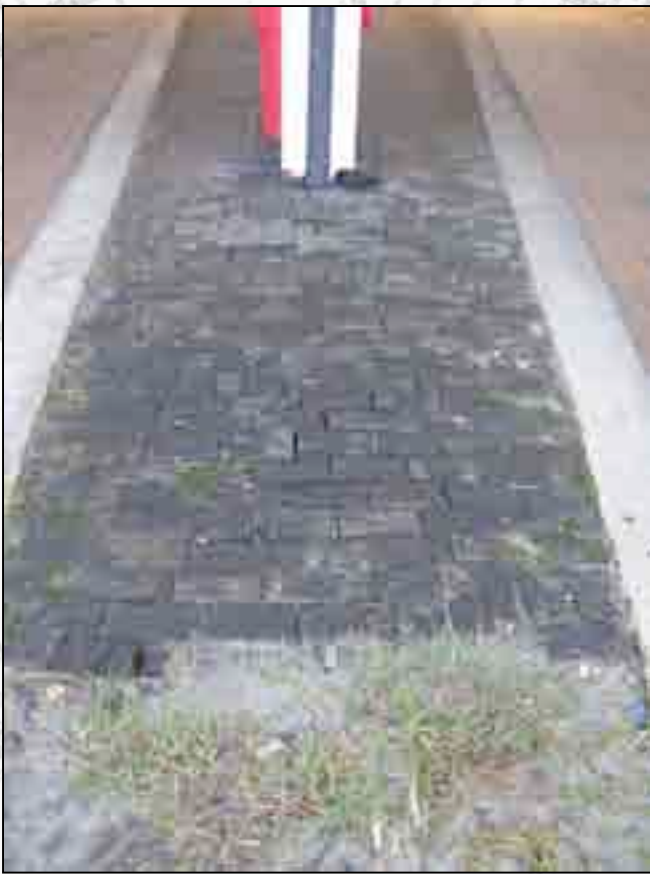
View of woodblock lane awaiting restoration.

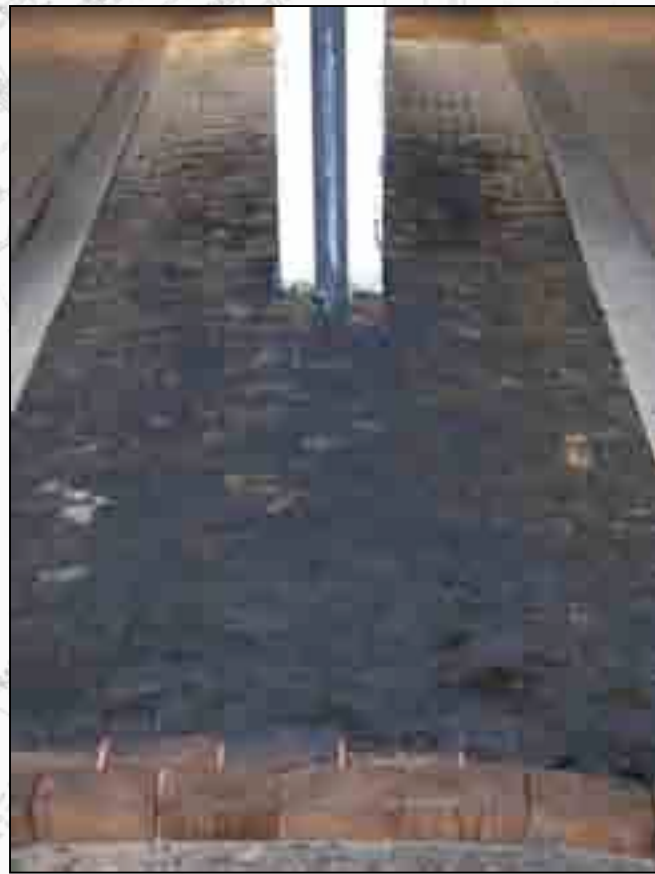
Restored woodblock lane.

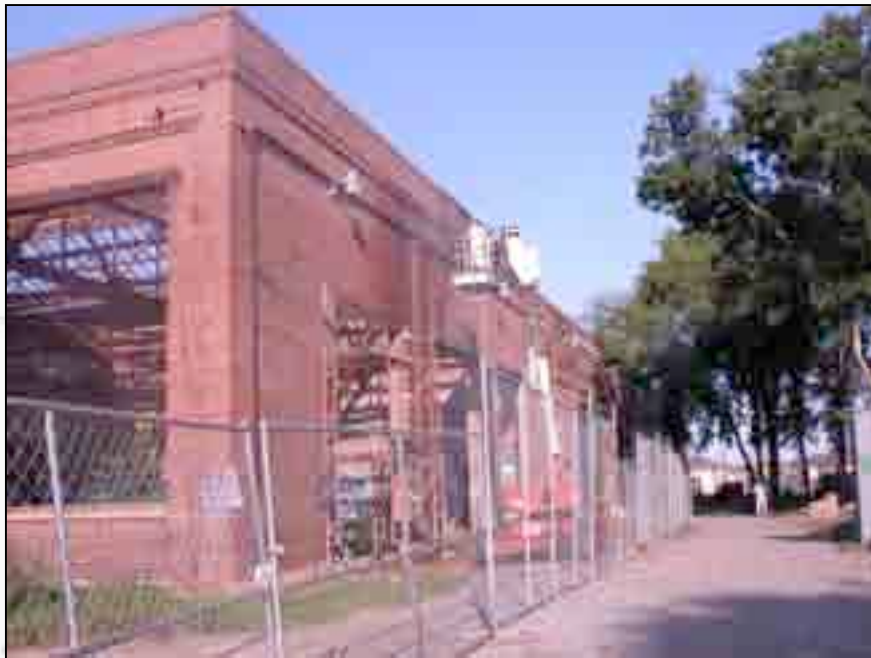
View of Coach Shop as it is being pressure washed to remove biological growth and general dirt accumulation from the last 40+ years.

Preservation Team member, Jason Cobb, is currently pressure washing the Coach and Paint Shops.

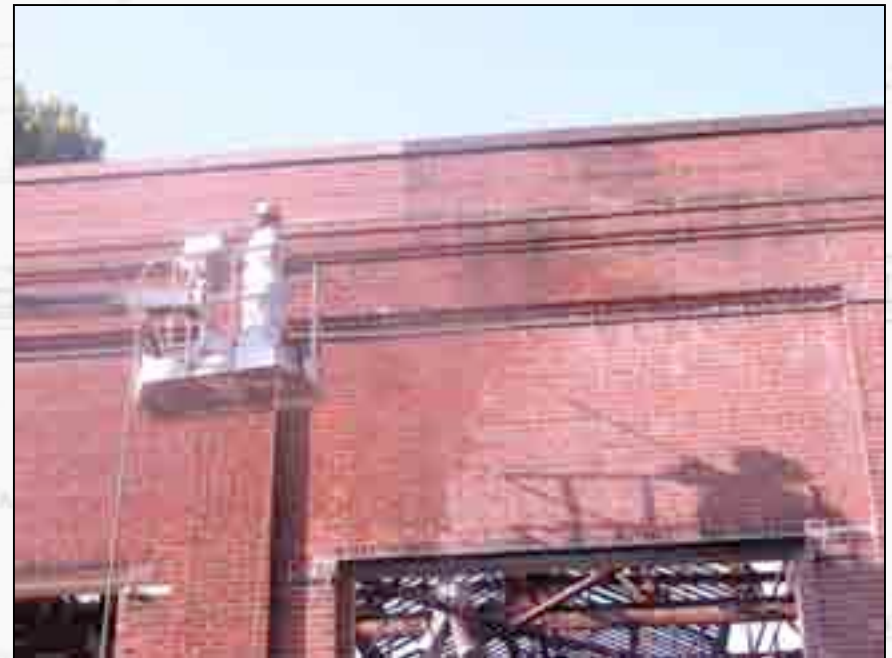
Left side of the building has been pressure washed while the right side awaits cleaning.

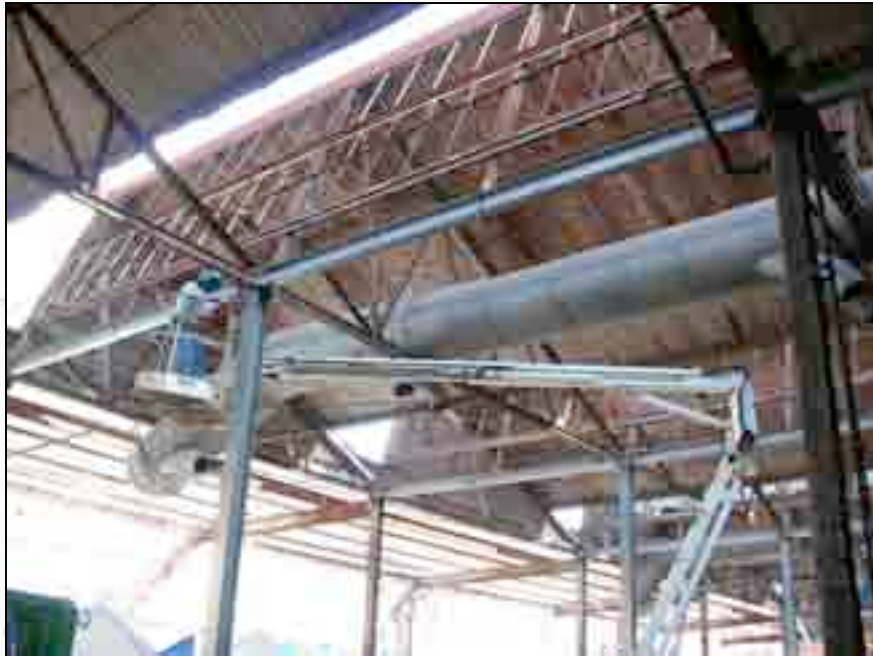
Bryan Law installs a cap plate to support cross beams.

Members of the CHS Preservation continue to repair the steel columns in the Paint Shop.

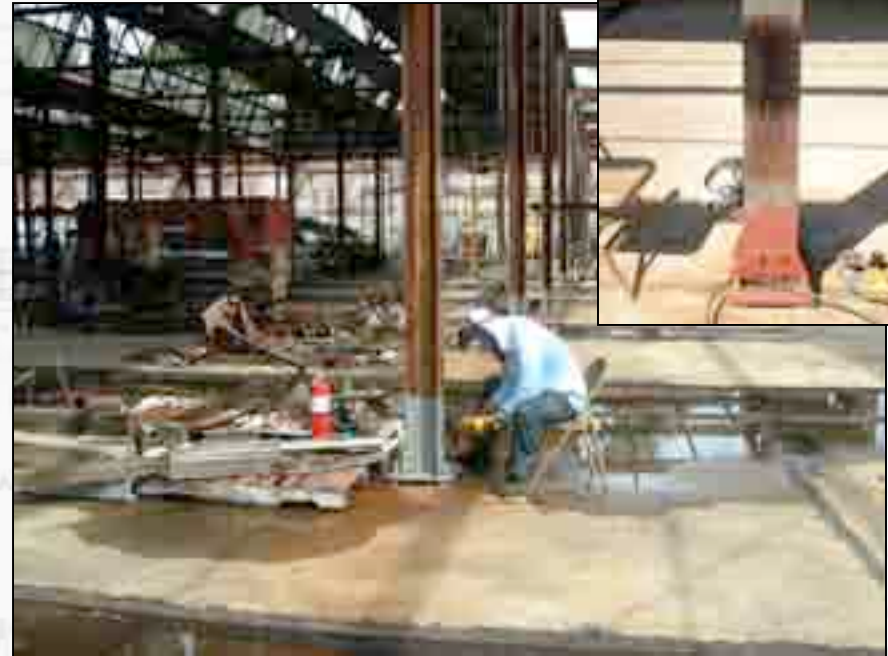
Joe Rothwell grinds a column to help conceal most of the weld seam. A small portion of the interior seam will be left visible to distinguish from the original and repaired parts of the column, a standard practice in historic preservation.

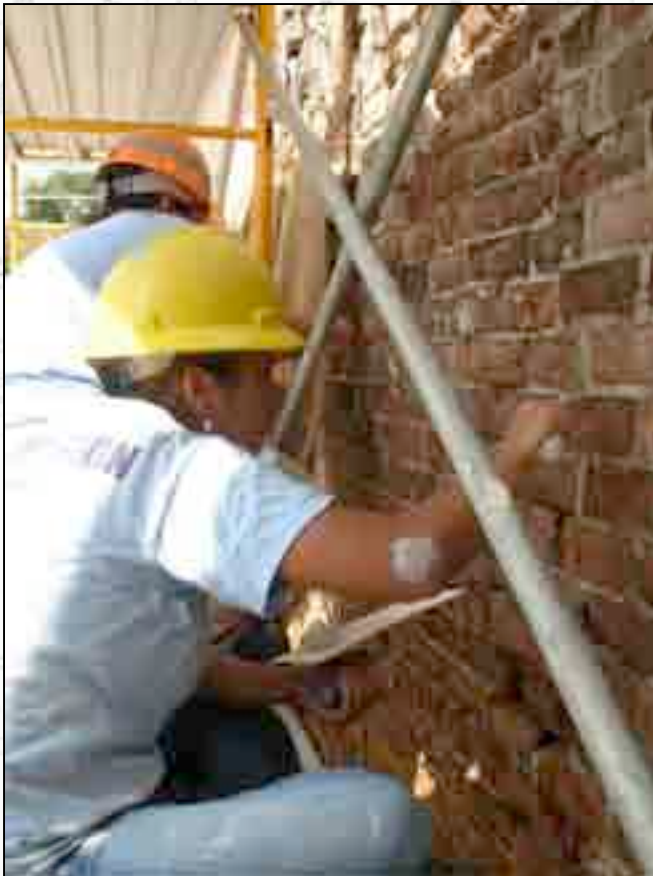
Ivey Ortiz repoints a section of the east wall.

The CHS Preservation Team continues working on the fourth phase of repointing on the east wall of the Carpentery Shop.

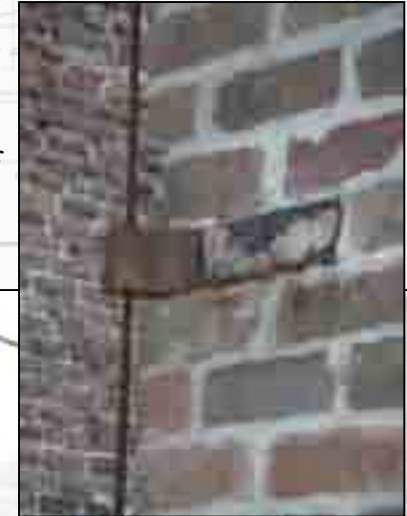
The original hinges of the Carpentry Shop doors are badly deteriorated and need replacing.

Close-up view of deteriorated hinge

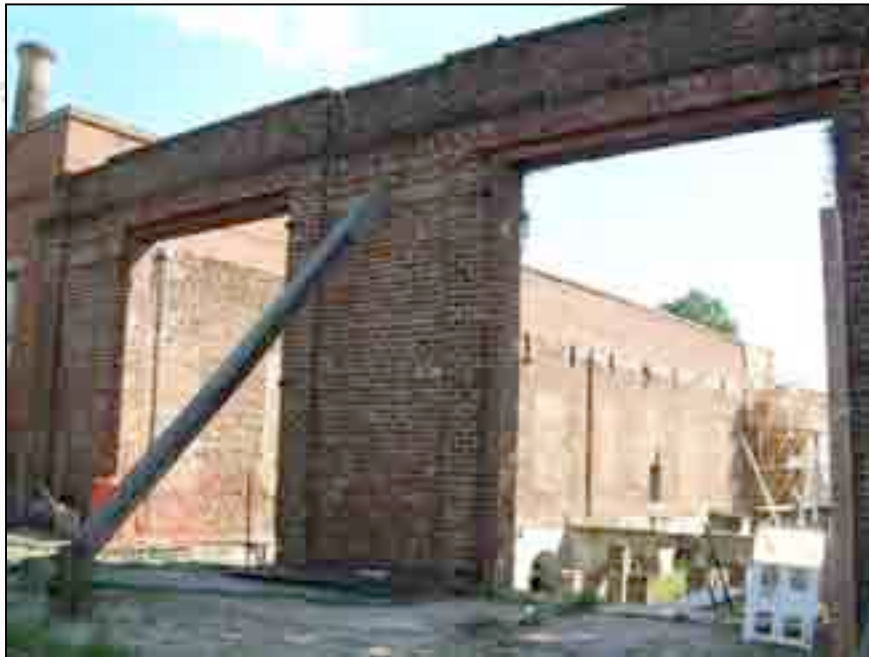
Hinges of the Carpentry Shop door frames will be replaced with new ones.

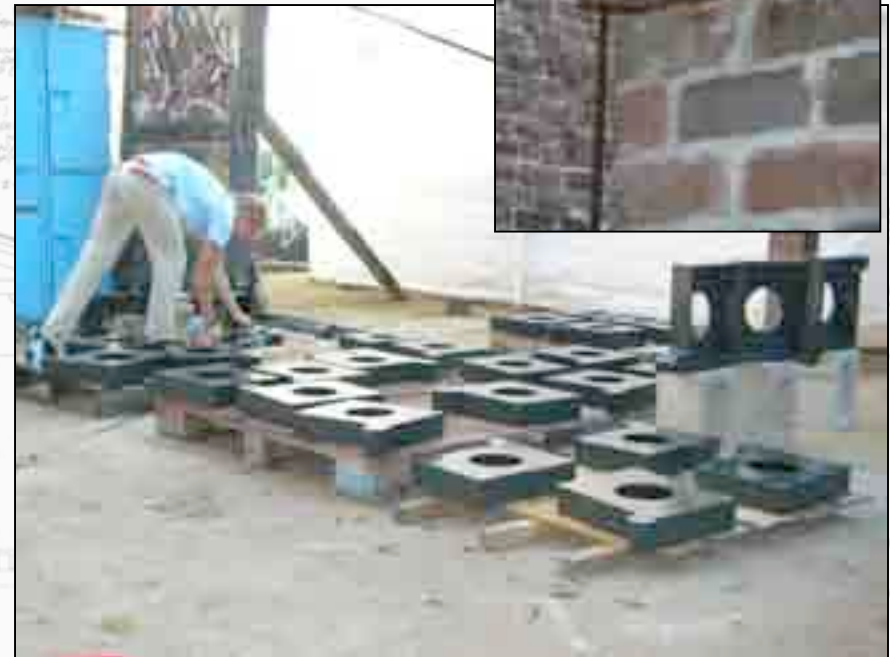
Amy Ver Beek paints the new hinges in preparation for insertion into the masonry door jambs.

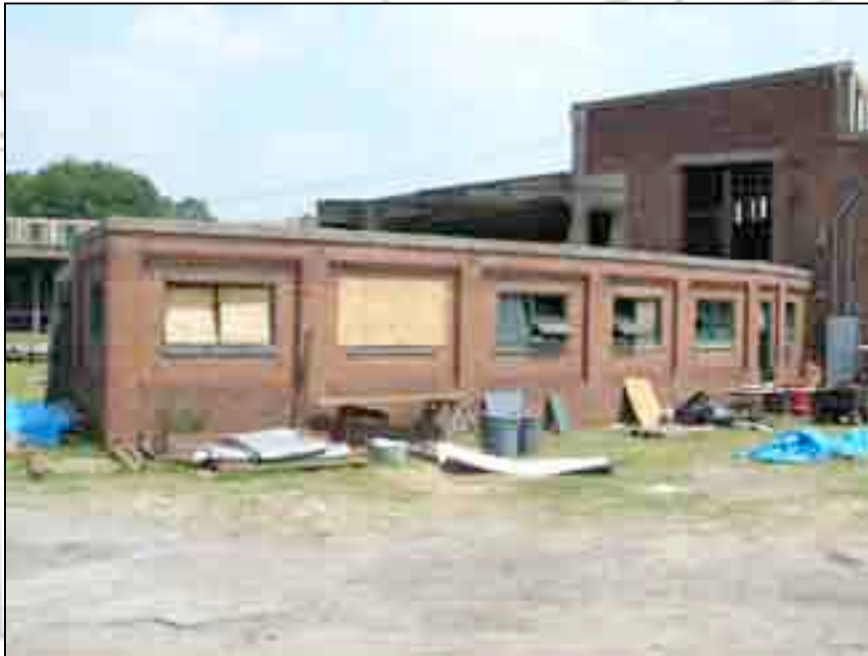
The windows were removed in order to restore them. This view shows two of the windows already removed.

The CHS Preservation Team is currently restoring the windows of the Colored Washroom.

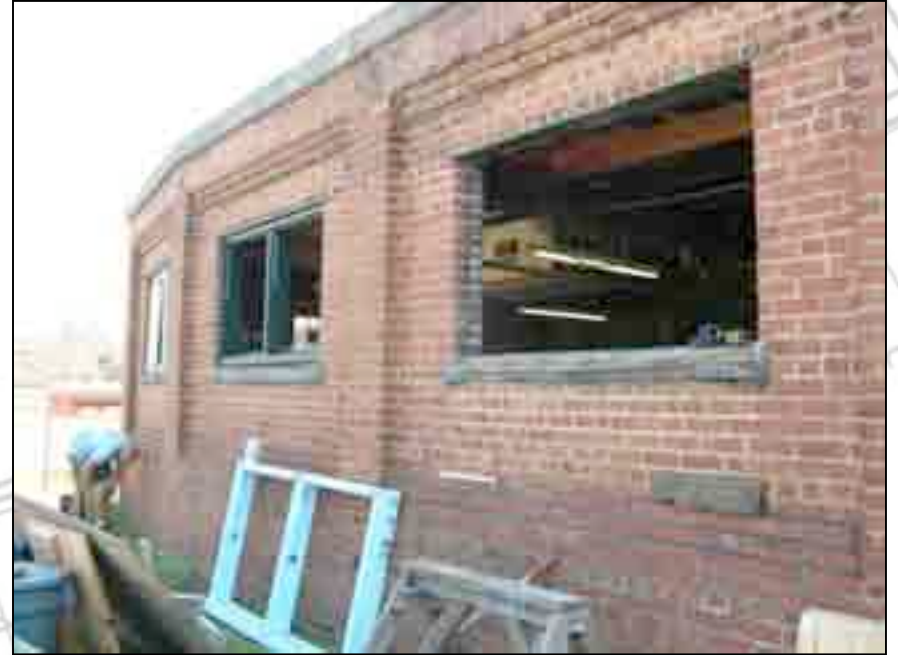
A closer view of the deteriorated window sills suffering from rust jacking.

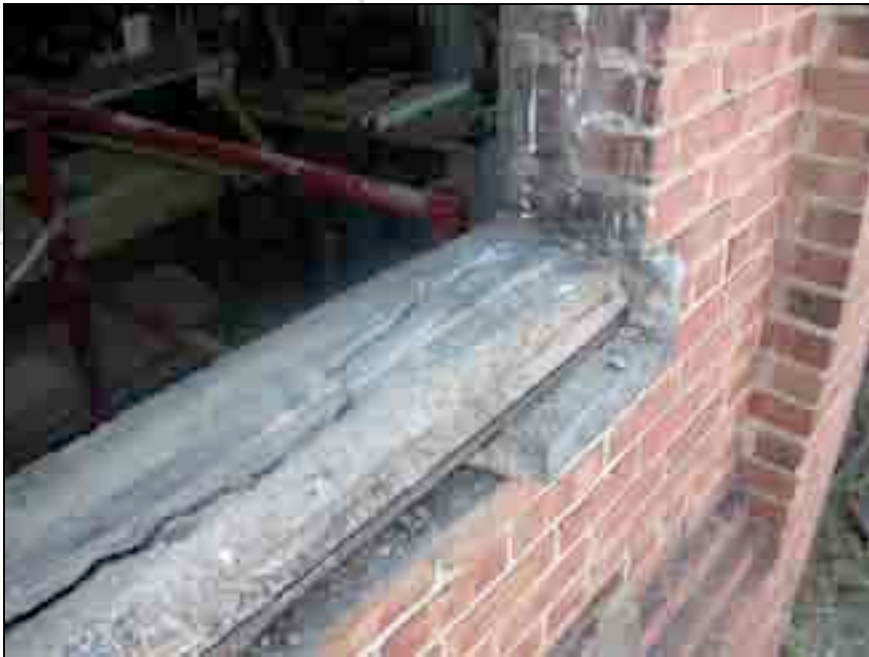
The deteriorated sills suffered from rust jacking and needed replacing.

Close-up view of window sill that was suffering from rust jacking.

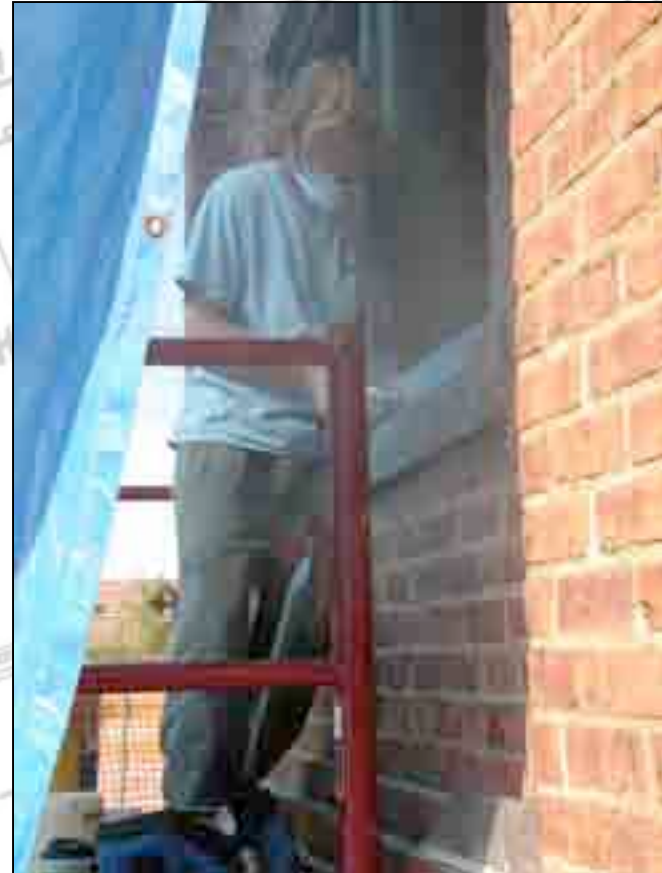
Masonry Foreman Travis Brown cuts away the deteriorated sill and creates a shoulder for the concrete repair patch, which ensures best adhesion to the original concrete.

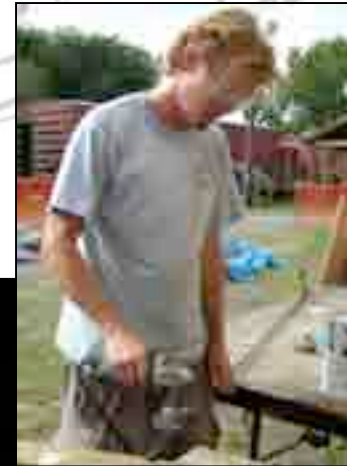
Travis prepares rebar to be painted with epoxy and inserted into the replacement sills. This practice helps prolong the longevity of the sill.

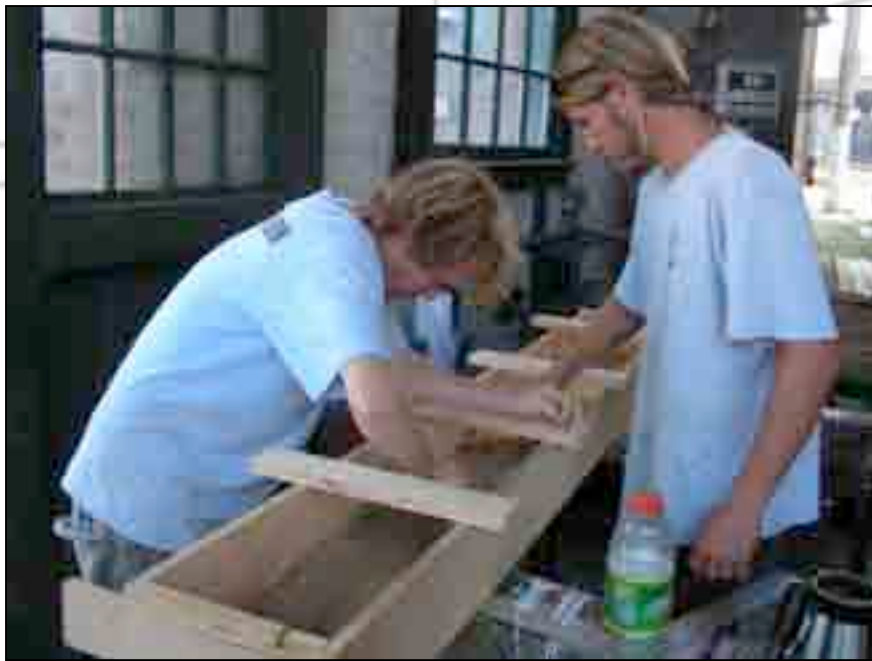
With help from Nathan Harris, Travis fills the sill form with concrete repair mortar that closely matches the original.

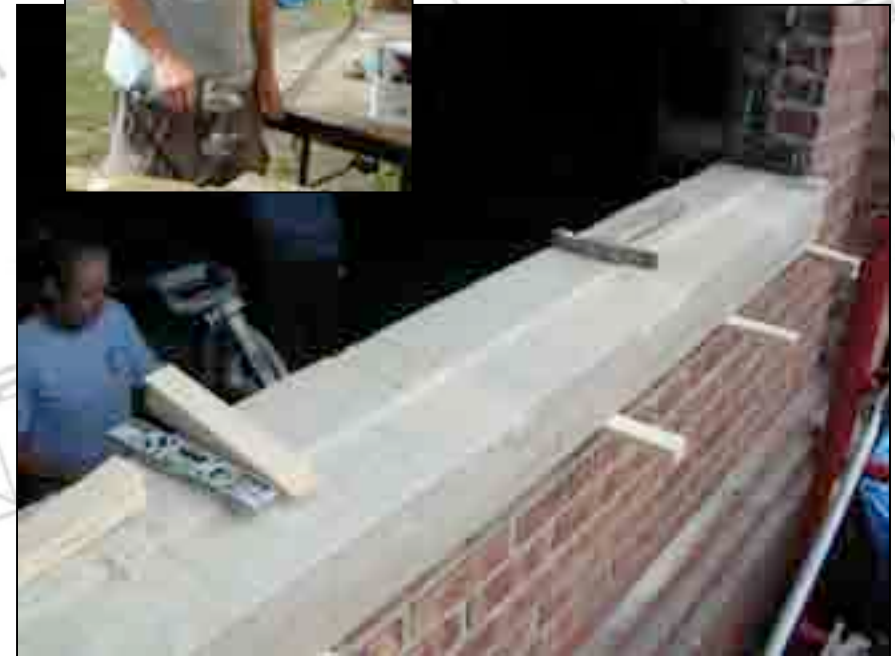
View of replacement sill.

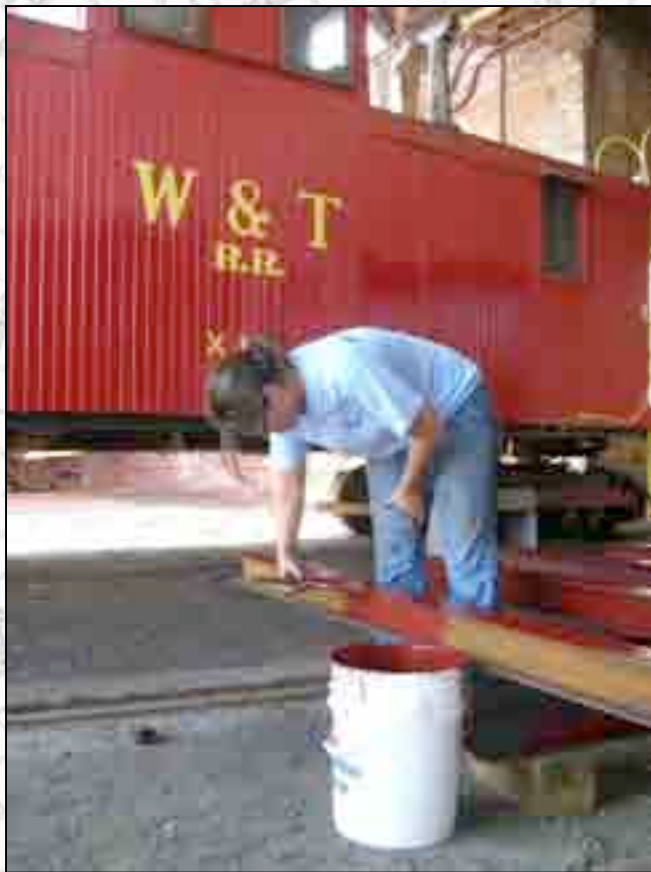
Lily McNee is applying primer to a temporary car frame before it is painted and installed over two trucks.
