Coastal Heritage Society

Visitors Center • Roundhouse Railroad Museum • Old Fort Jackson

Preservation Team • Railroad Operations • Archaeology

January 2007

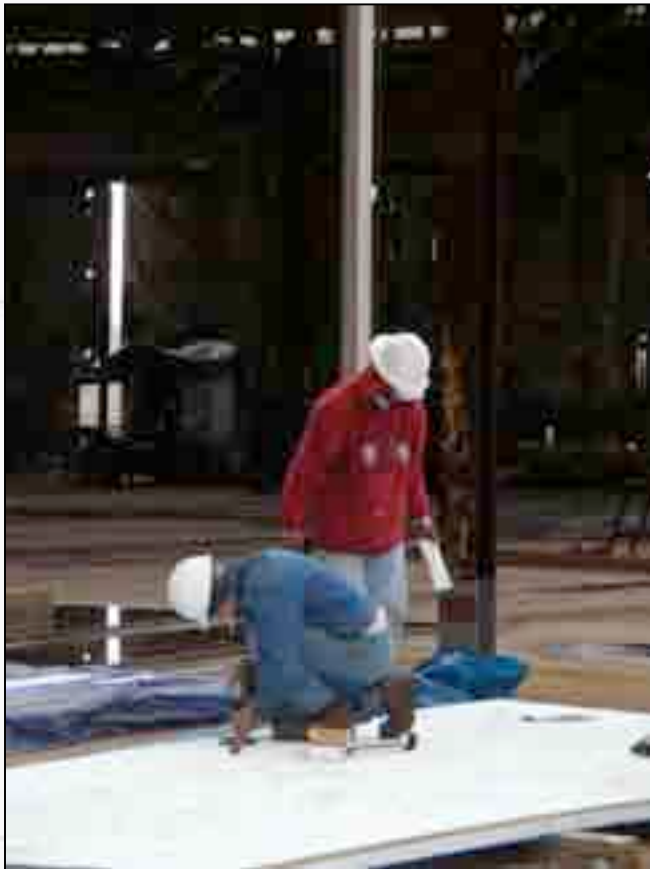
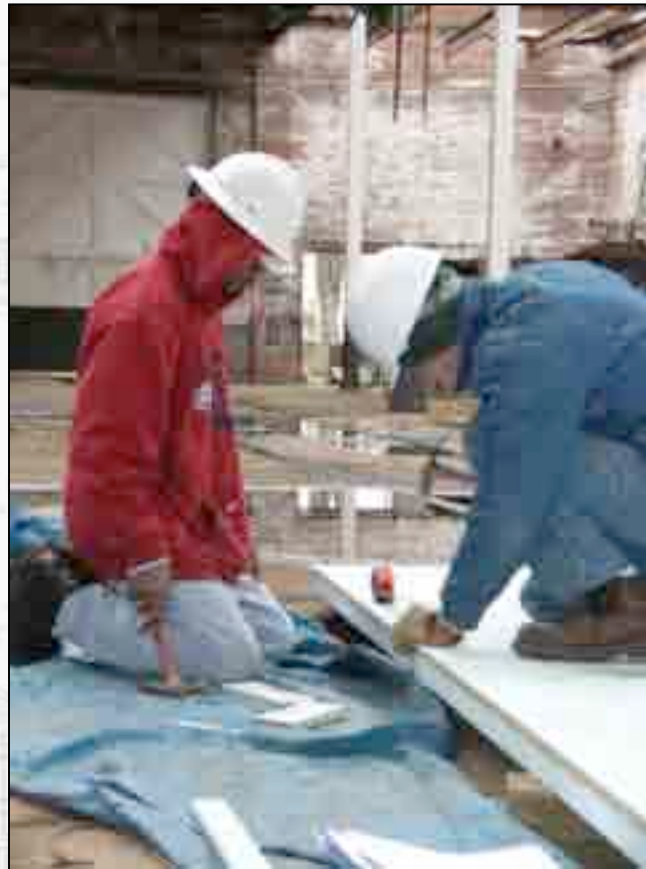
Another Paint Shop door was recently restored. The Coach & Paint Shops door crew will be hanging the newly restored “barn” door soon. It is the westernmost “barn” door on the north side of the Paint Shop.

Preservation Team members Chris Bostic and Charles Adkins put the finishing touches on the recently restored barn door.

The door will be painted in the circa 1930's green (exterior sides) and white (interior) after the doors are reinstalled.

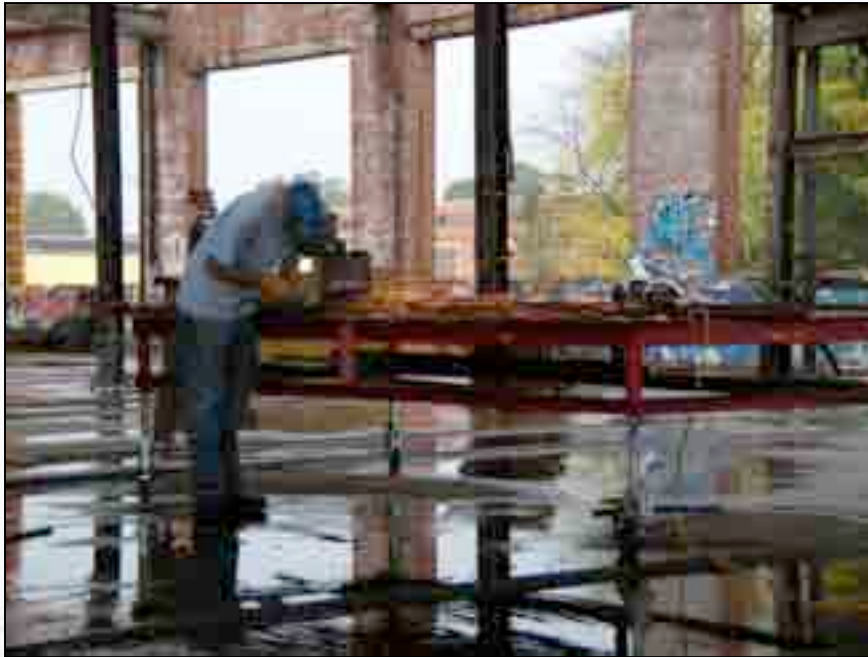
Joe Rothwell heats the wire ends in order to straighten and remove them from the steel channel frame.

Preservation Team members Chip DeYoung and Joe Rothwell have recently started restoring window guards that originally covered the lower-level windows of the Paint Shop. The historic window guards were fabricated in 1924-25 by the former Savannah Iron and Wire Works.

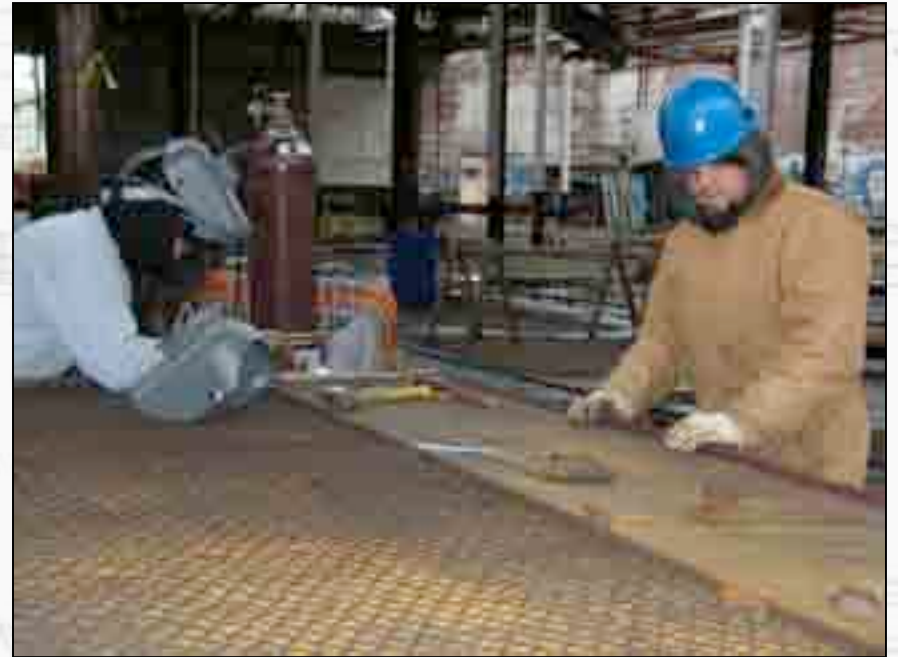
Chip DeYoung (right) lines up insertion holes on the original deteriorated steel frame of the window guard in order to fabricate a new one.

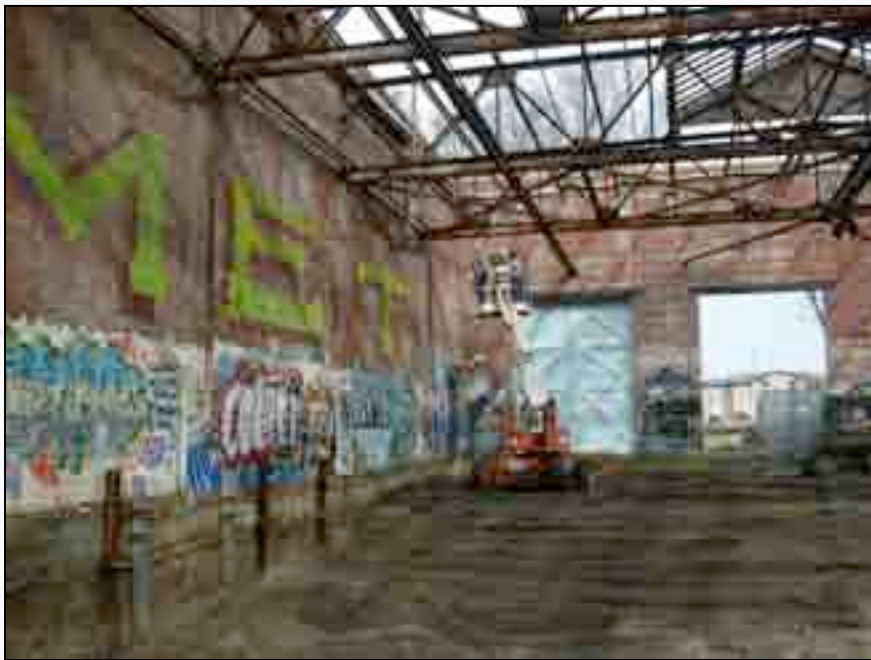
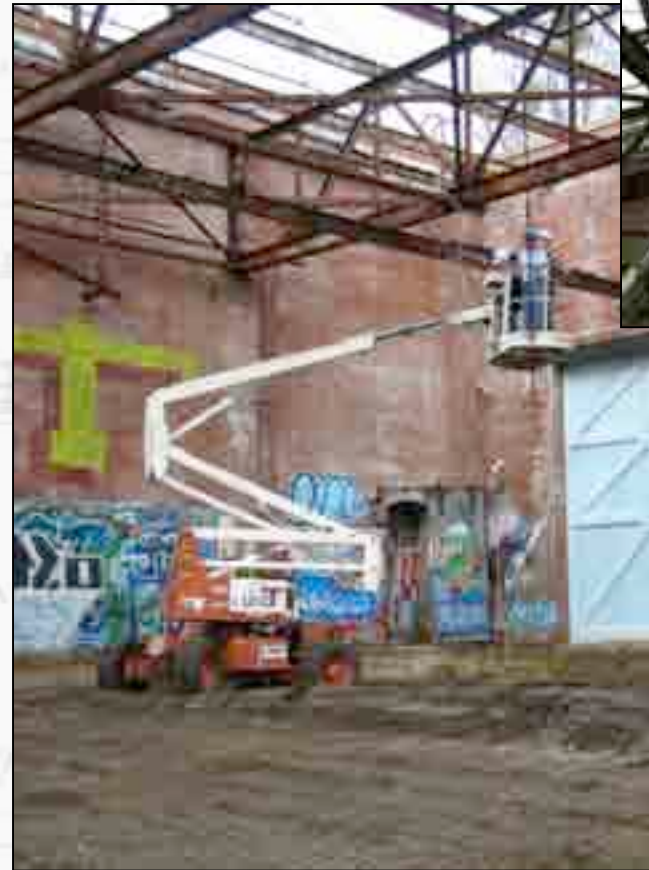
Structural Engineer Hunter Saussy, Jeanne Fullam, and Bryan Law inspected the condition of the structural steel beams of the Coach Shop roof.

Once the structural integrity of the roof is sound, the Preservation Team plans to reconstruct the flat roof.

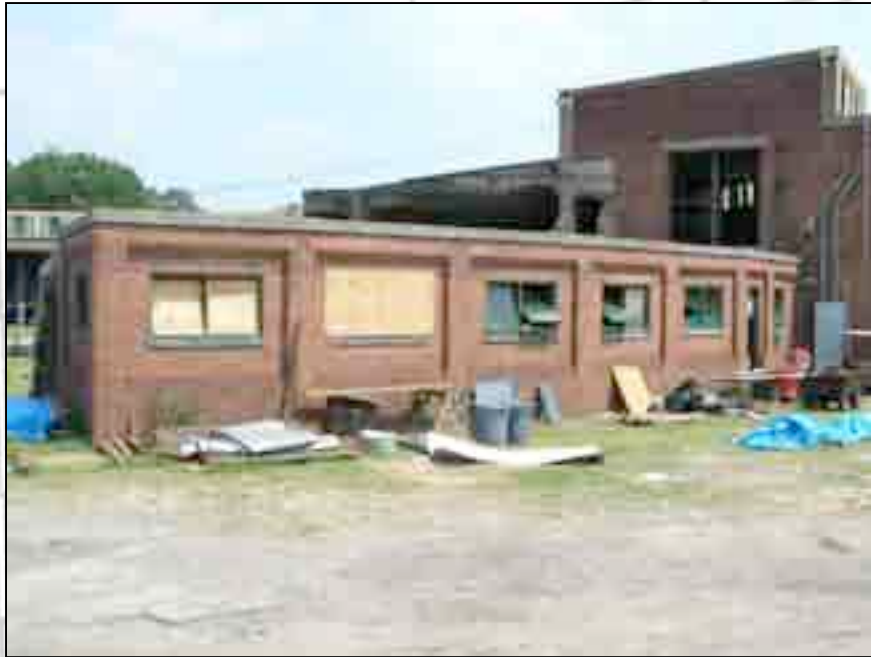
Colored Washroom shortly after window restoration project began. In this photo, only two sets of windows have been removed for repairs.

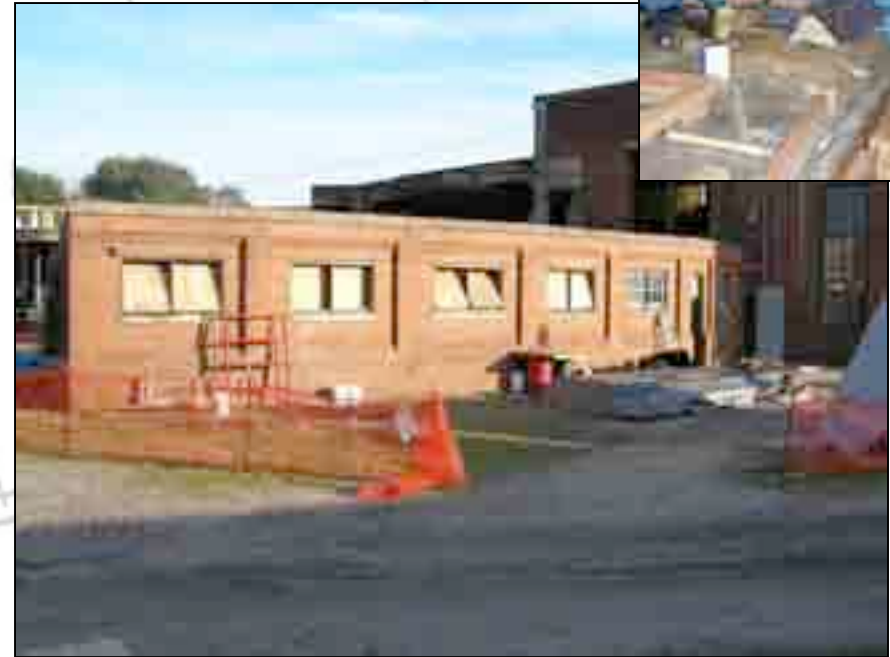
Current view of the Colored Washroom. Two windows have been reinstated on the right.

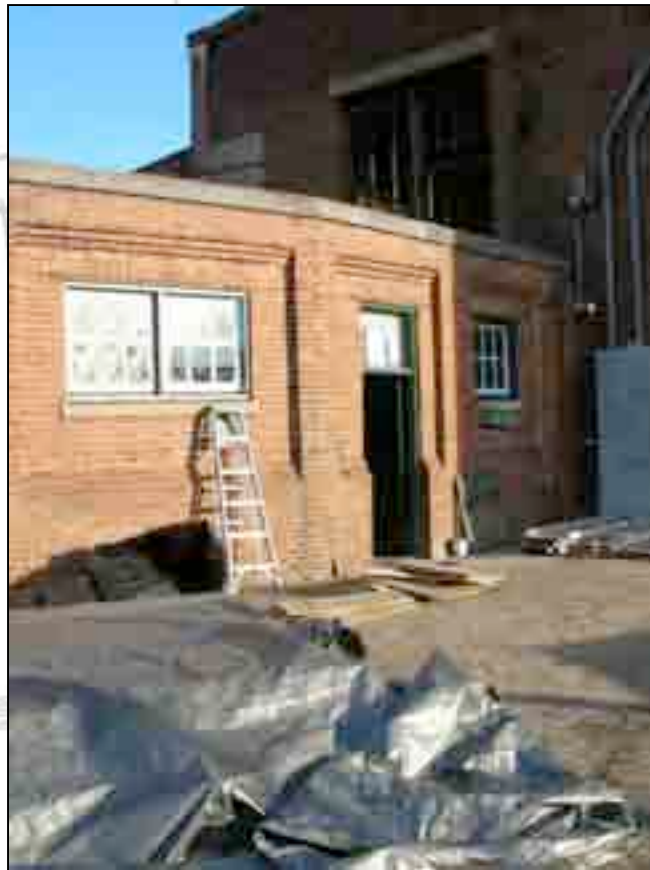
The original wood windows were too deteriorated to reuse; therefore, new windows were built using recycled heart pine that was originally part of the Paint Shop roof.

Close-up view of recently installed windows.

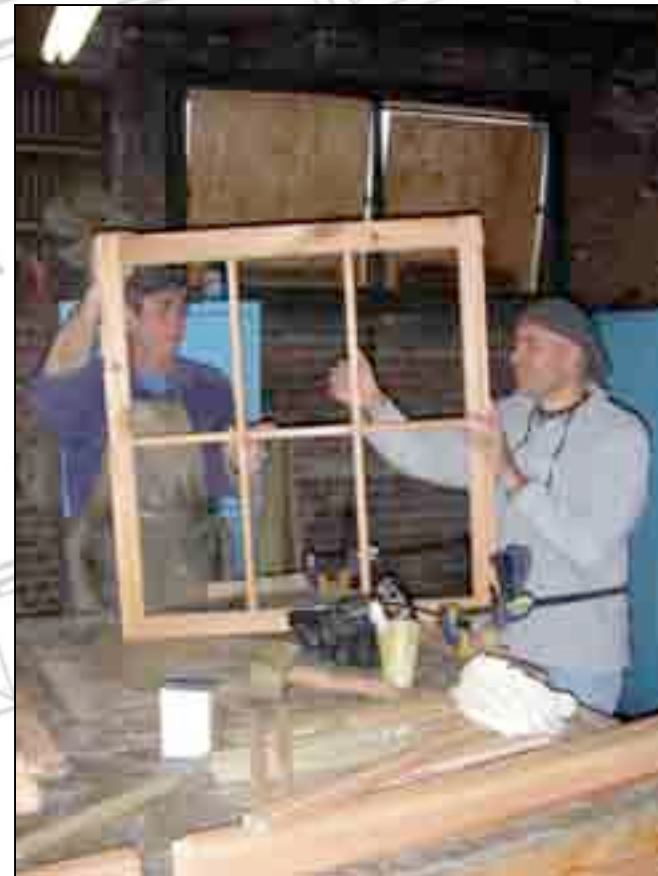
Carpentry Foreman Kurt Benton and Don Miller put finishing touches on one of the windows.

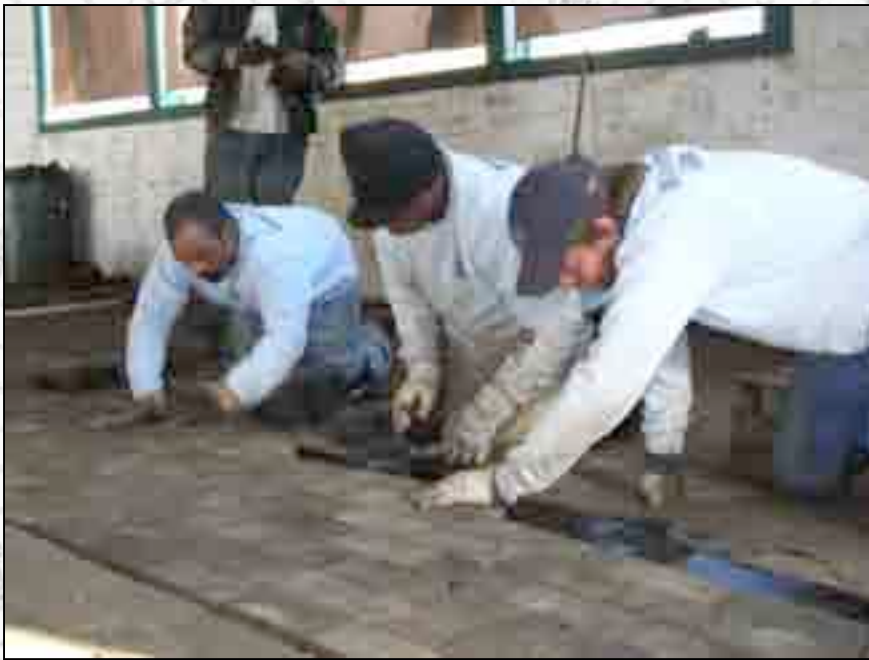
John Passmore, James Jackson, and Kevin MacMillan lay wood blocks at the rear wall of the Overnight Shed.

The Preservation Team continues to restore the wood block floors.

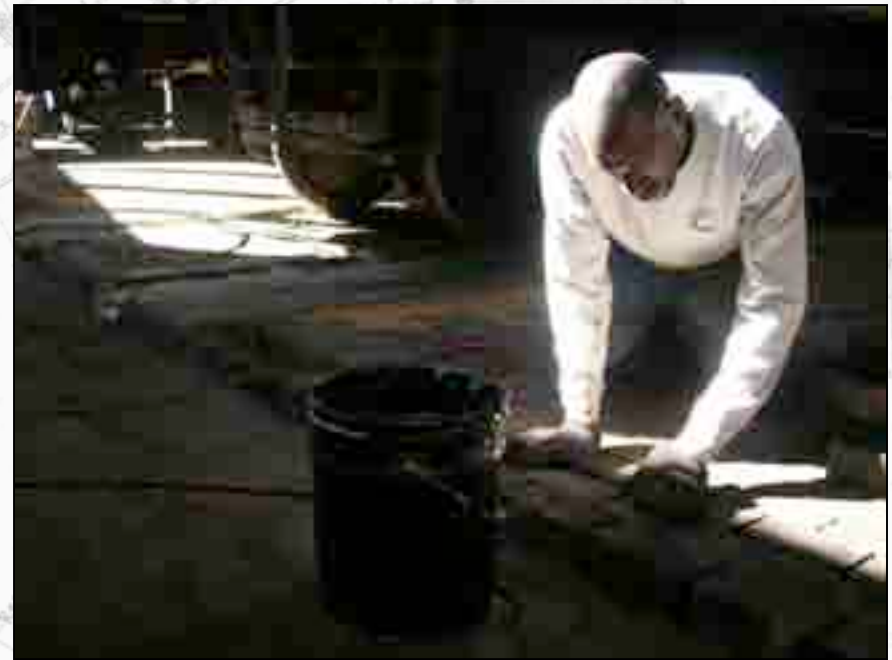
Anthony Temple finishes one of the last wood block lanes to be restored.

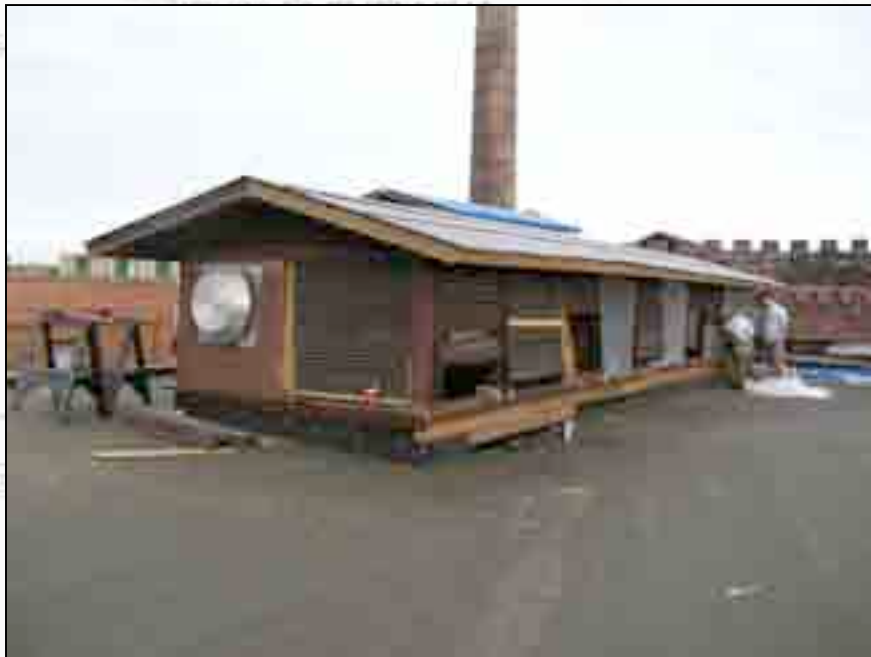
View of the monitor shortly after restoration began.

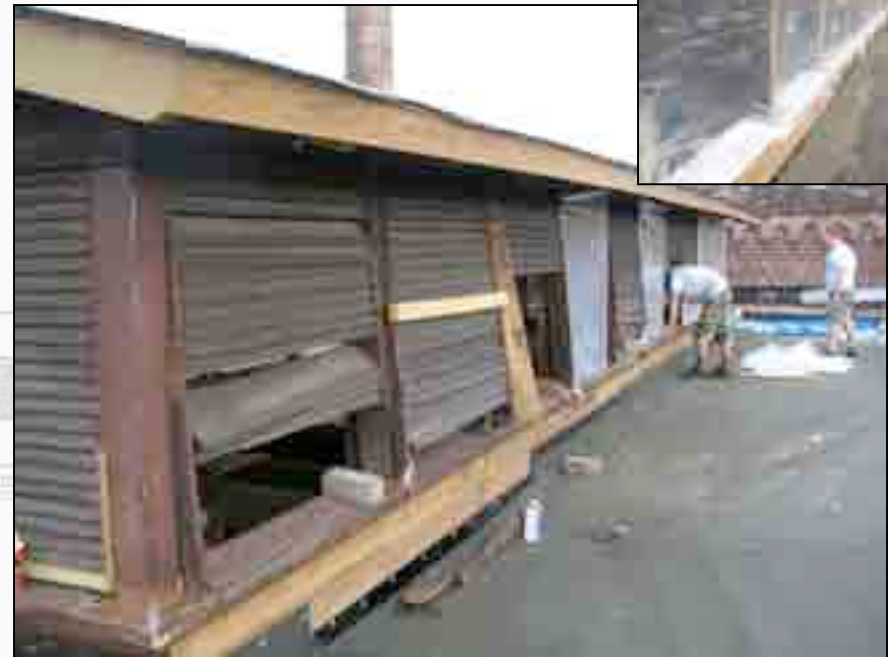
To keep rain from entering the Compressor Room, Preservation Team members Nathan Harris and Ryan Griffiths covered the openings with a protective plastic sheathing.

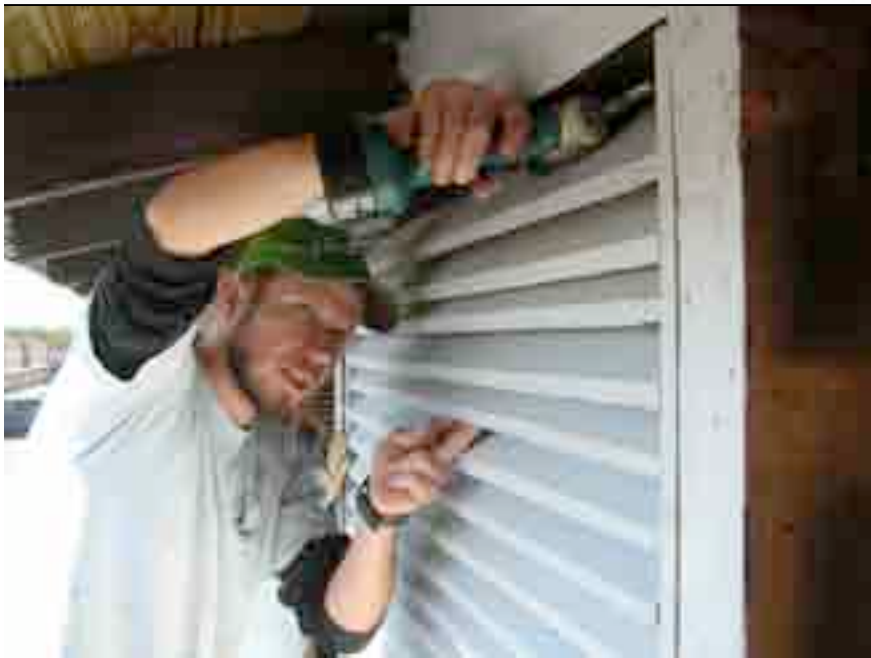
Nathan Harris secures the restored louvers into place.

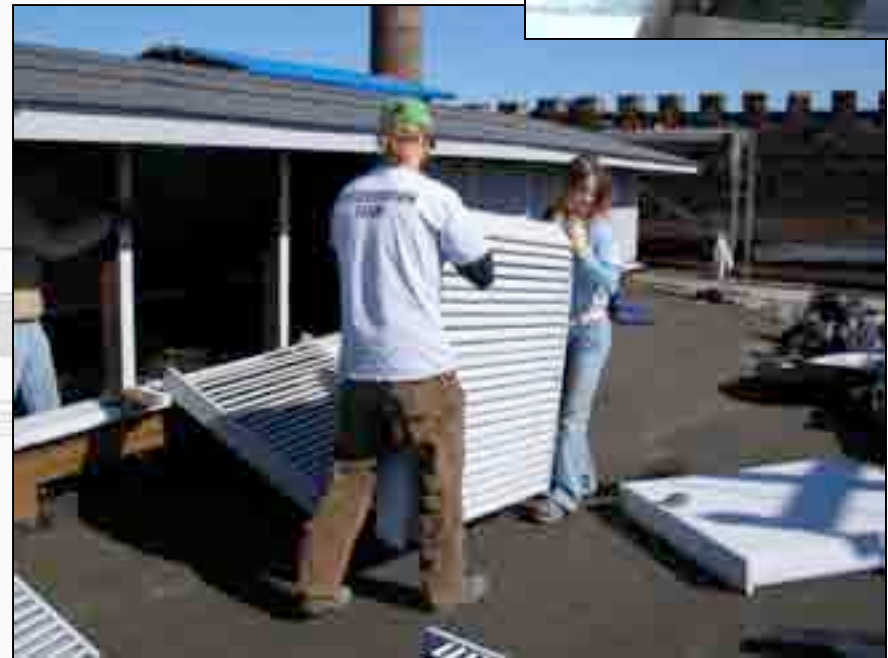
Nathan Harris and Amanda Smaridge position a restored louver frame into the monitor.

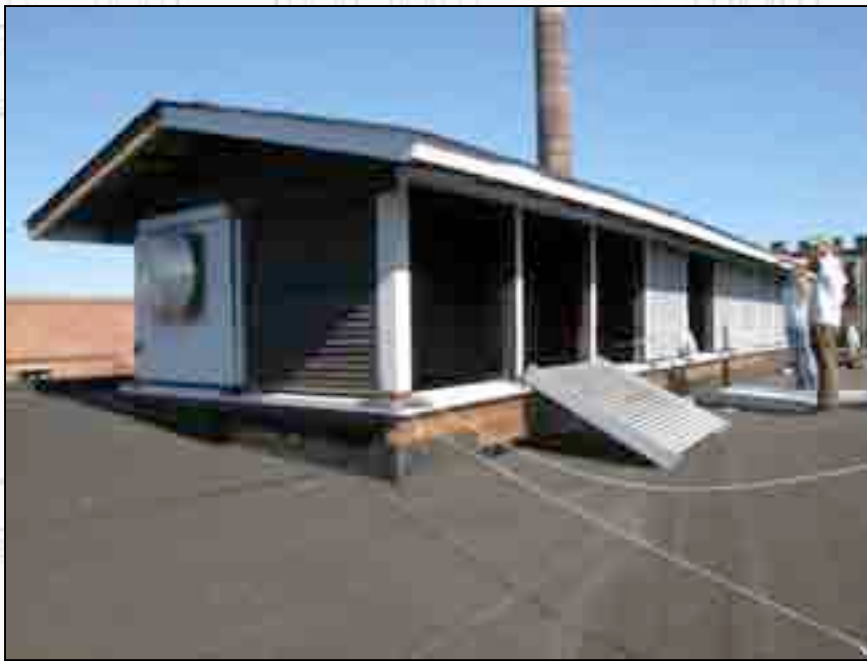
Nathan Harris and Amanda Smaridge help Kurt Benton (inside monitor) reinstall restored louvers into the monitor.

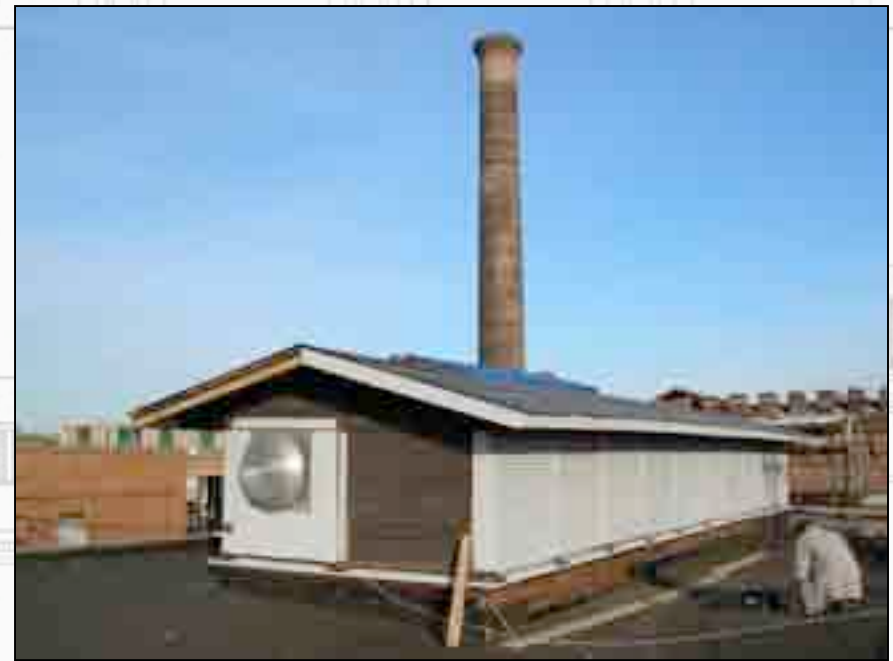
Current view. All of the louvers on the monitor have been restored and reinstalled.

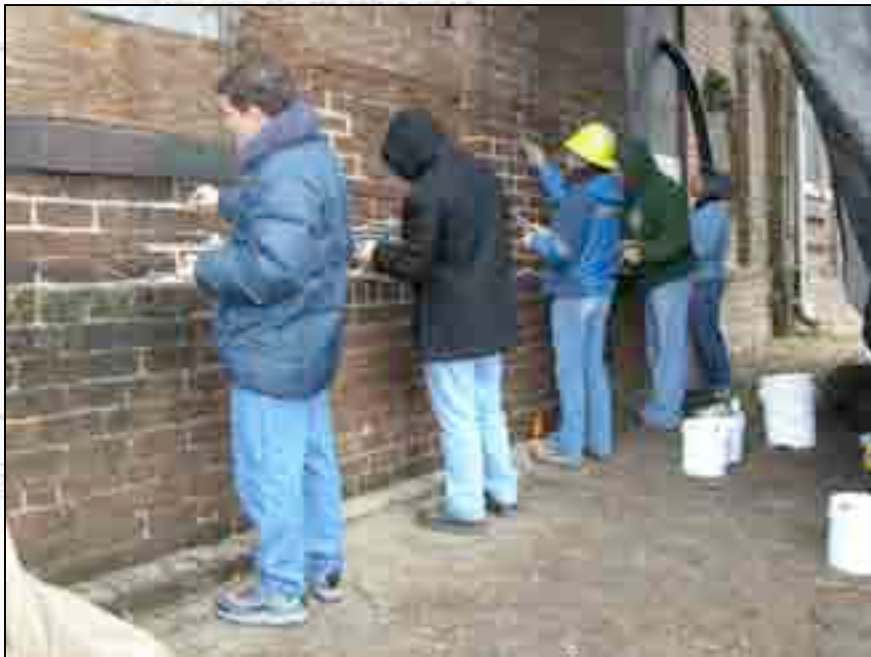
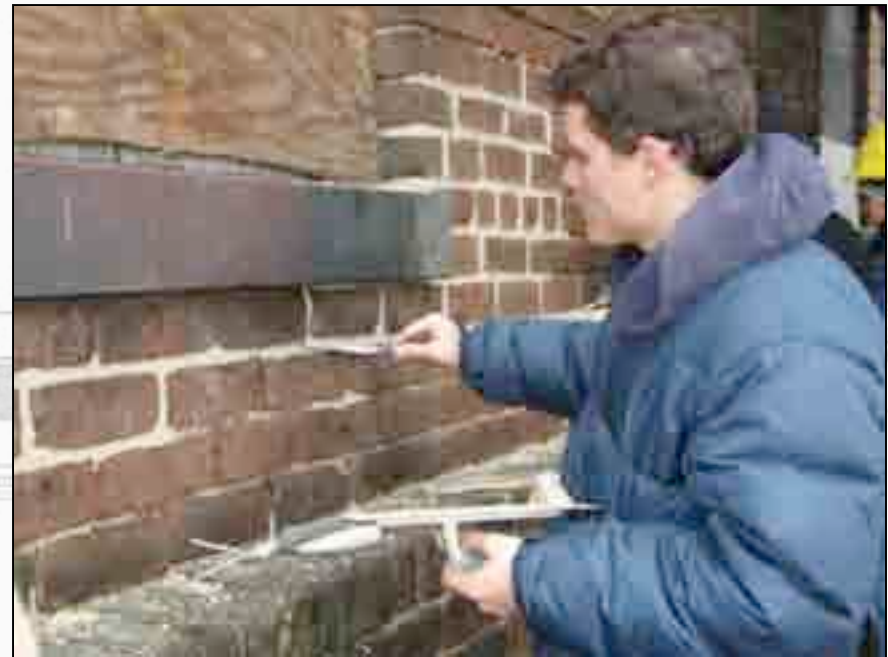
After digging out deteriorated mortar joints, Preservation Team members repoint the south wall of the Compressor Room with lime mortar.

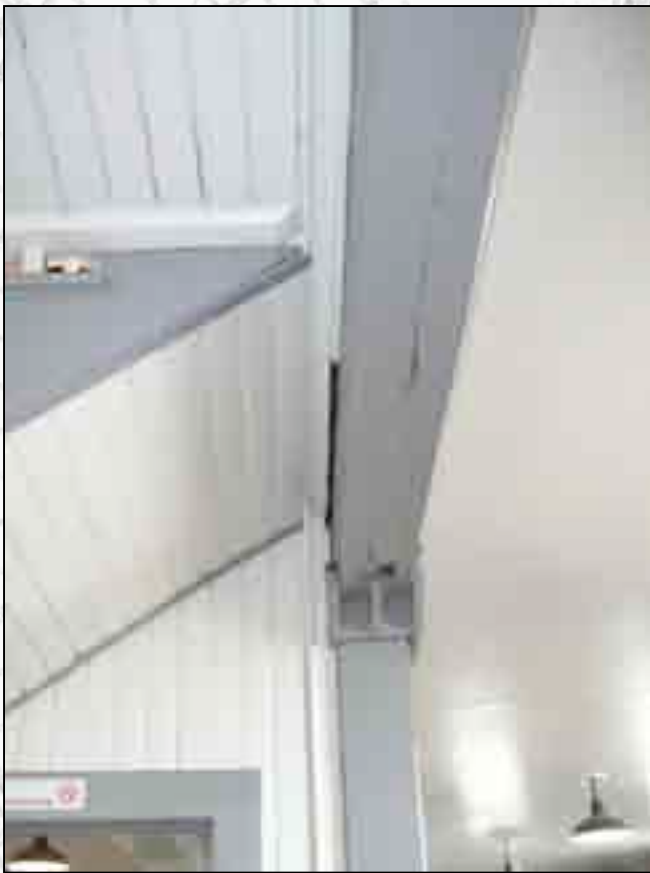
A wood beam in the Dispatch Office was badly deteriorated from water damage and needed repairing.

View of beam before repairs.

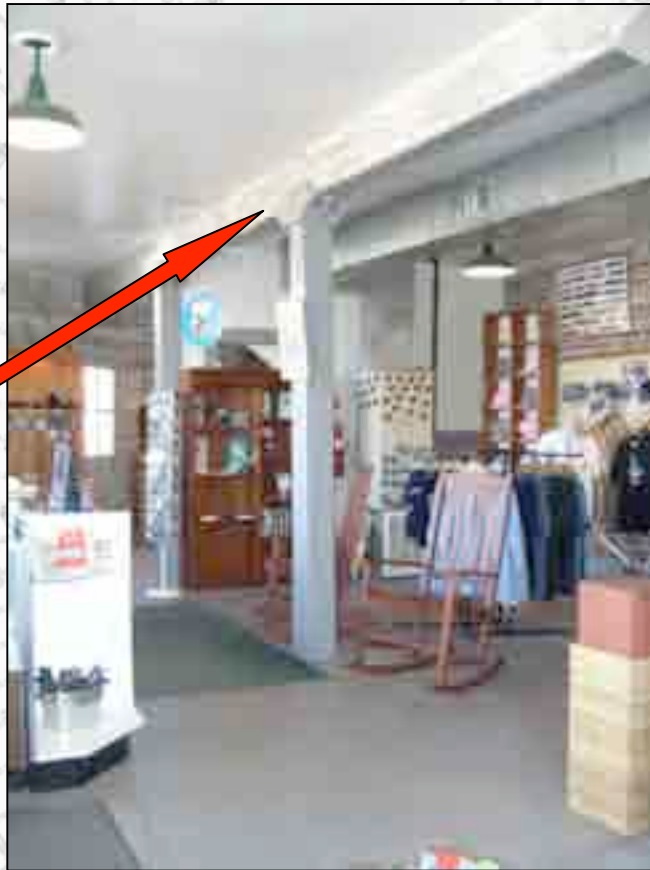
Treated beam

The remaining wood beam was recently stripped and treated with Boracare to prevent future termite infestation.

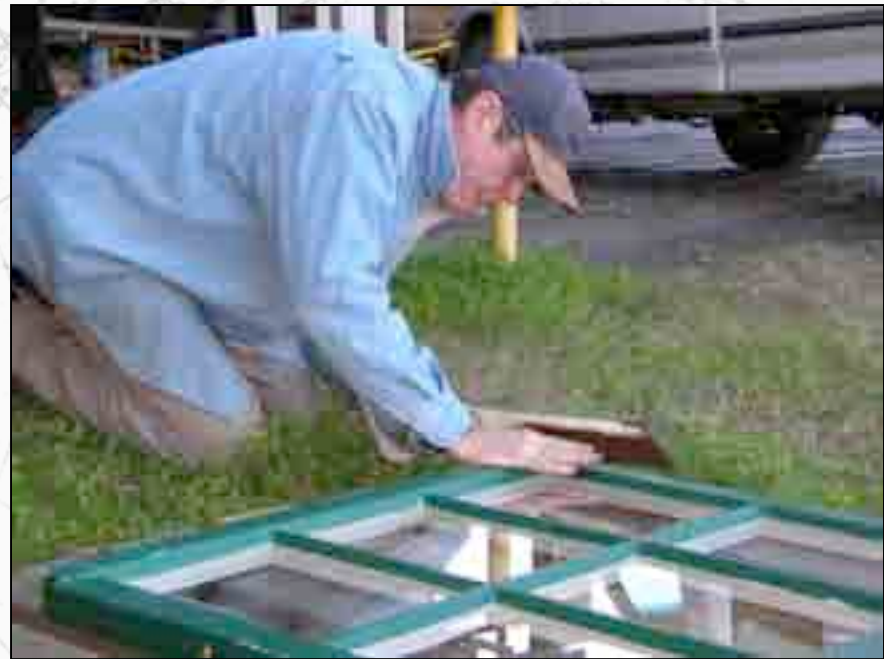
A few of the existing second floor windows were also restored.

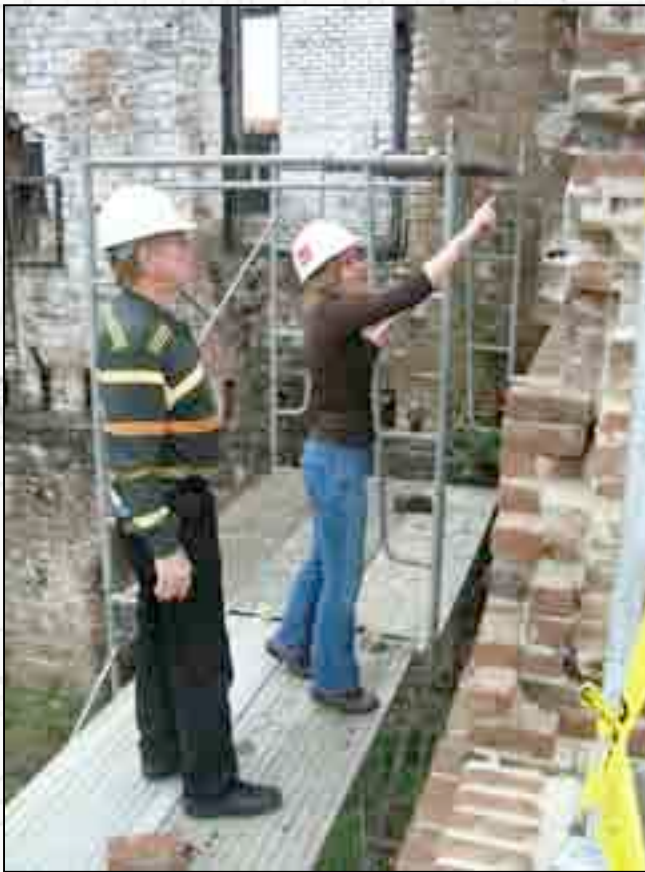
Becki points out areas of structural concern to Hunter.

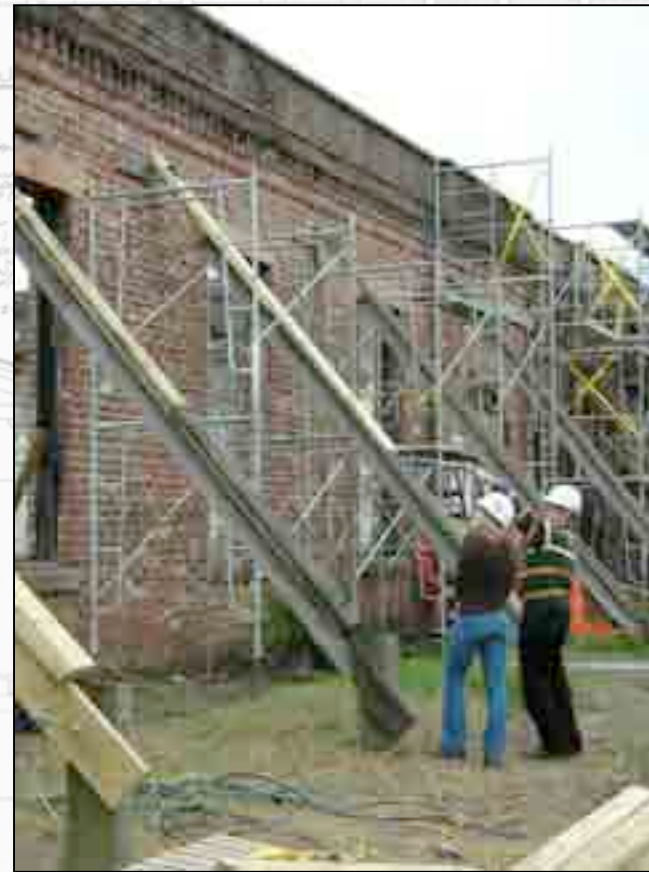
Hunter and Becki discuss the current bracing on the west wall of the building.

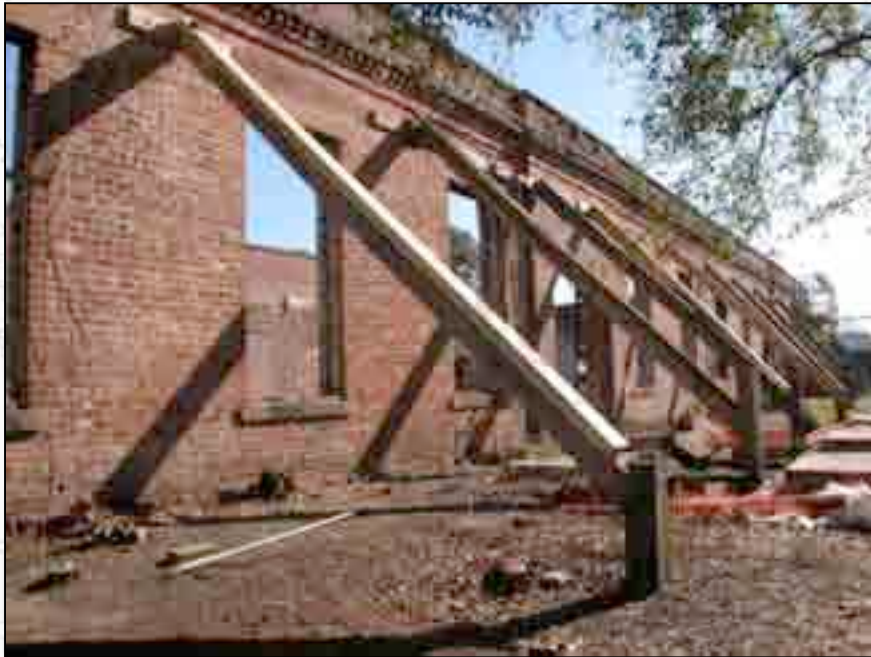
Older bracing on the wall was recently reinforced or replaced.

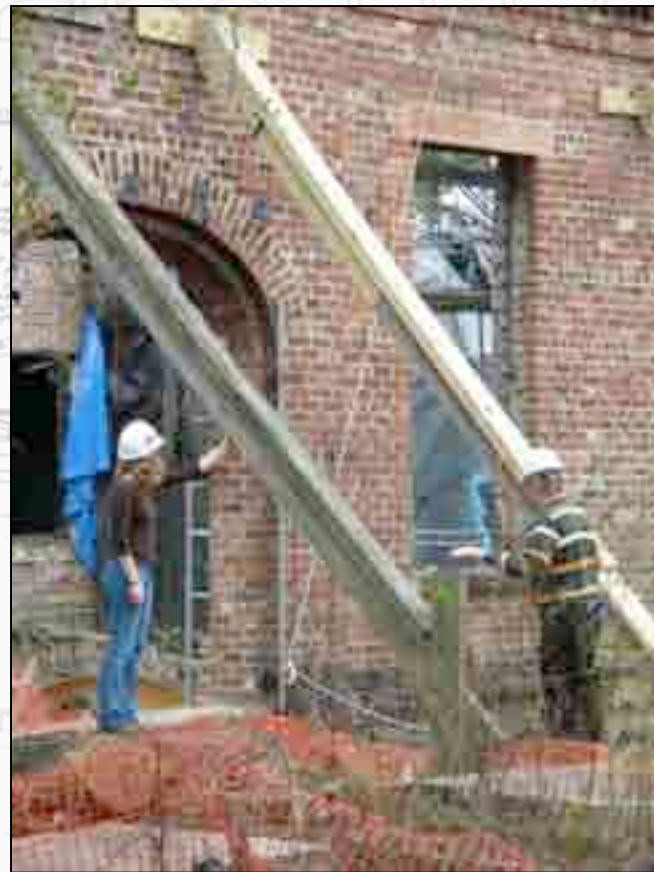
Becki and Hunter analyze recent improvements to the older bracing.

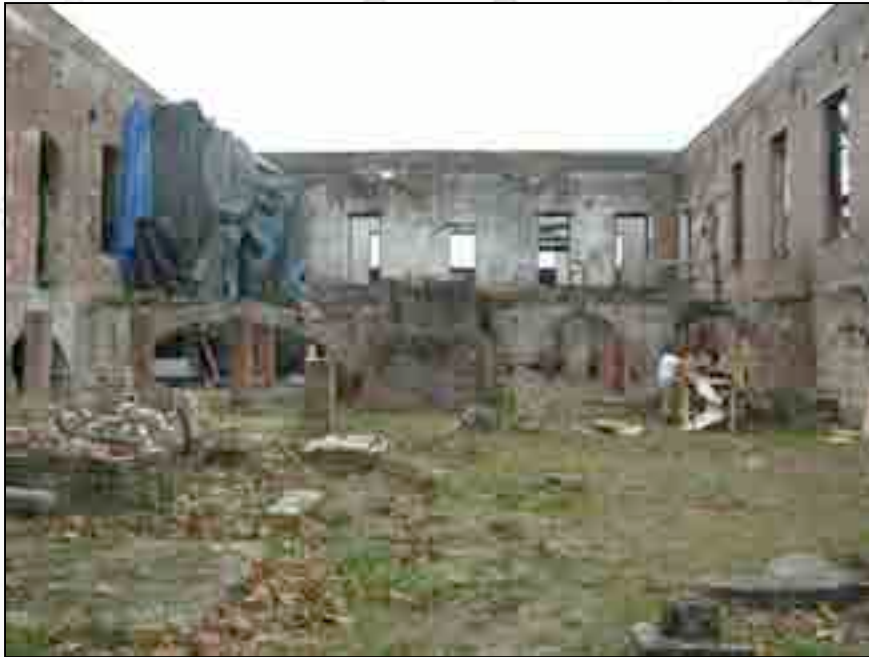
View of Carpentery Shop shortly after Southern Preservation Systems began reinforcing the foundation arches for repairs.

The foundation arches are currently being reinforced and stabilized for future masonry repairs.

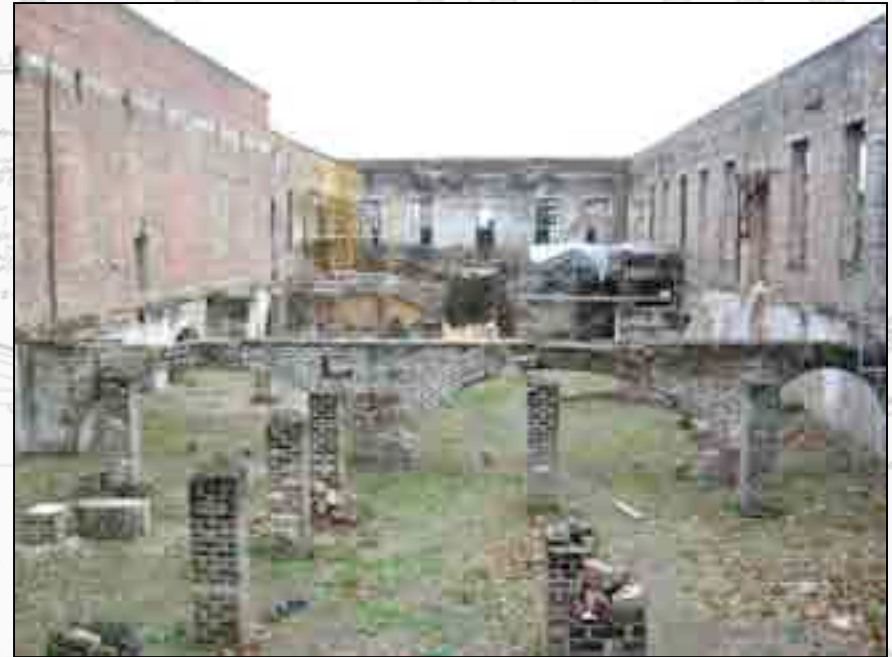
Current view of foundation arches that have been reinforced.

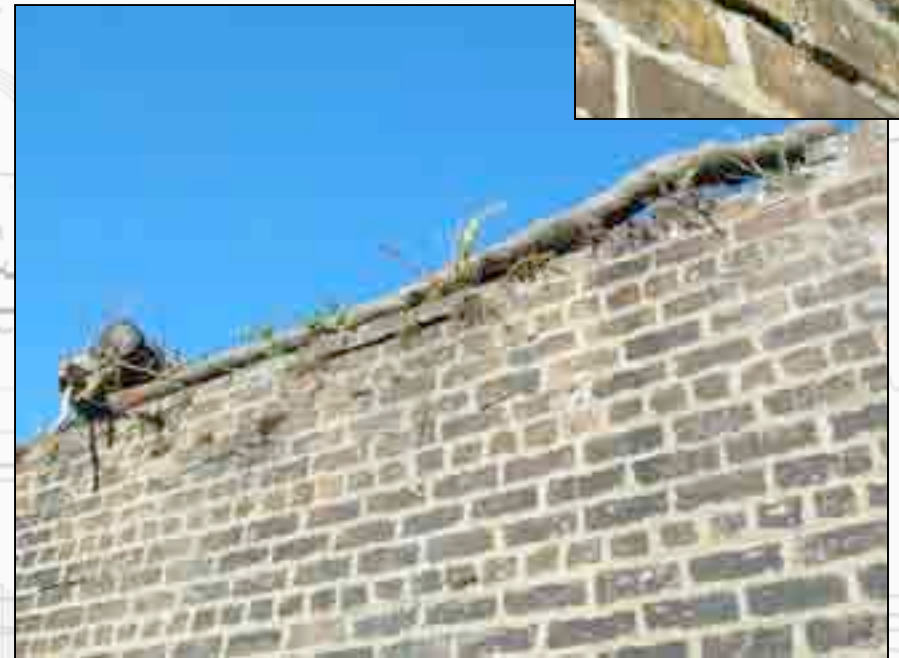
View of tree and its roots growing along the masonry retaining wall.

A major area of concern focuses on a tree that was growing out of the masonry wall. The root system has dislodged a brick as shown in the photos below.

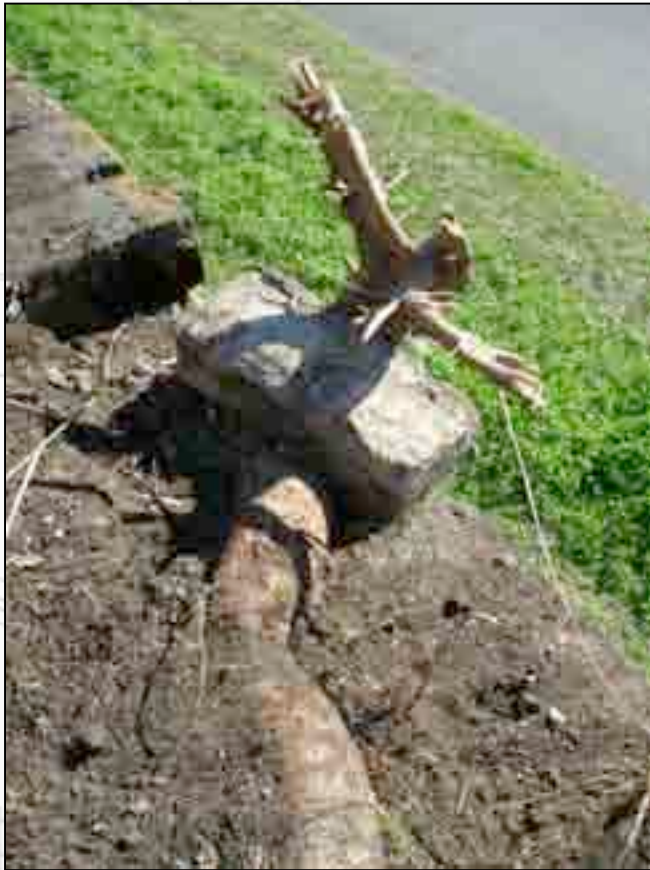
View of brick from top of masonry wall. The root can be seen growing through the wall.

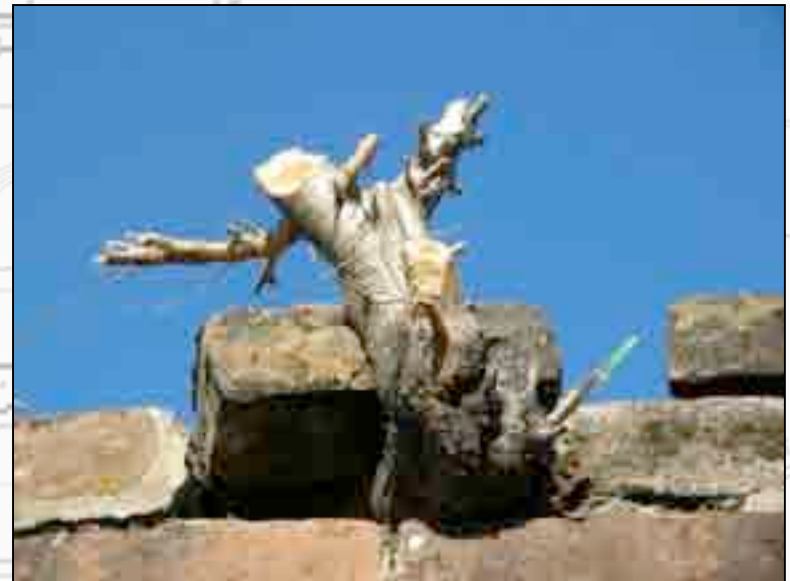
View from Louisville Road. Root can be seen dislodging the brick from the rest of the wall. In order to remedy this problem, the team drilled holes into the remaining trunk and root system and applied a tough brush killer.

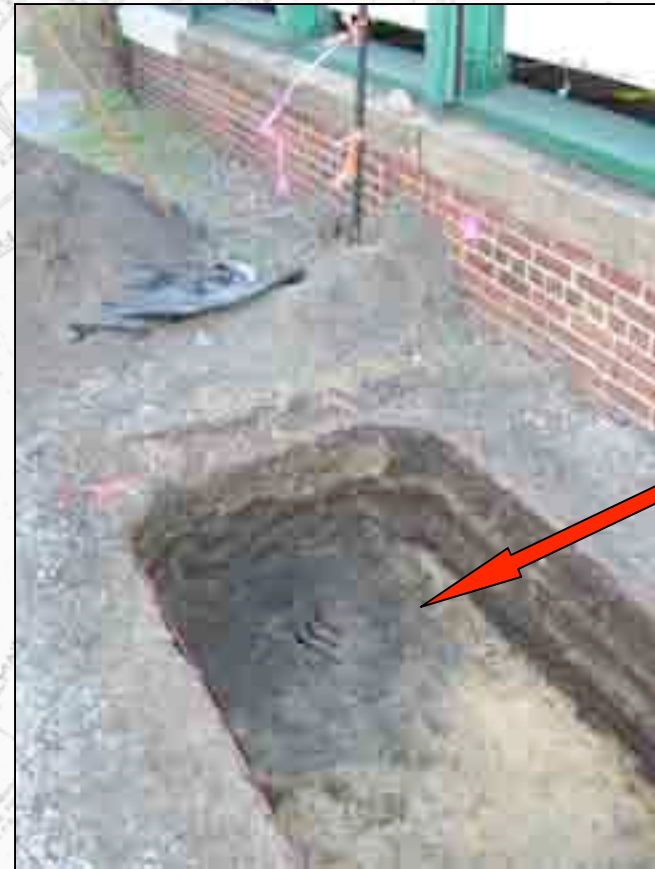
Grate from previous drainage system

A grate from a former drainage system was unearthed.
