Coastal Heritage Society

Savannah History Museum • Roundhouse Railroad Museum • Old Fort Jackson

Preservation Team • Railroad Operations • Archaeology

March 2007

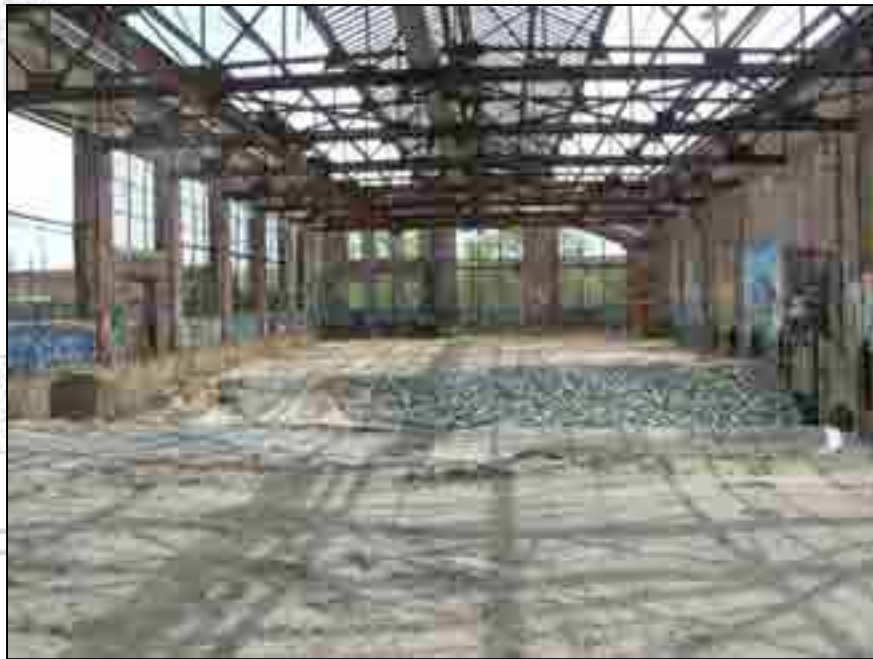
Interior of Coach Shop before windows were removed.

The CHS Preservation Team is currently removing window sashes from the Coach Shop, the proposed future site of the Children's Museum. All the original sashes suffer from severe deterioration and will be repaired or replaced in kind.

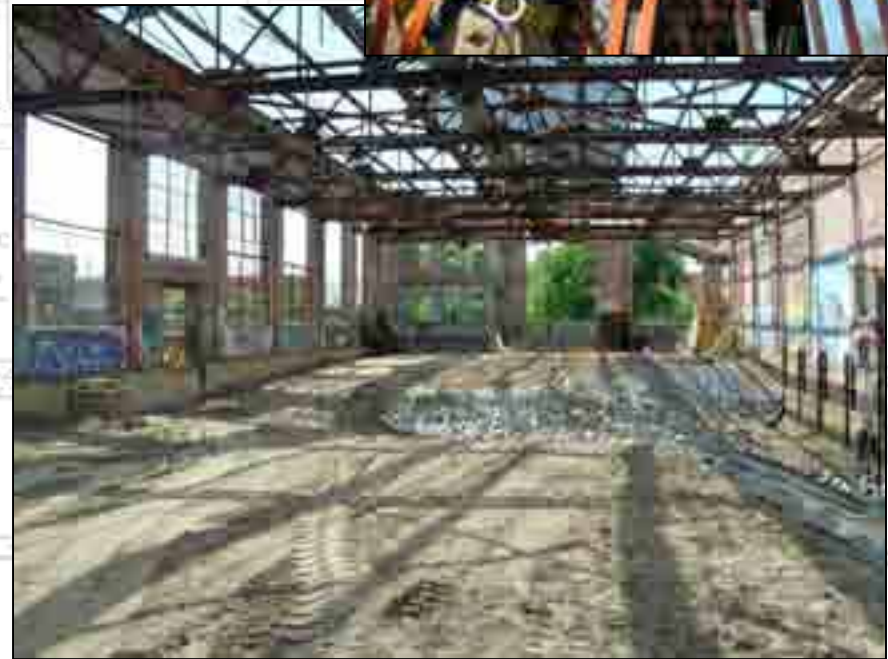
Current view of Coach Shop. Sashes have been removed from 8 ½ window openings to date (3 of the window openings are not in this view).

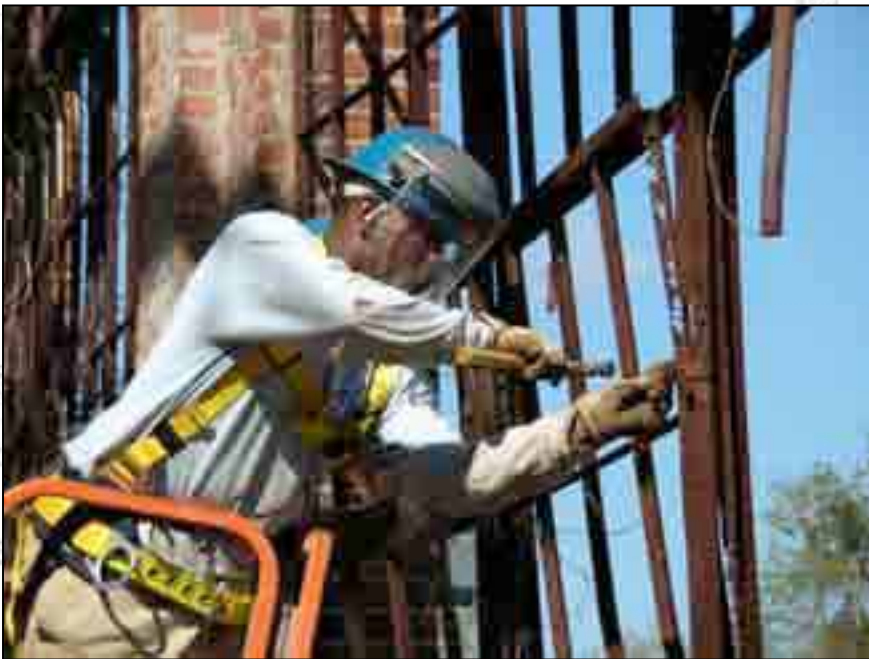
Chris Latson removes a pin that secures the ventilator window so that it can be removed from the sash.

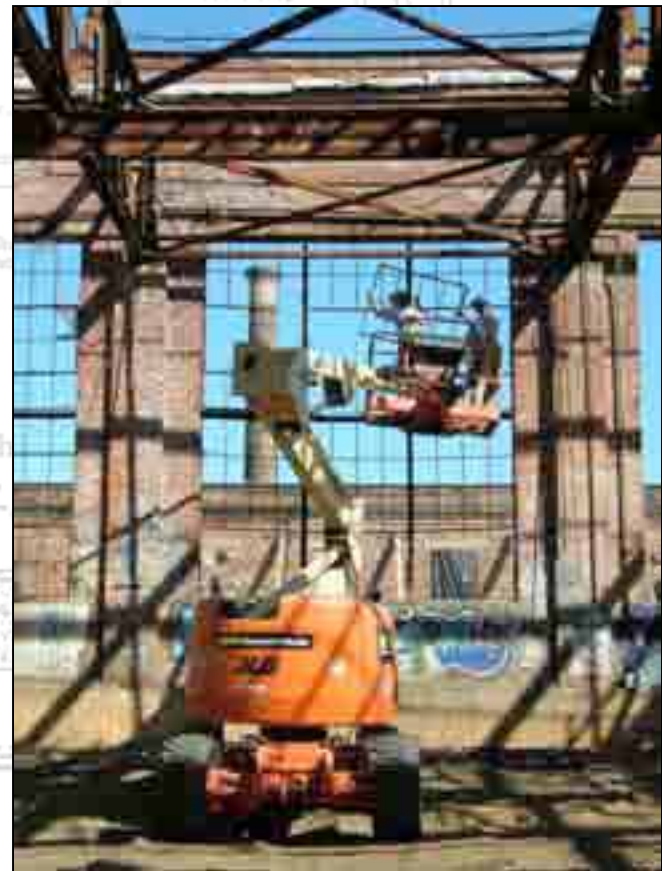
Joe Rothwell and Chris Latson remove one of the sashes from the Coach Shop.

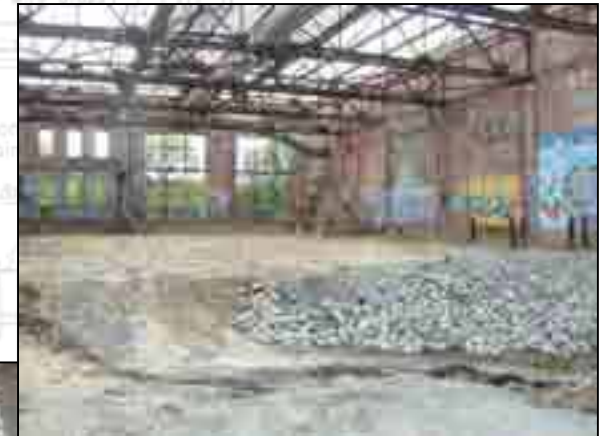
View from inside Coach Shop

The masonry crew has been repairing a masonry crack that runs along the partition wall of the Coach and Paint Shops.

This southern section of the partition wall represents the only remains and only information we have of the brick wall construction and design of the predecessor 1907 Paint Shop buildings' main floor level. The 1907 building was largely destroyed by a 1923 fire. The ductwork was a 1924-25 addition.

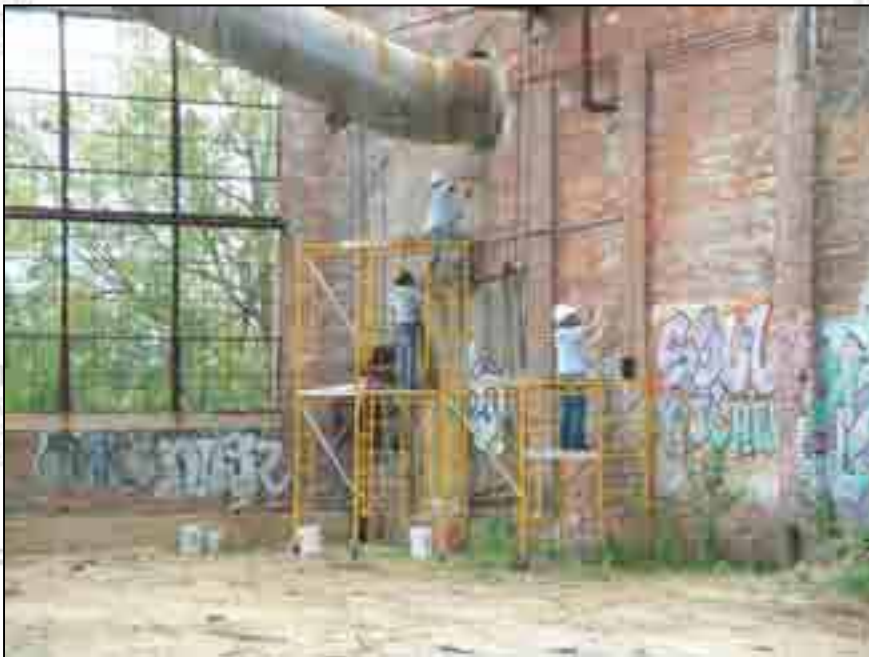
Masonry team members remove deteriorated mortar from the masonry crack in preparation for repointing.

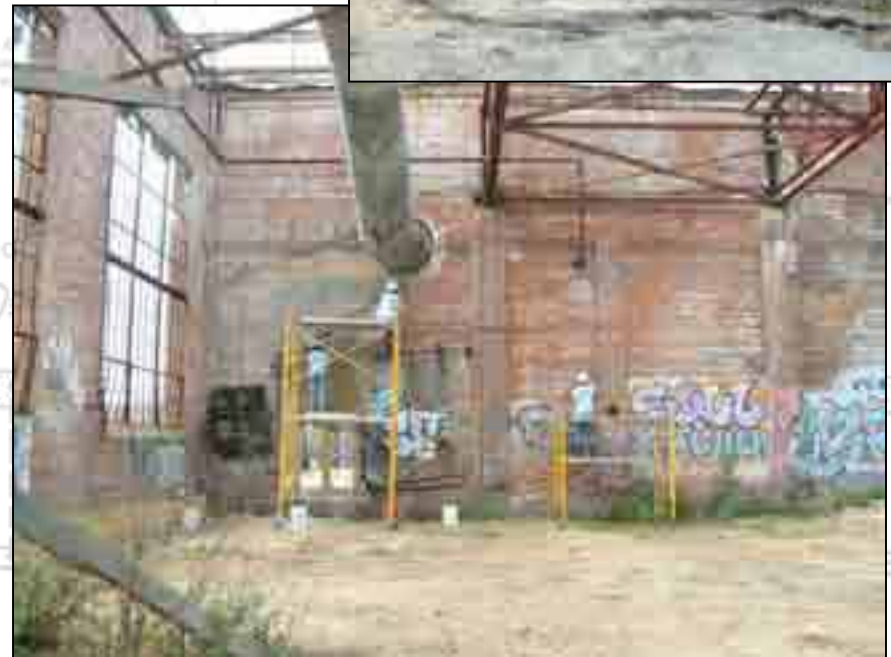
View of partition wall looking west from interior of Coach Shop.

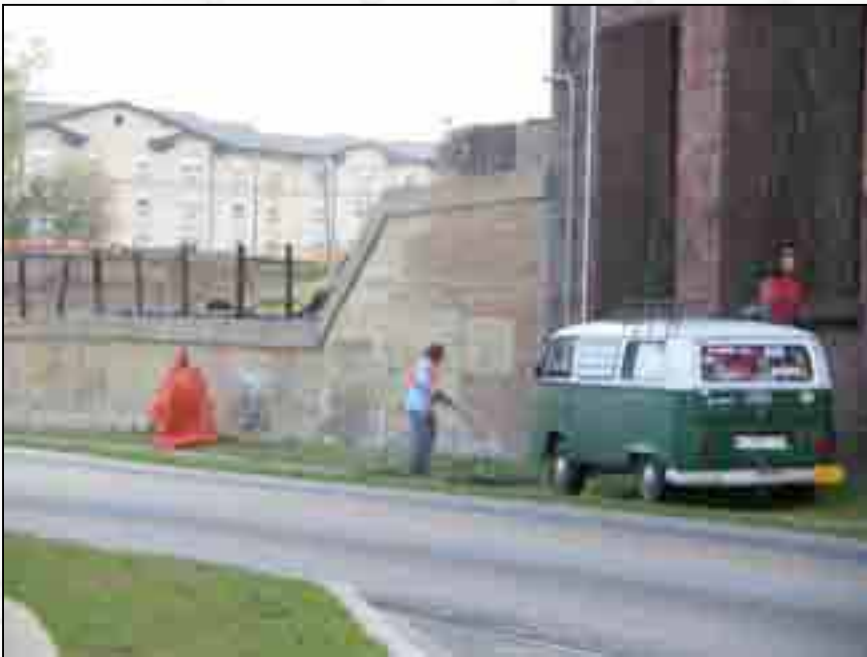
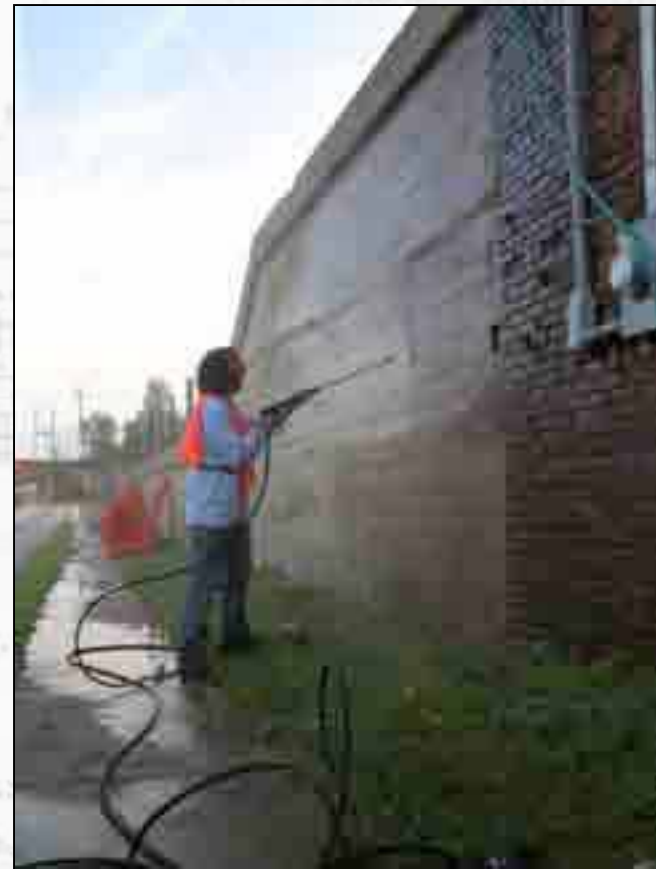
Graffiti was removed from the poured concrete retaining wall along Boundary Street. This wall dates back to the early 1900's, possibly in the late 1910's when the transfer table area was filled in or in the 1920's when the existing Coach & Paint Shops were built.

Jason Cobb first applied a gentle paint remover. Then Lyman DeLiguori gently rinsed the wall with a low-pressure washer.

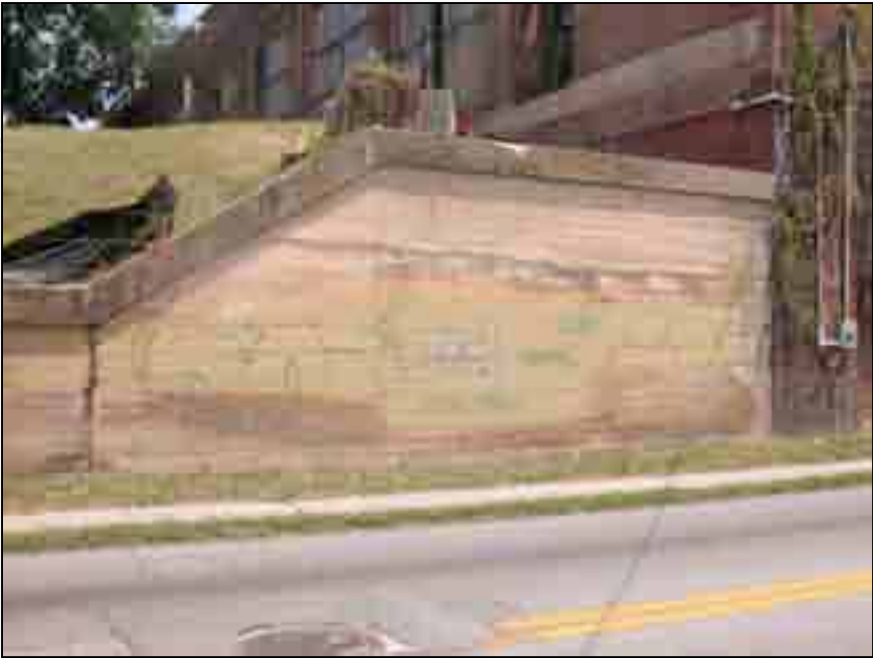
Before graffiti was removed.

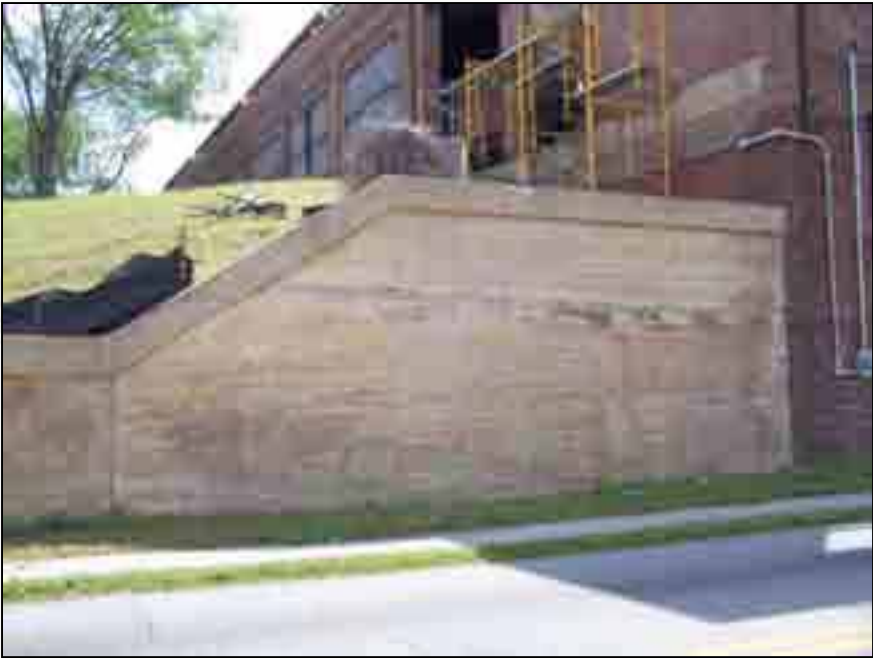
After

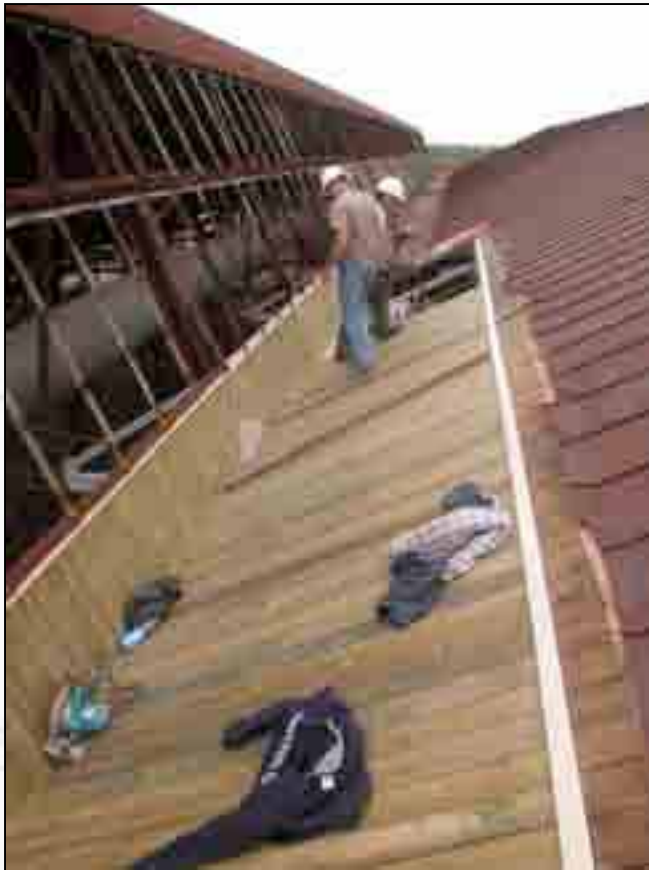
The CHS Preservation Team is currently making repairs to the sawtooth roof. Existing wood was too deteriorated to reuse so pressure-treated wood was cut to match the historic profiles of the original pieces.

View from top of sawtooth roof.

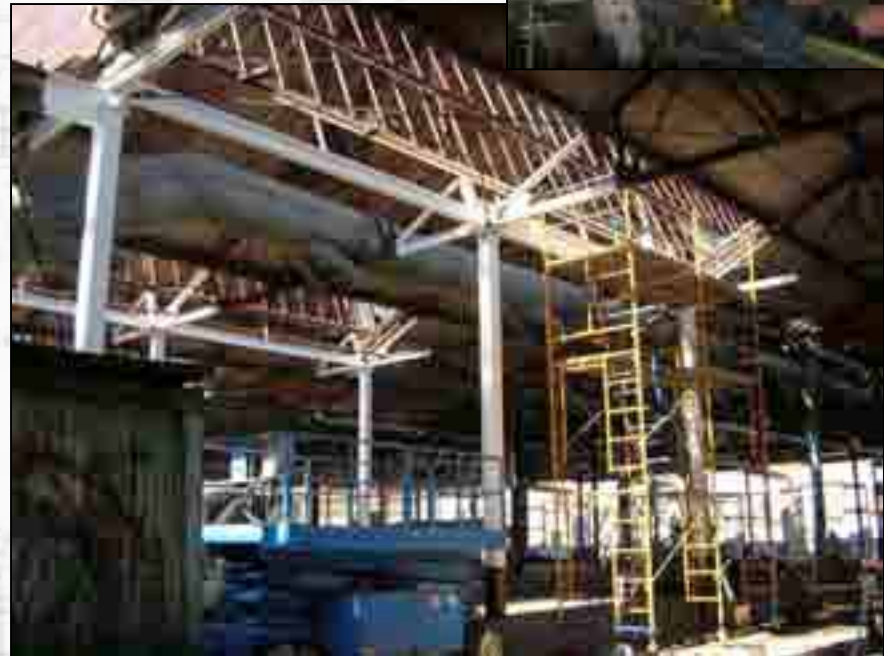
Scaffolding has been set up to repair the first of five valleys of the prototype area.

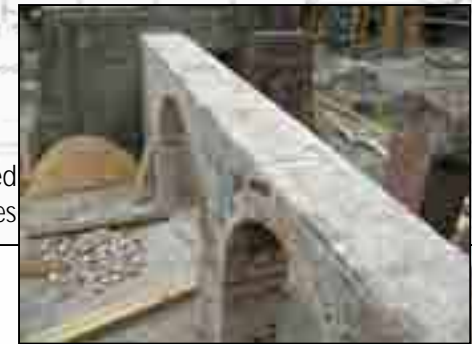
Close-up view of restored foundation arches

Before masonry repairs took place, many bricks were missing and mortar was badly deteriorated in the foundation arches, leaving them severely unstable.

Masonry repairs on the southernmost foundation arches in the Carpentry Shop are nearing completion.

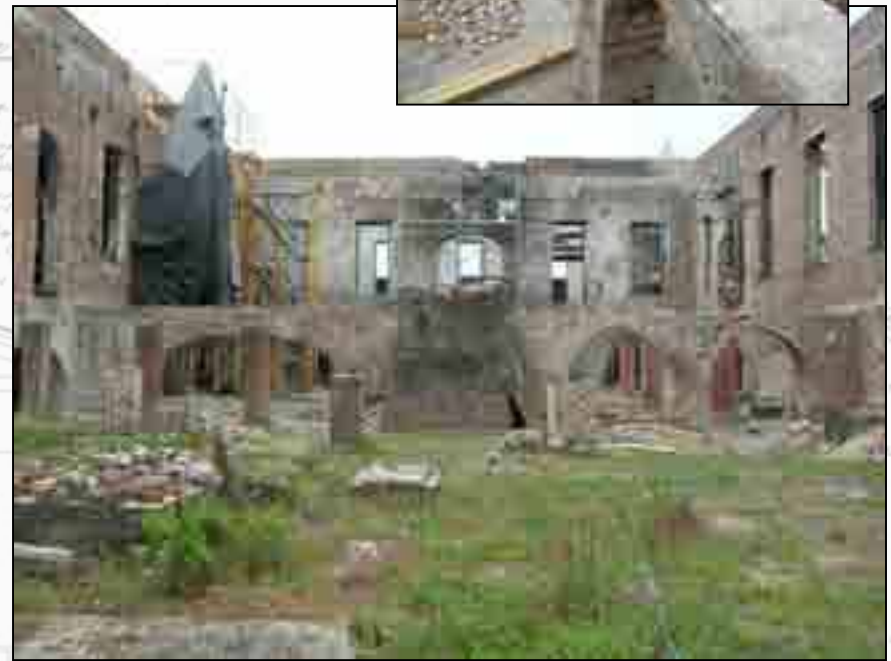
Current view of the southernmost foundation arches. Southern Preservation Systems had to rebuild much of the masonry on top of the arches.

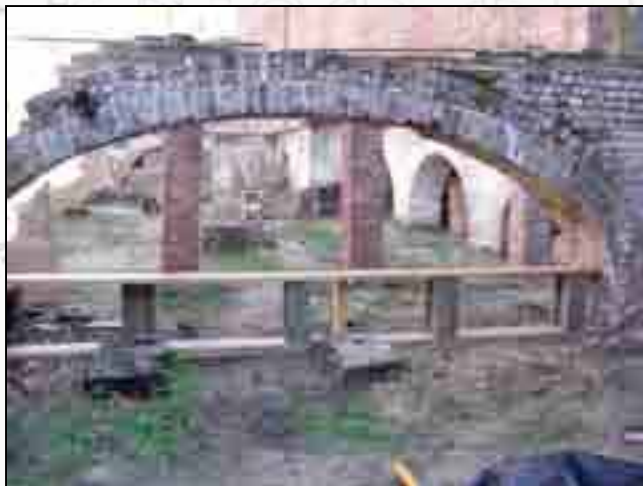
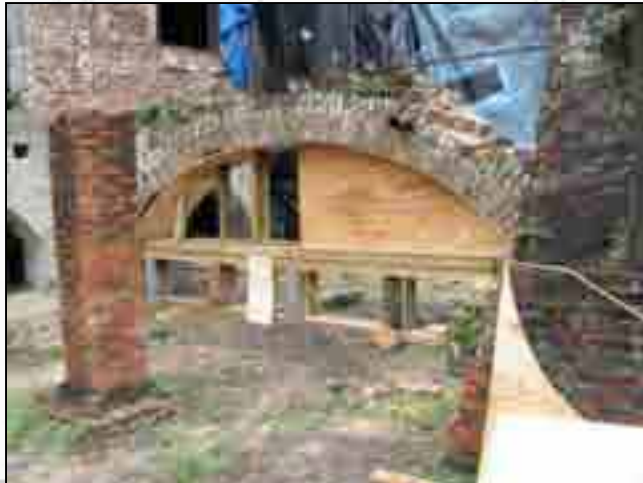
Views of deteriorated arch before masonry repairs.

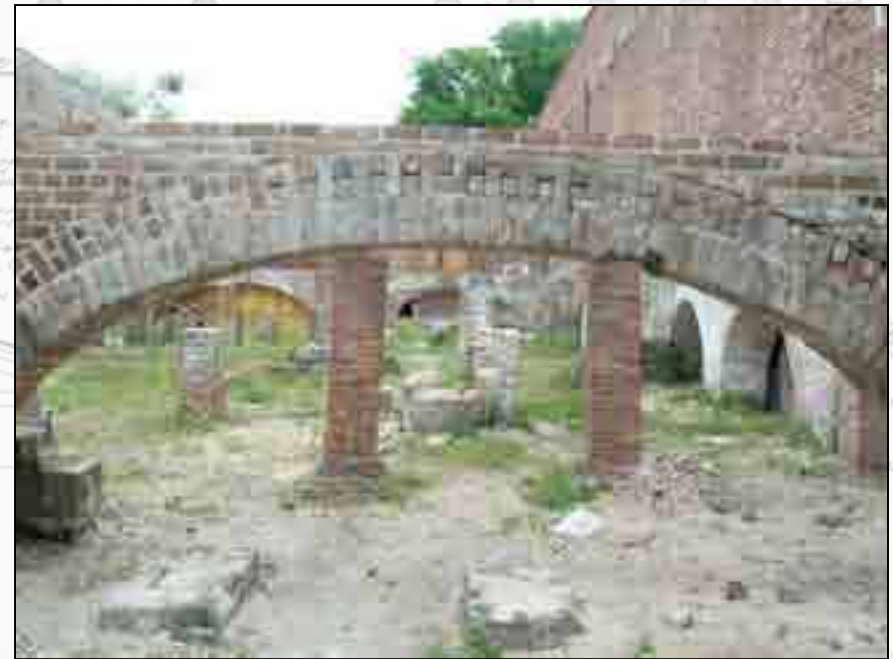
Current view of arch after masonry repairs.

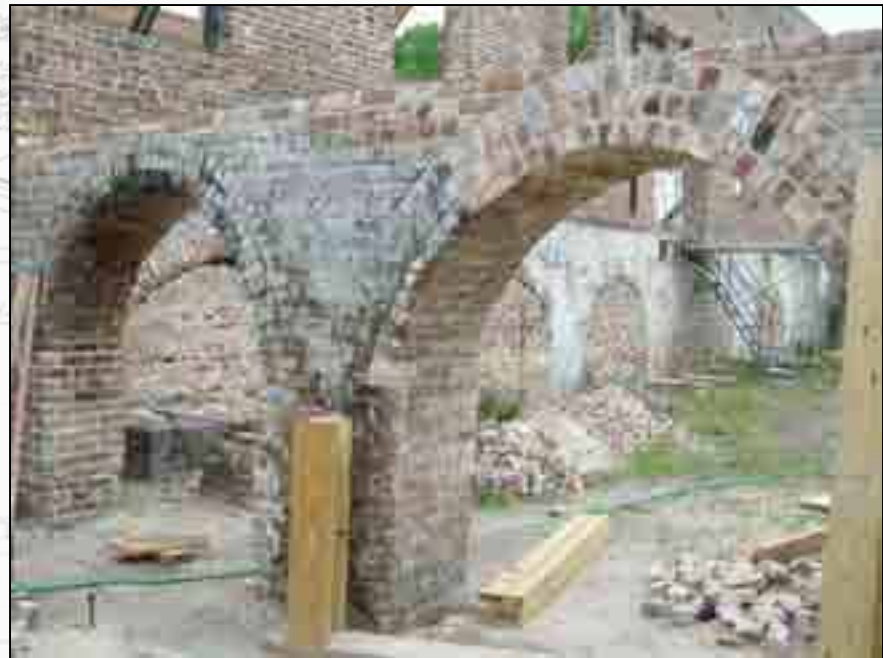
View of arch before masonry repairs.

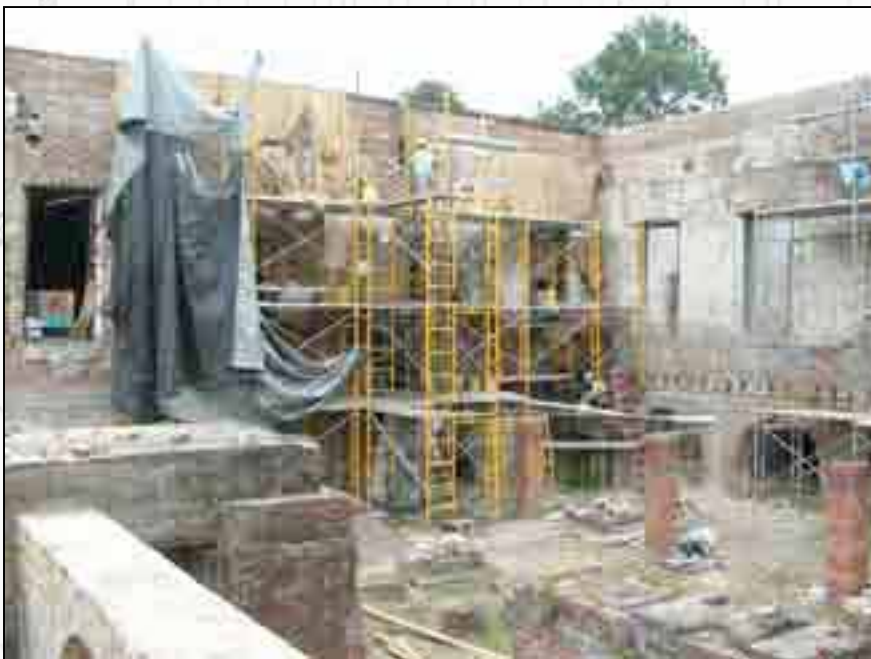
View of southeast corner of Carpentry Shop.

The CHS Preservation Team is nearing completion on the fourth phase of repointing on the east wall of the Carpentry Shop.

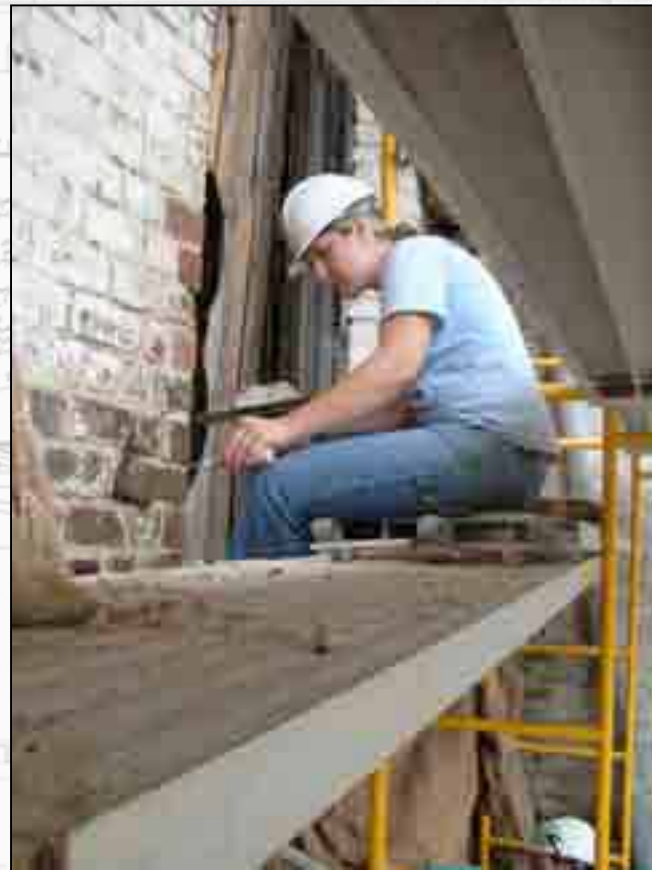
Tarin Erickson repoints a corner of a window opening.

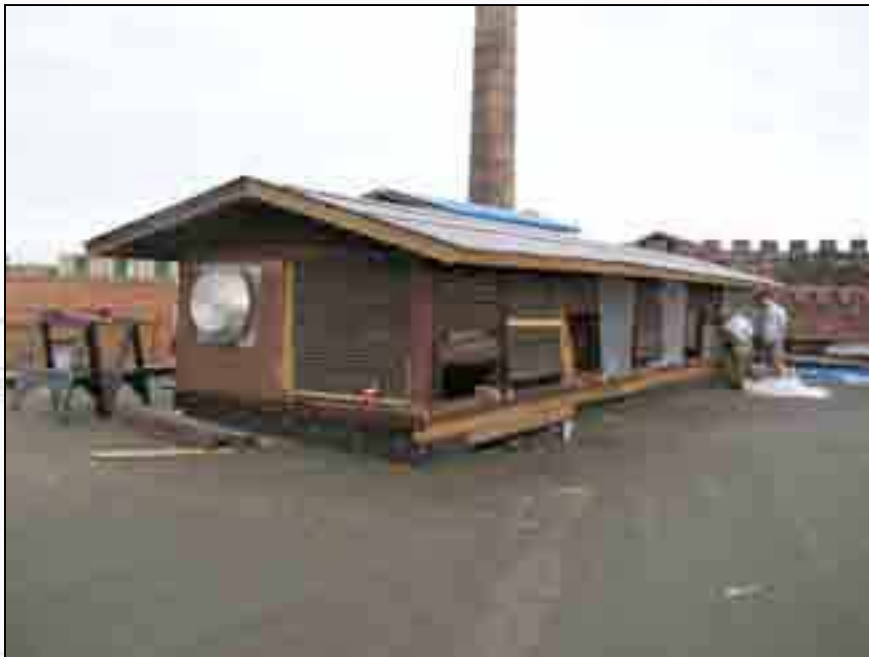
View of monitor shortly after restoration began.

After months of hard work, the CHS Preservation Team recently finished the restoration of the Compressor Room monitor. A standing seam metal roof will be installed on top of the monitor, and a modified bitumen roof will be placed on top of the main roof.

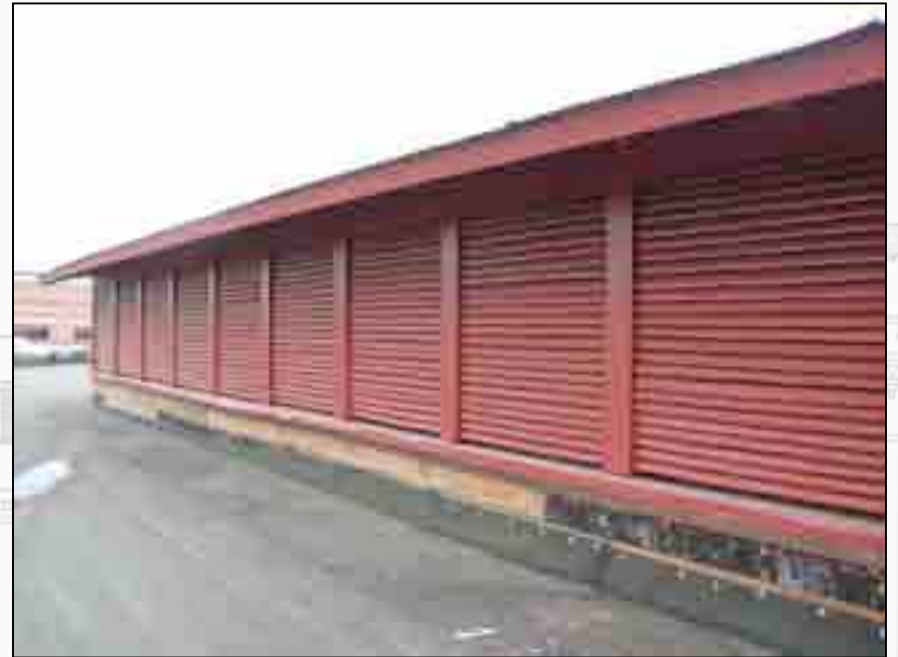
Deteriorated wood was repaired or replaced.

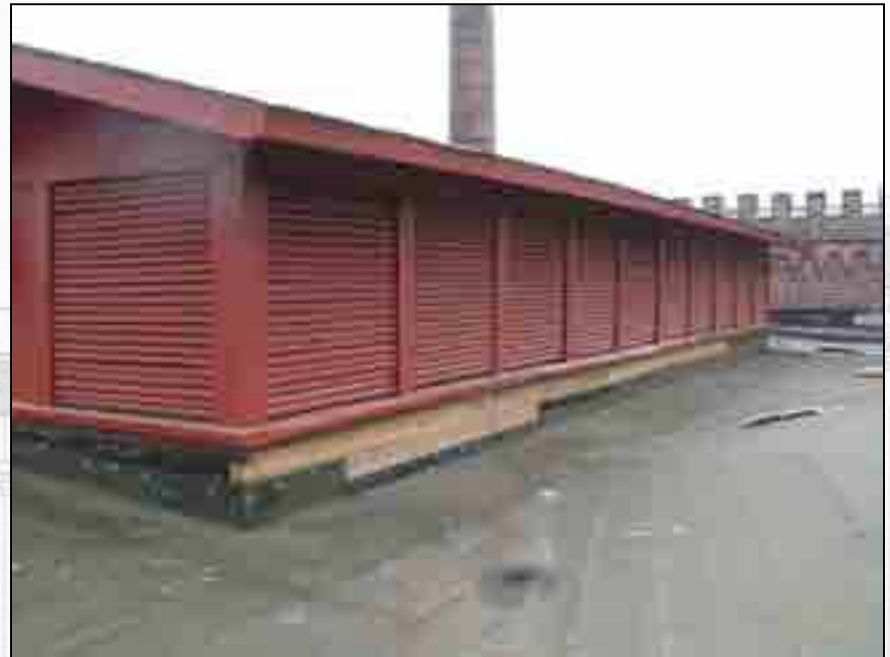
An historic paint analysis was performed to determine the original paint color.

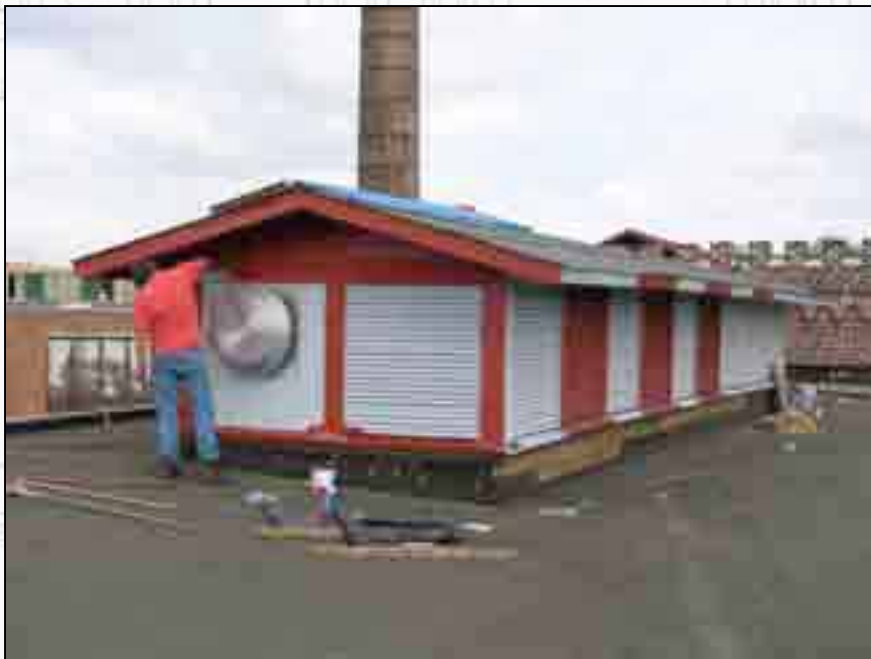
Kevin MacMillan applies the first coat of paint.

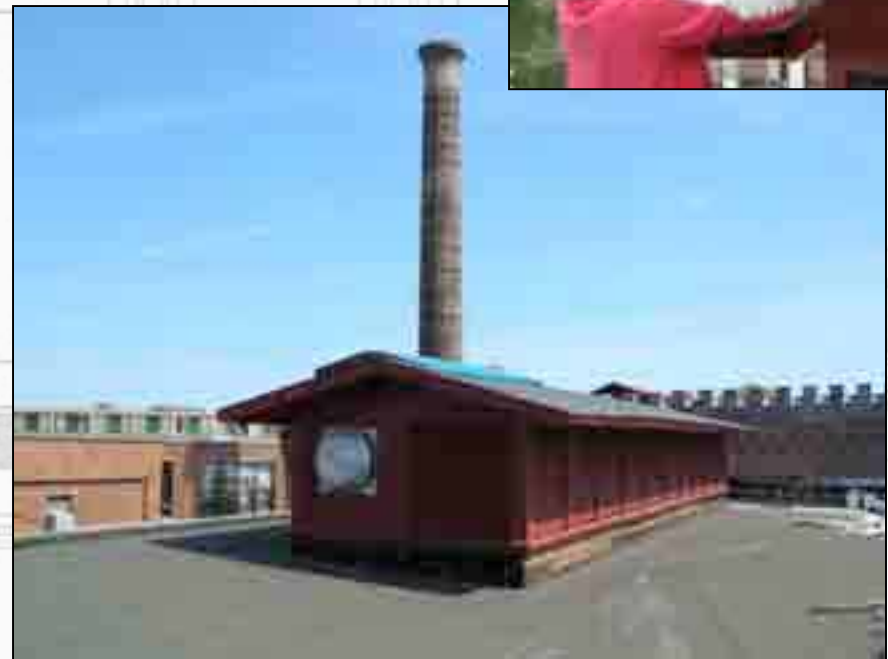
The monitor after restoration.

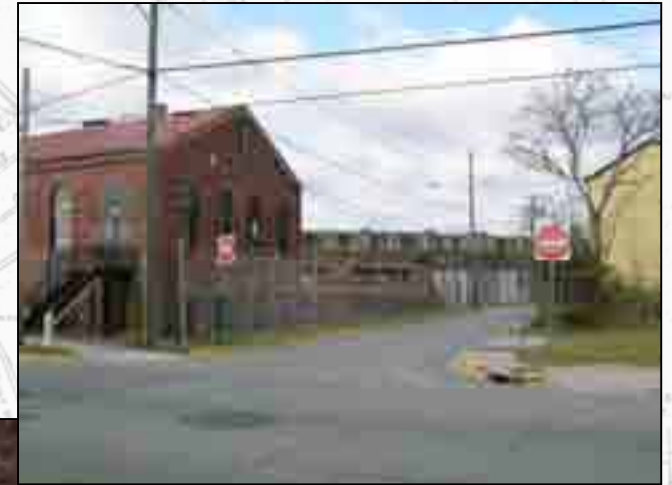
Chain-link fence at Purse Street

The Purse Street chain-link fence is currently being replaced with one that is historically accurate. Earliest documentation of the original wood fence dates back to 1926. The new wood fence will be painted "Box Car Red" in accordance with Central of Georgia paint standards and specifications from 1911 and 1917.

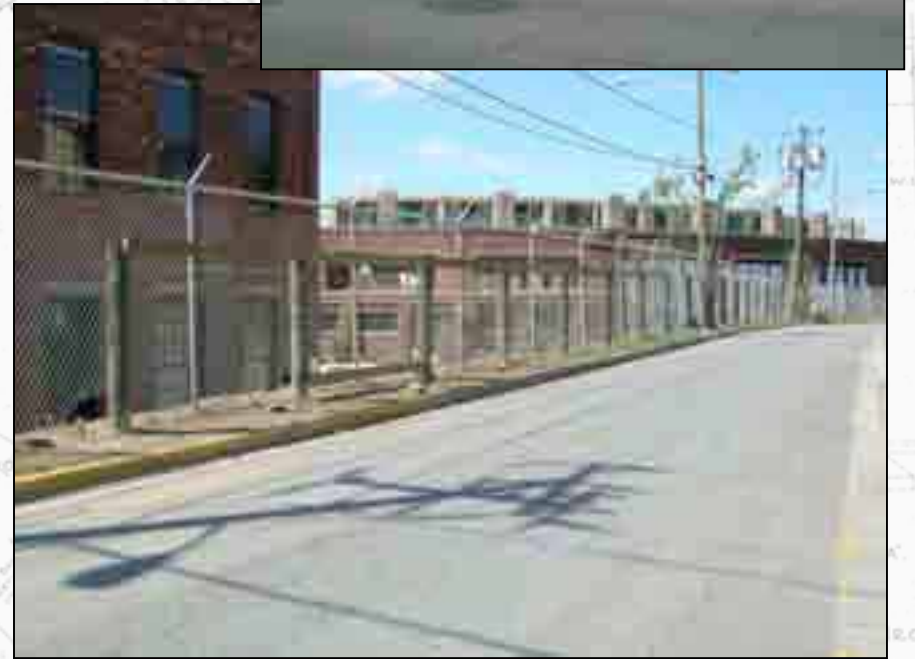
Wood posts of new fence as it is being installed.

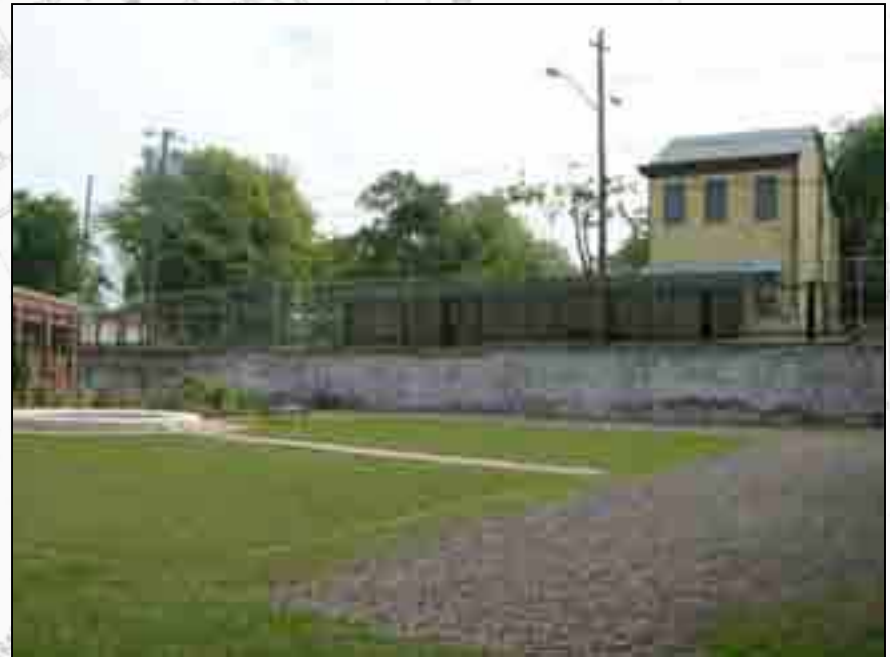
View of fence from Workers' Garden

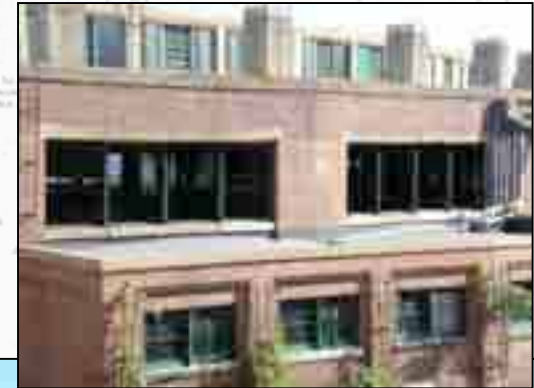
The Preservation Team repaired and restored window frames on the Overnight Shed that were suffering from water damage and rot. Reusable wood was repaired with epoxy and treated with borate to prevent mold, mildew, and bug infestation.

Close-up view after repairs

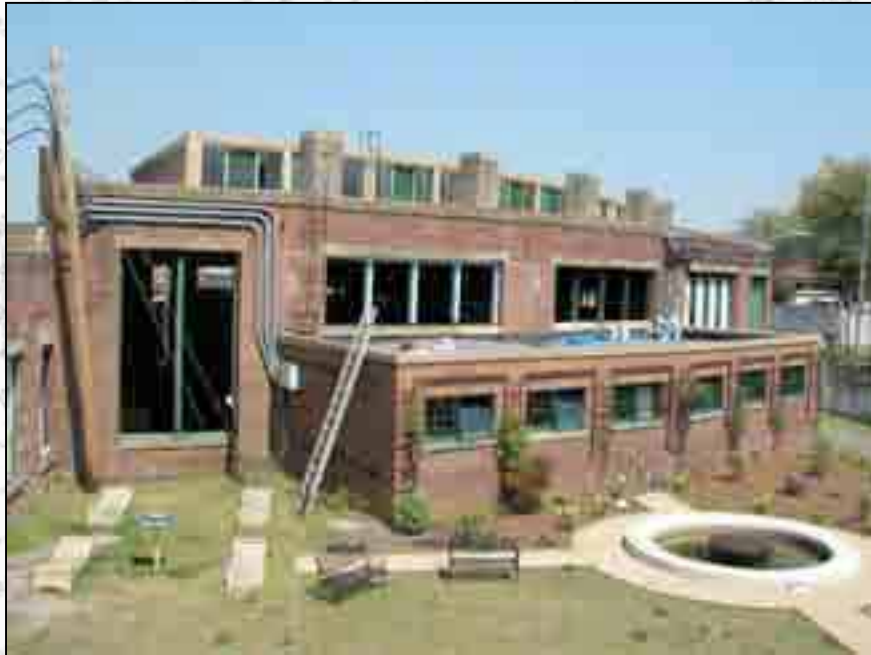
View during repairs

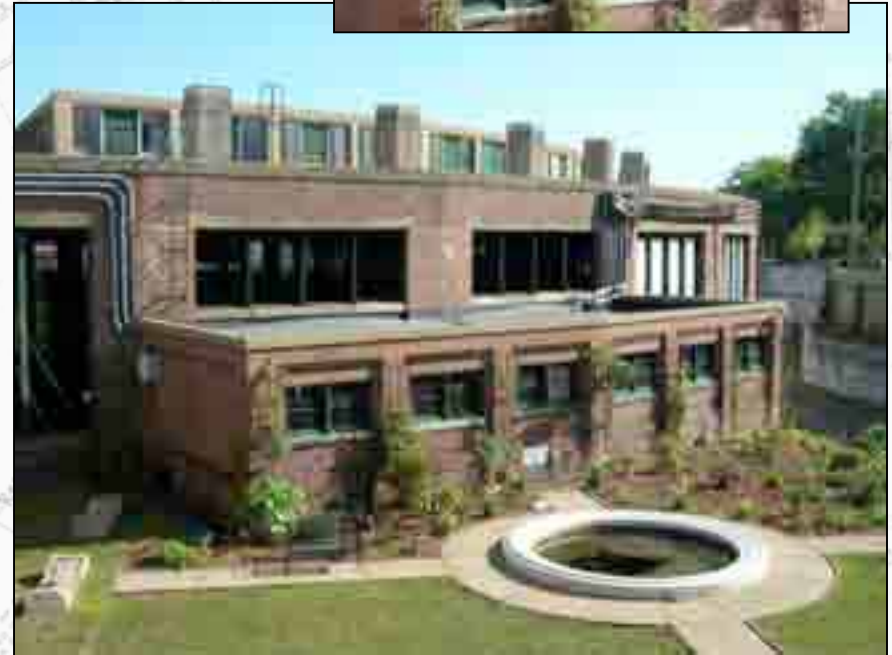
After repairs

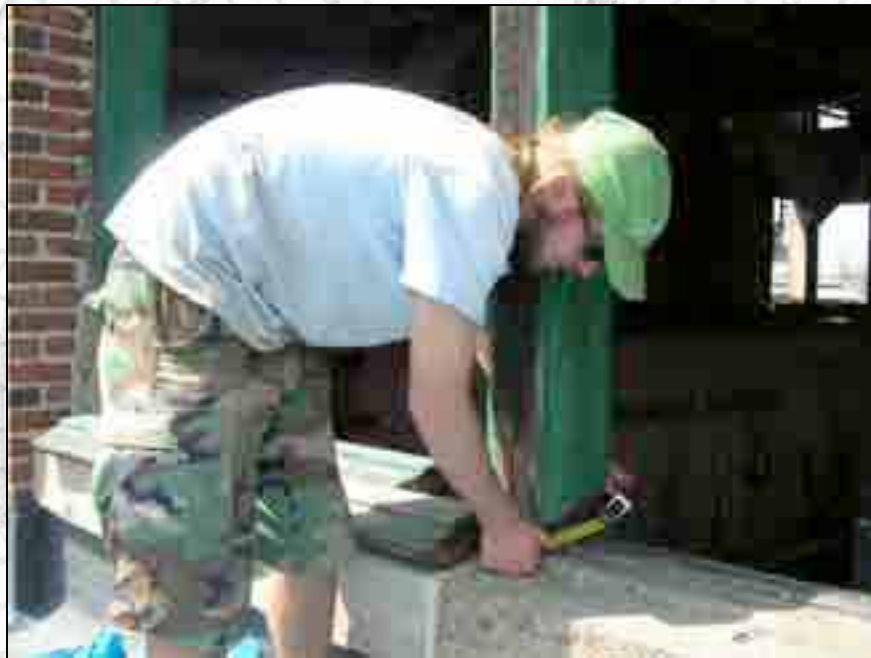
Nathan Harris measures a deteriorated segment that needs repairing.

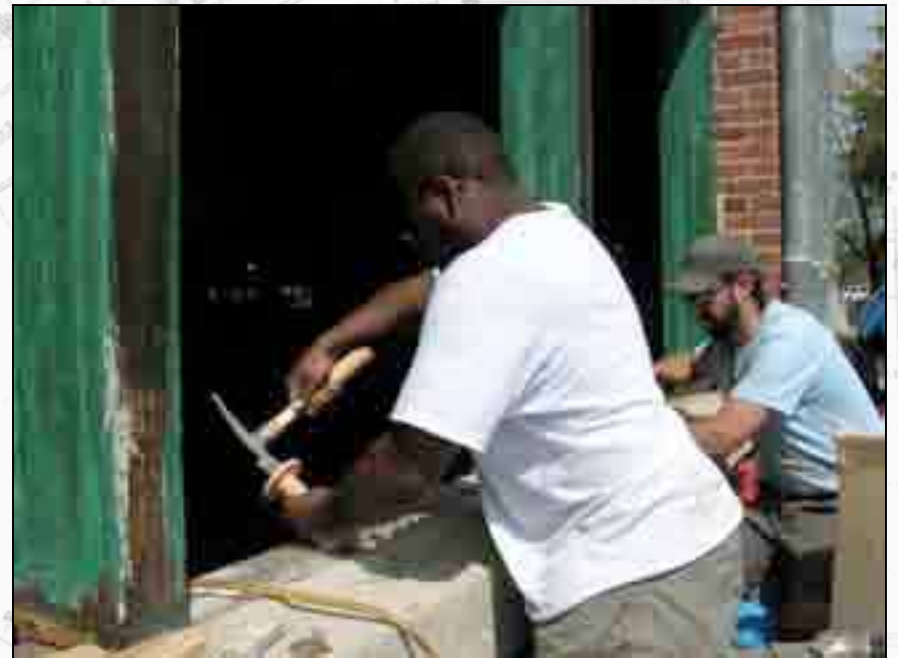
Allan Ballard and Justin Wiedenbach prepare the concrete sill for the window frame.

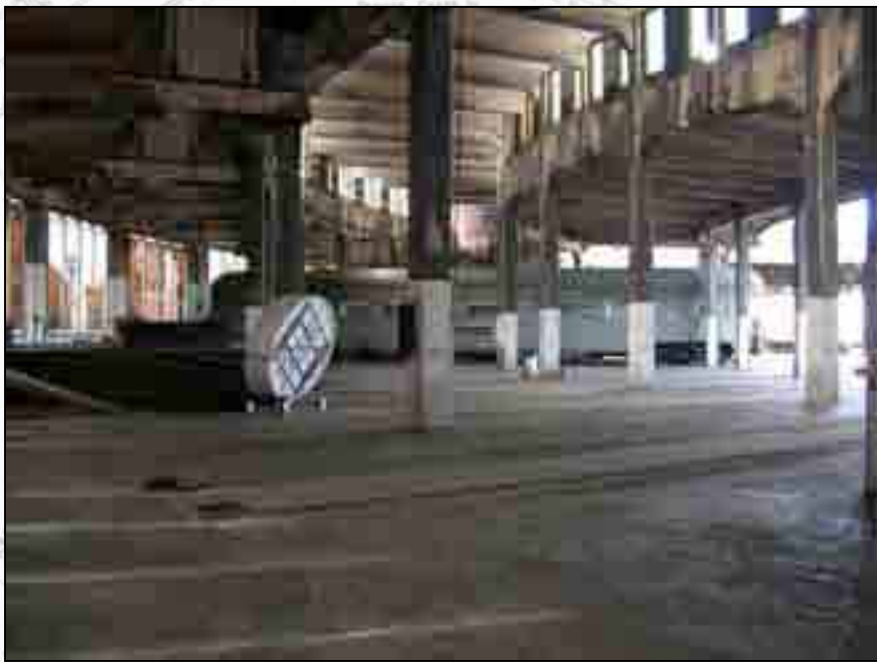
Overall view of restored wood block floors inside the Overnight Shed.

The wood block floors in the Overnight Shed were officially completed on March 21, 2007. TV and newspaper crews came out to cover this momentous event.

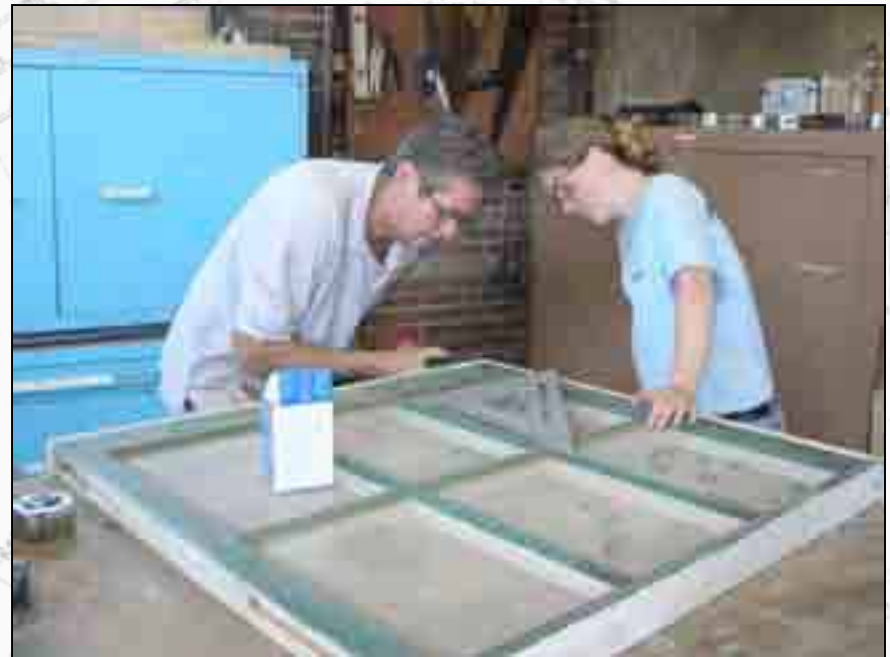
The CHS Preservation Team is currently repairing the modern windows in the Dispatch Office.

Don Miller and Amanda Smaridge repair one of the non-historic windows.

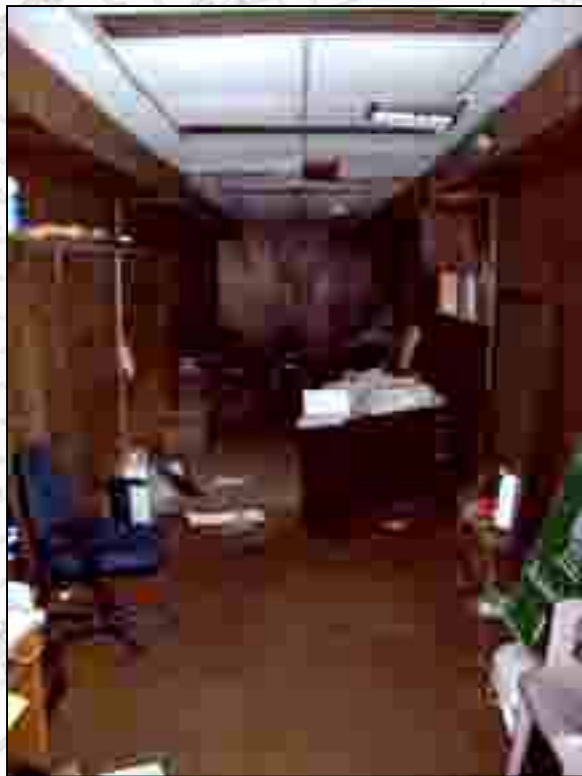
View of interior when CHS acquired car from museum in Augusta, GA

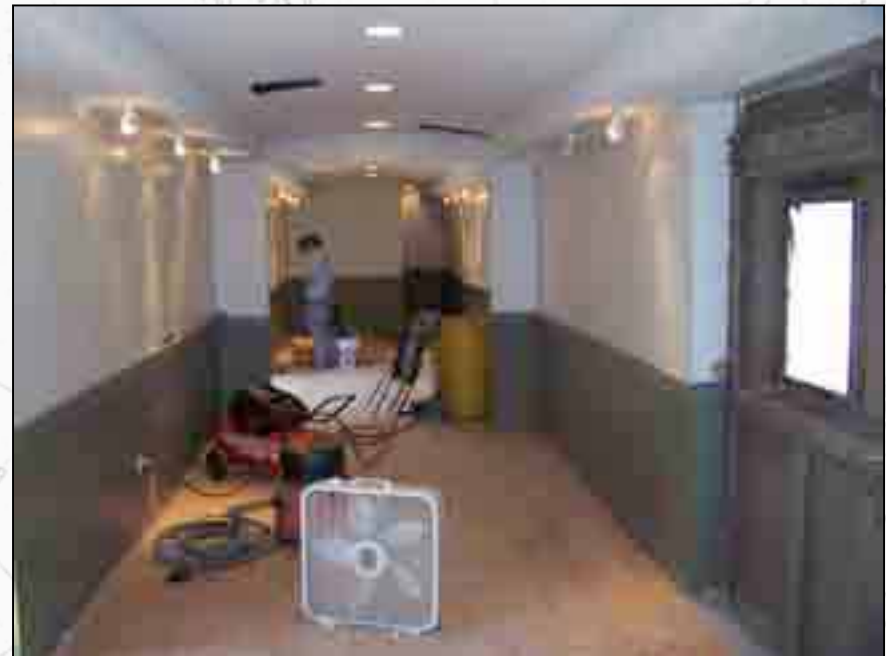
Drywall was recently installed inside the 430 Baggage Car (right), which was originally built in 1924 as a passenger car for the Pullman Company. The Central of Georgia purchased the car in 1941 and turned it into a baggage car, extensively changing the interior and exterior.

Current view with drywall and fresh paint.

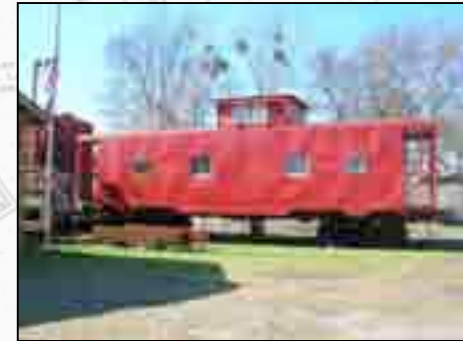
In order to prepare the caboose for public use, a full rehabilitation was done. The railroad operations team patched portions of the wall that suffered from rot. They also removed the existing carpet and replaced it with tile flooring. The new color scheme is vibrant and energetic and reflects its new use as children's space.

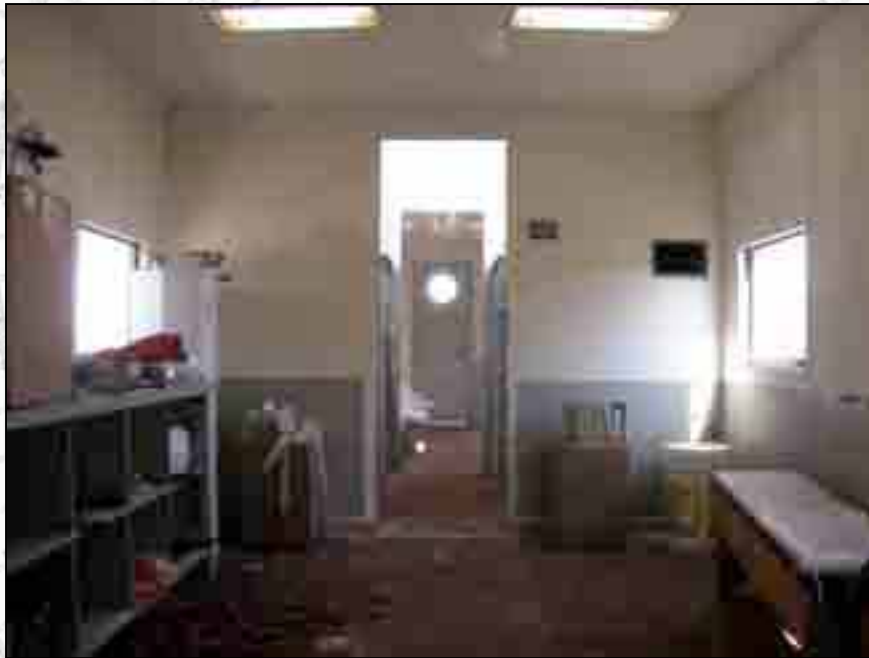
View of interior during construction

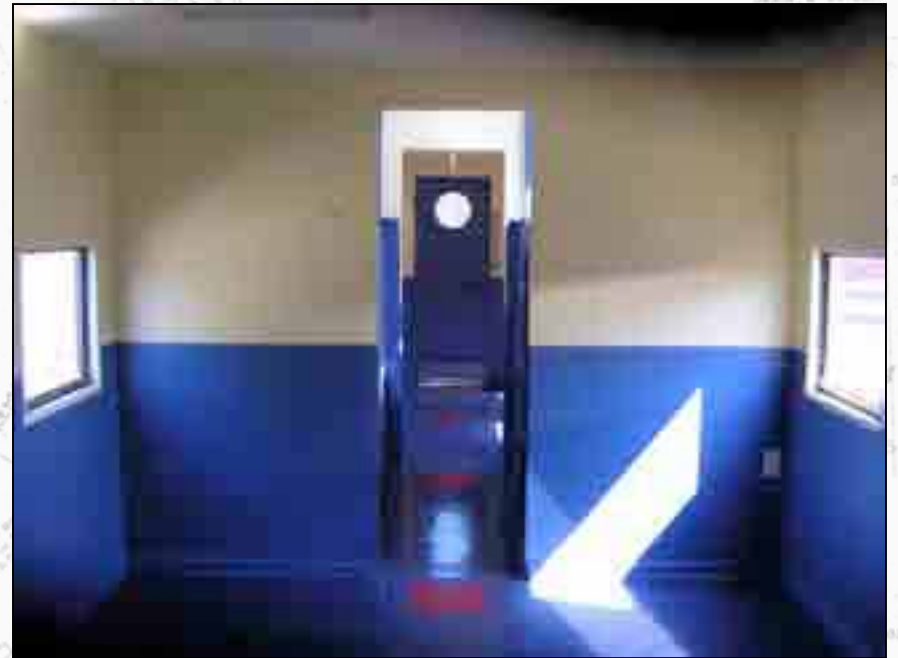
Current view
