Coastal Heritage Society

Savannah History Museum • Roundhouse Railroad Museum • Old Fort Jackson

Preservation Team • Railroad Operations • Archaeology

March 2007

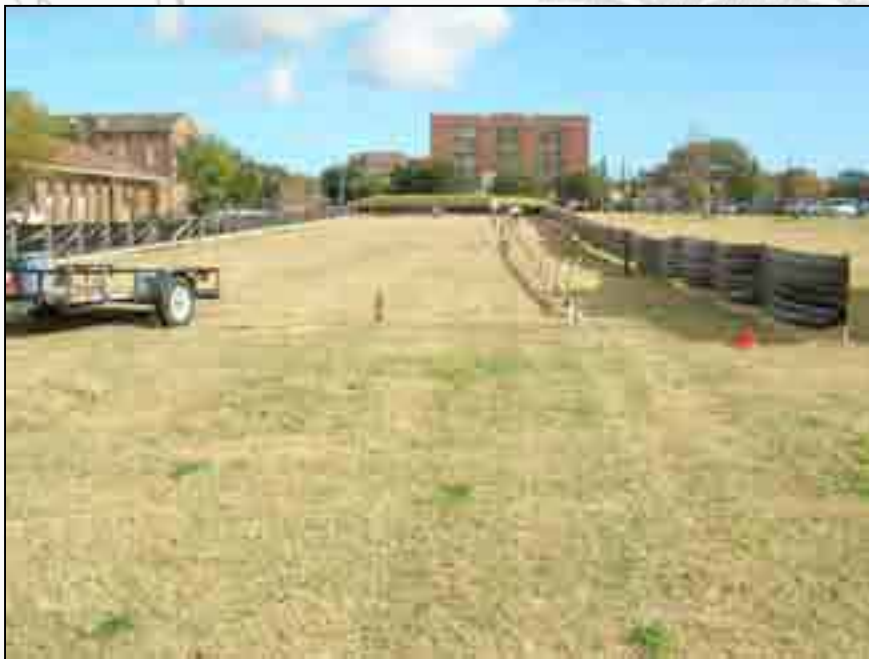
A memorial walk, consisting of 800 granite markers, will be constructed to represent and memorialize the Continental Army soldiers that were wounded or killed during the Siege of Savannah.

Site of memorial walk before construction began.

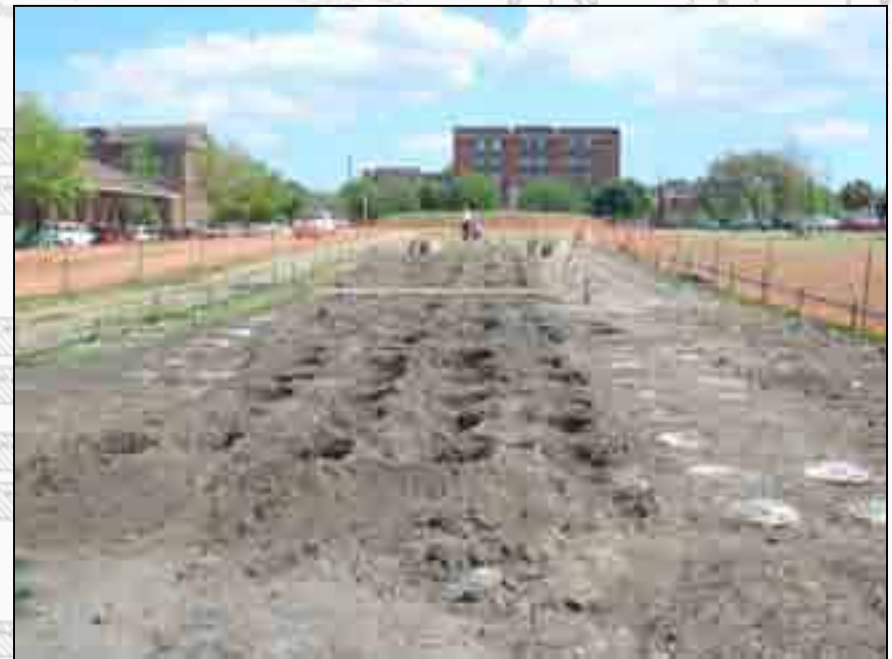
Concrete piers were poured into the ground in preparation for the granite markers.

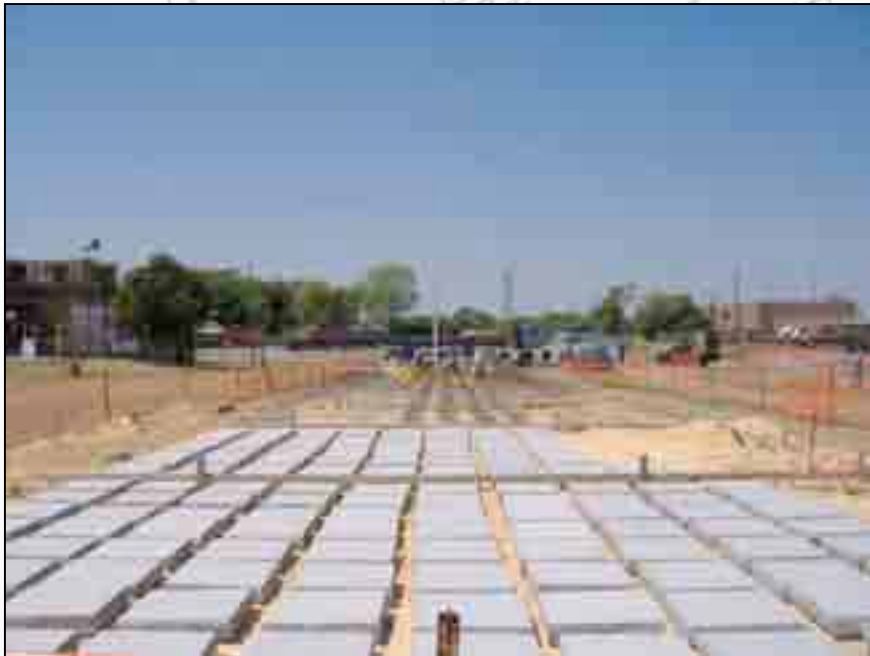
View looking west down the memorial walk. A flagpole was recently installed.

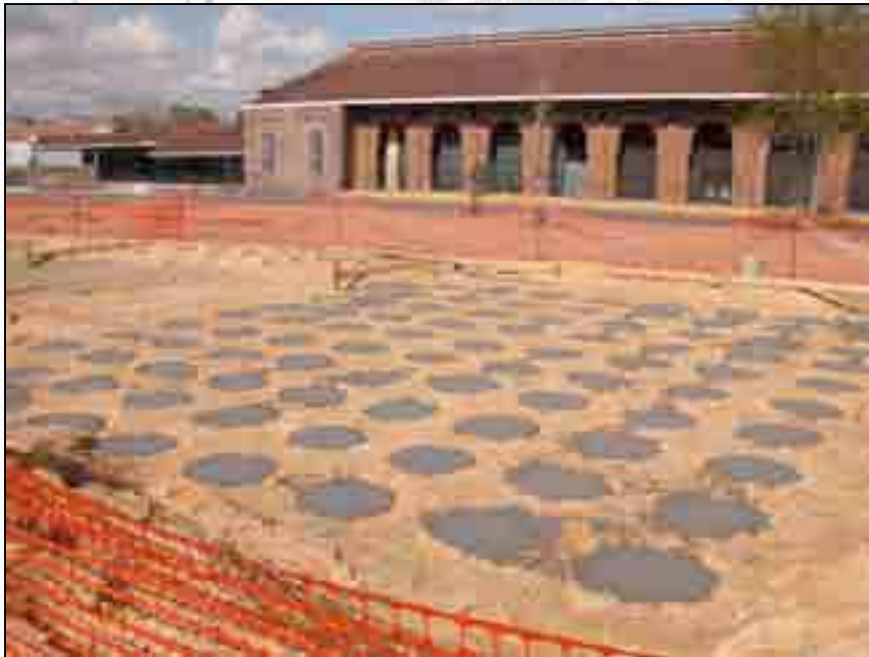
View of memorial walk shortly after construction
began. Concrete piers were poured.

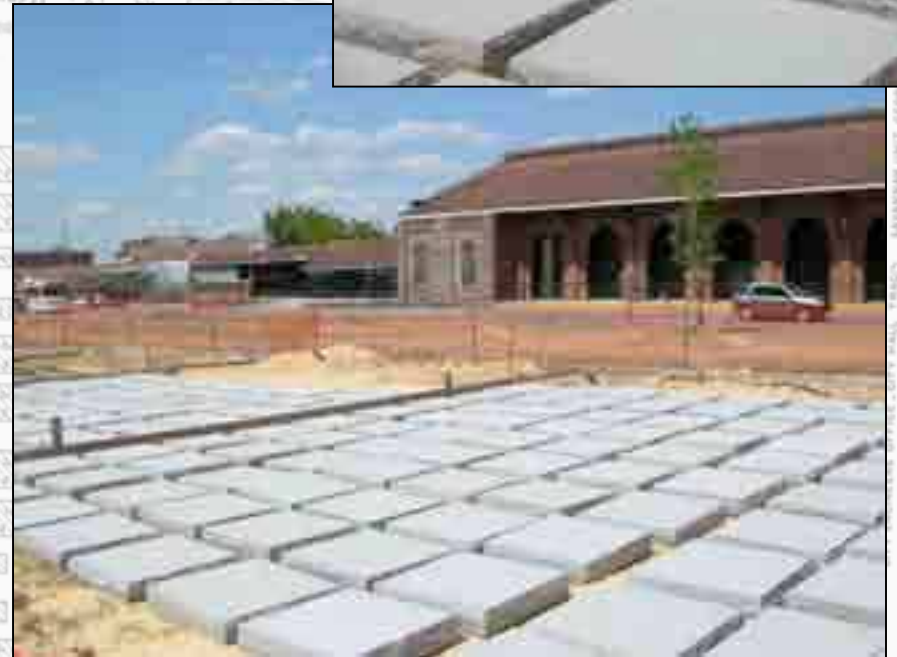
Current view of memorial walk with
newly laid granite markers placed on top
of the concrete piers.

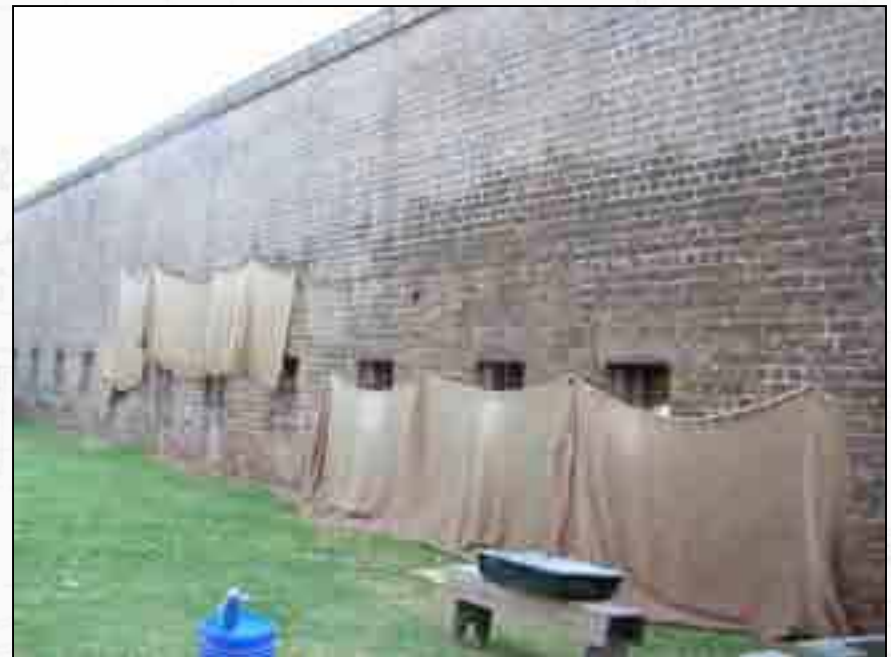
Deteriorated mortar joints on the interior wall of the fort have recently been repaired. Mortar must cure at a slow pace by absorbing carbon dioxide. Burlap has been placed over the repairs to ensure it does not dry too quickly.
