Coastal Heritage Society

June 2007

Paint Shop 1925

Roof Repairs

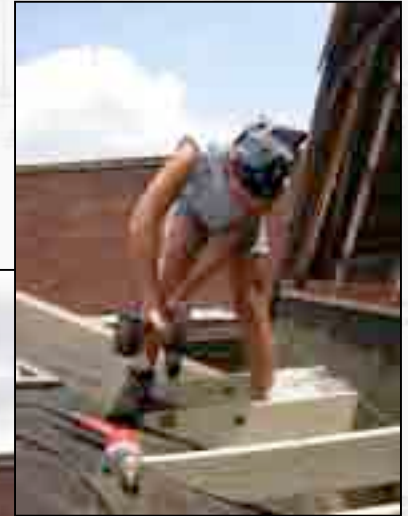
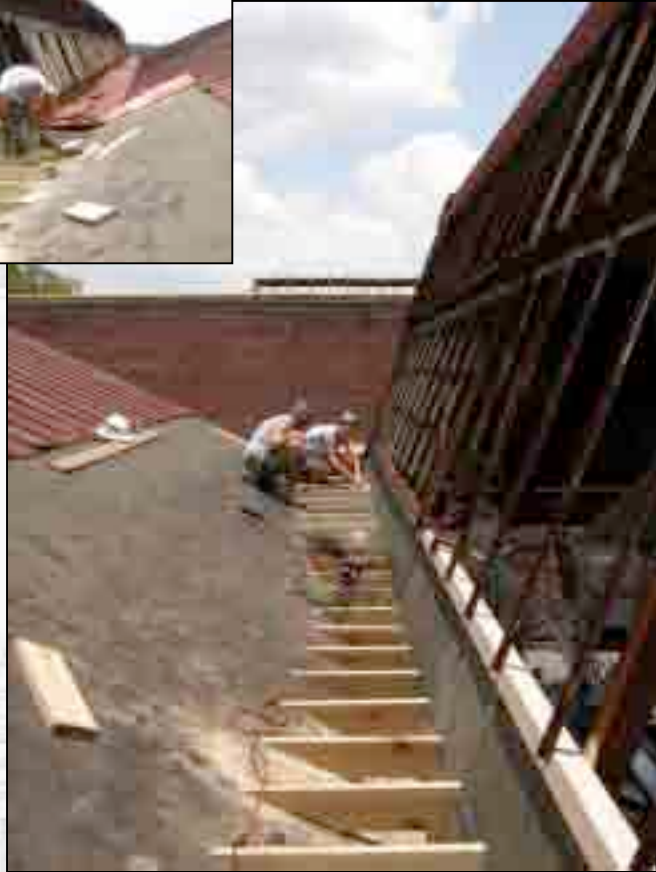
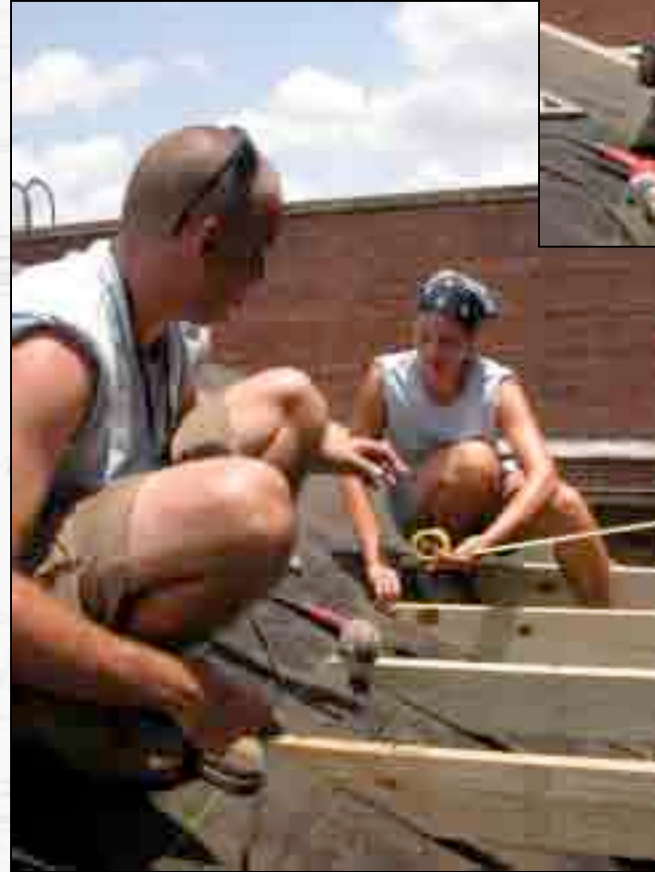
Preservation Team members continue working on the initial phase of sawtooth roof work at the east end of the building.

Kurt Benton and Jeanne Fullam install a cricket roof on the Paint Shop. This will help drain water from the roof.

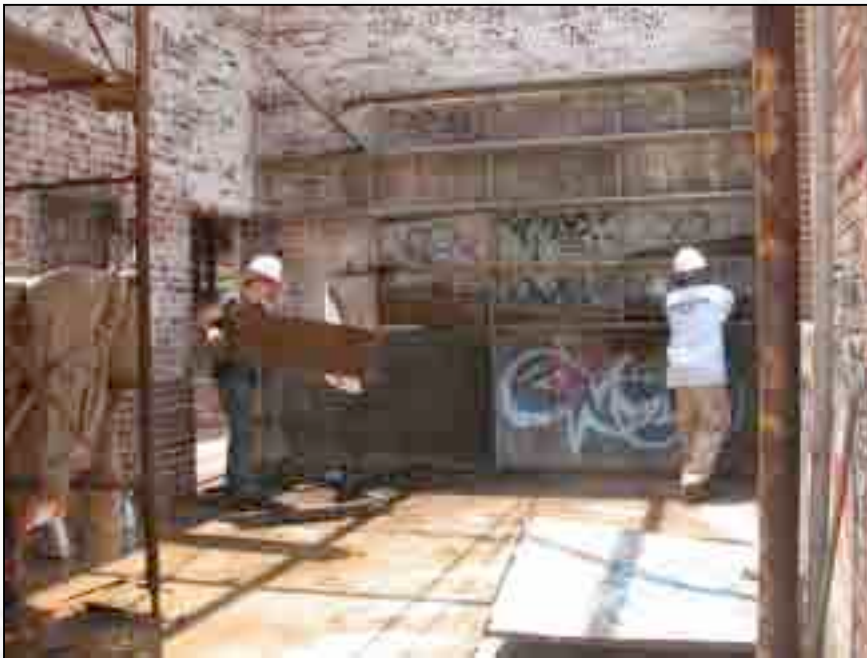
Kevin and John start by taking out the metal backing.

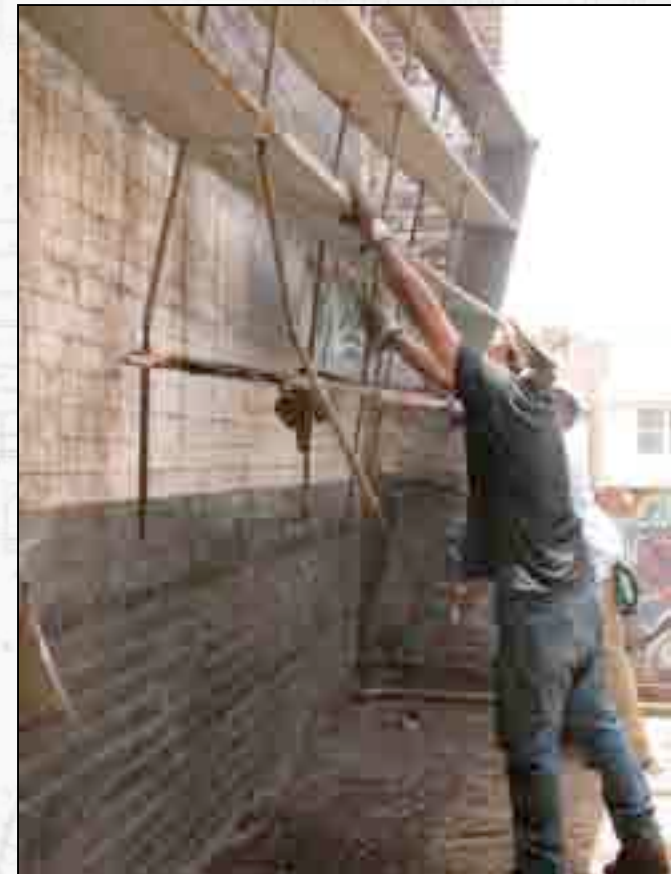
After loosening the screws, Kevin and John take the remaining structure down.

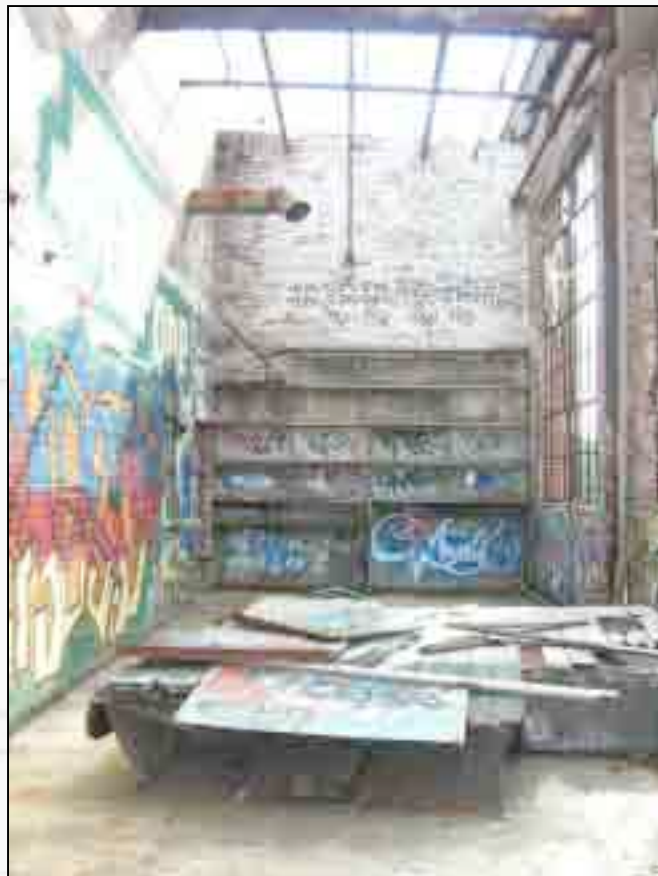
Storage shelves in October 2006. Since then graffiti has been removed from areas of the room.

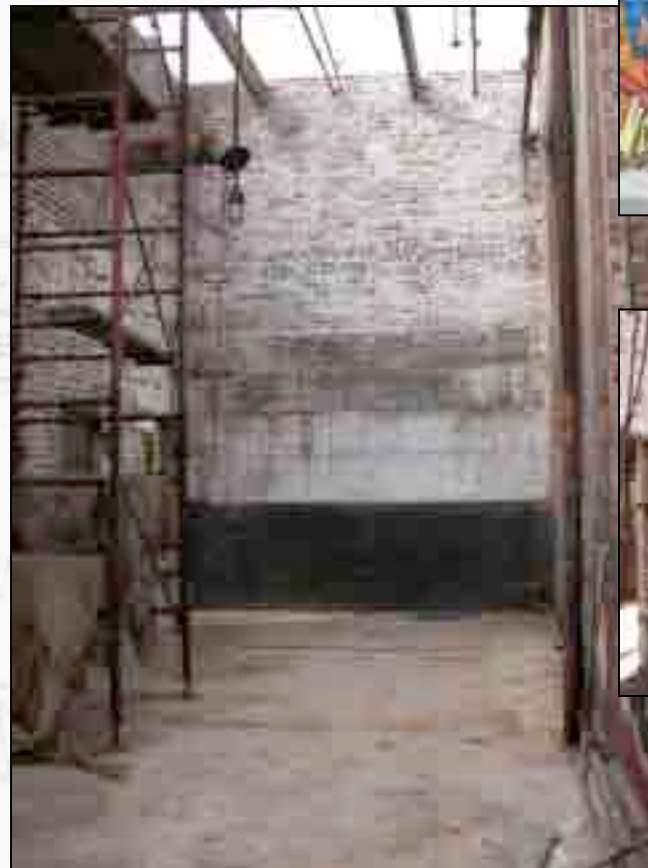
A good example of the building's original paint color scheme of bottle green at the four-foot wainscot and white above was revealed after the shelves were removed.

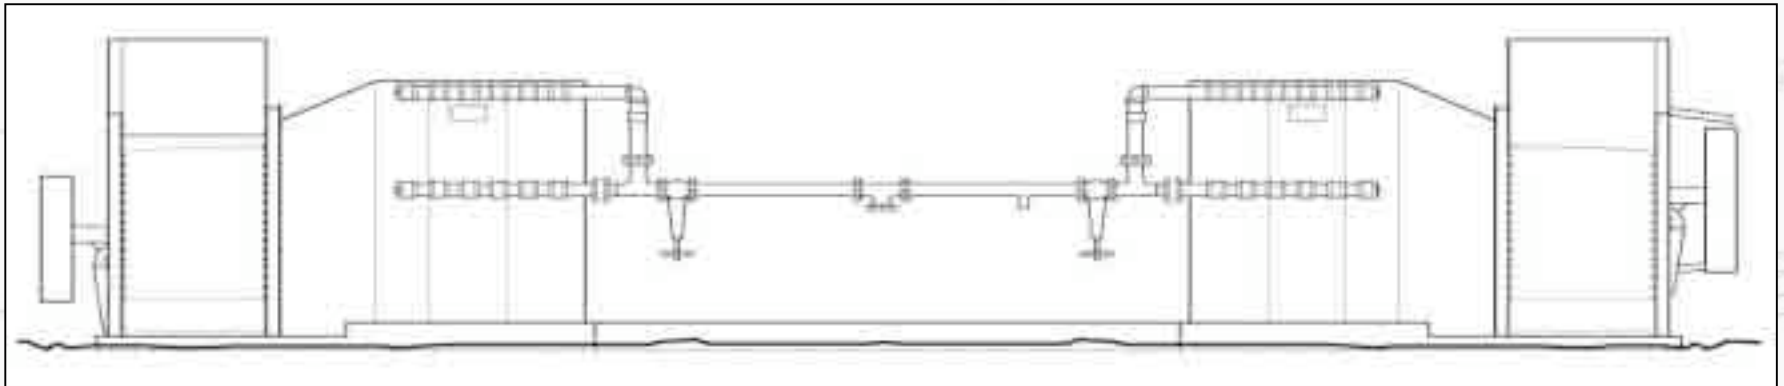
Sirocco heat unit system as documented by the CHS design team

The CHS design team recently finished documenting the Sirocco heat unit system. After it was completely documented, the unit was removed from the basement.

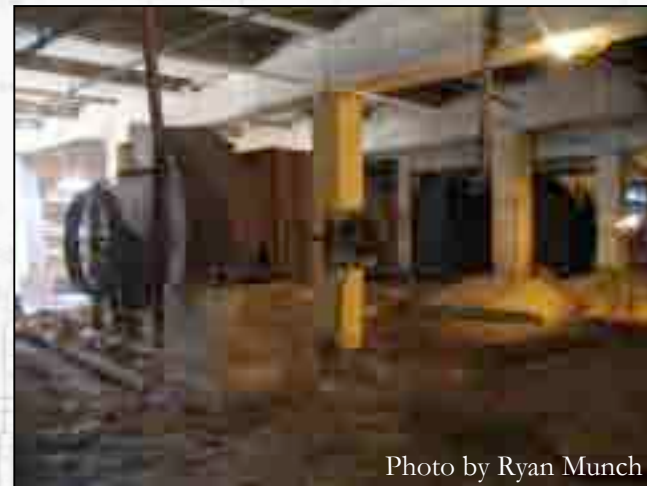
View of Sirocco heat unit system before it was removed from the basement.

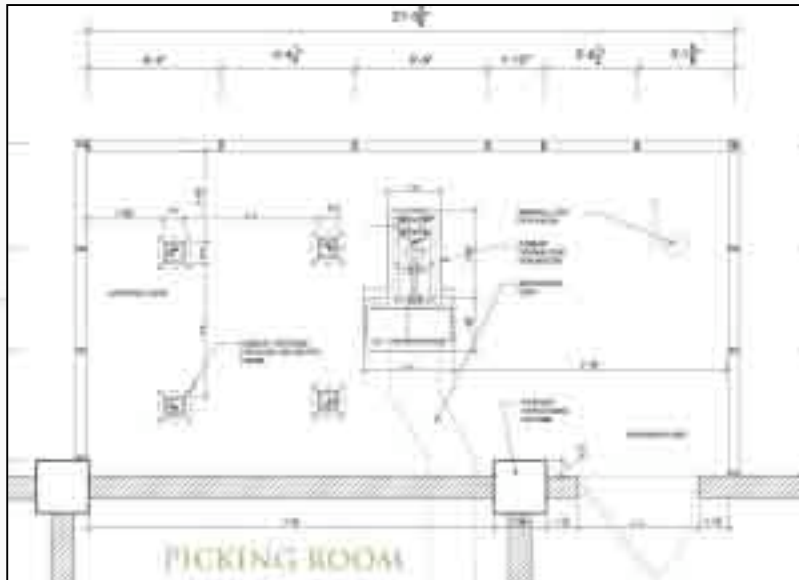
A dust collector in the basement of the Paint Shop was recently documented by the CHS design team. The dust collector was historically used to collect dust from the picking room, where textiles were processed. The dust collector was manufactured by Buffalo Forge Co., located in Buffalo, NY. Buffalo Forge Co. is still going strong as part of Howden-Buffalo, Inc. and is a leader in fan engineering today. The galvanized metal blowpipe system (shown below) was locally made by Savannah Blowpipe Co, a predecessor of Great Dane Trailers.

Floor plan showing location of dust collector in the basement of the Paint Shop.

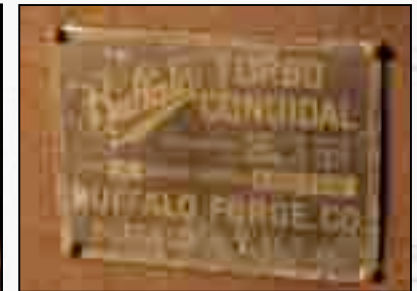
Manufacturer's plaque found on dust collector.

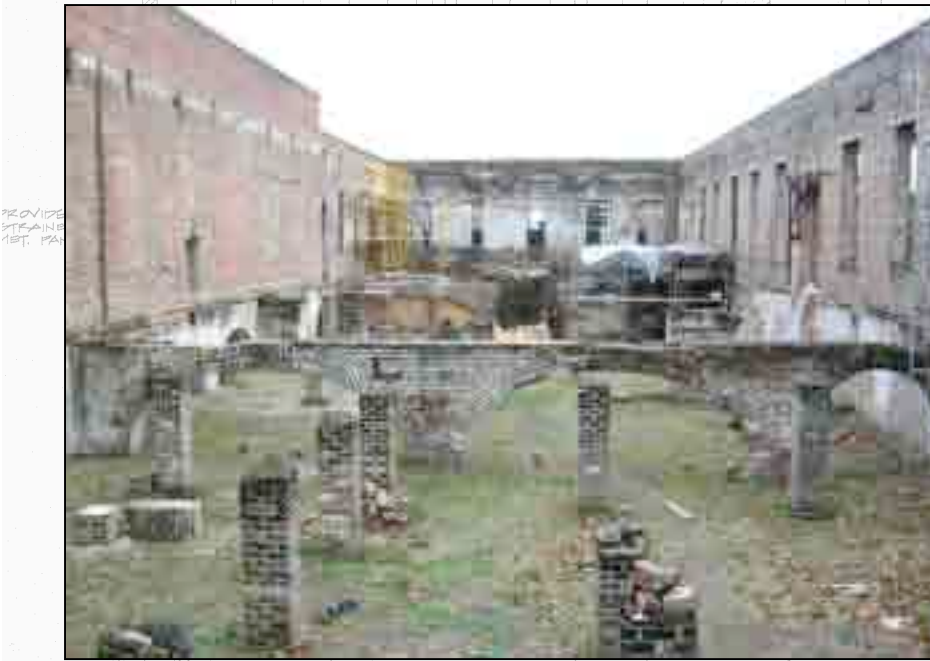
View of foundation arches shortly after masonry restoration began. Most areas were severely deteriorated and unstable.

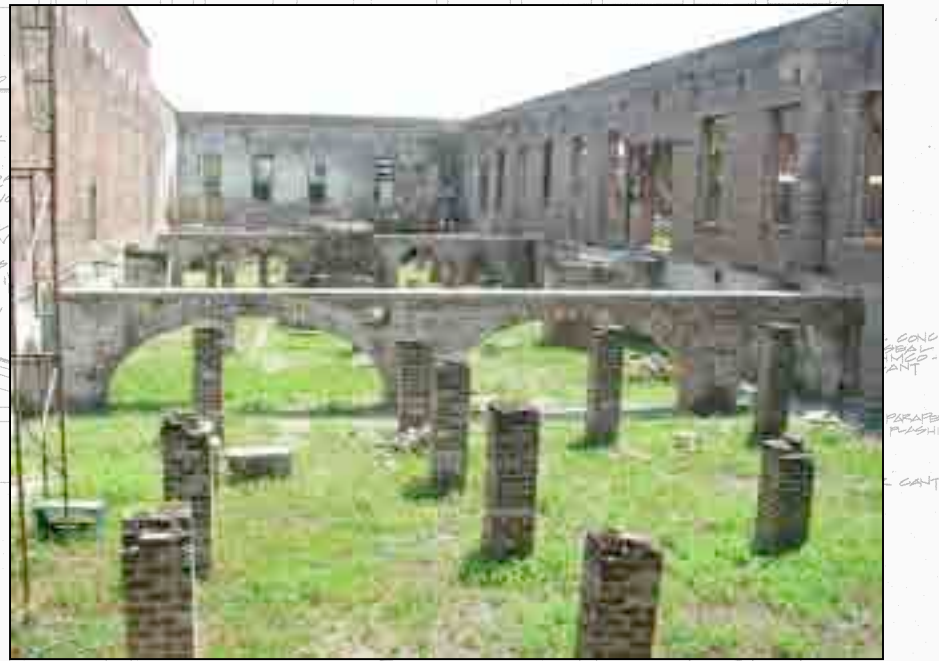
Current view of foundation arches that have been restored and rebuilt.

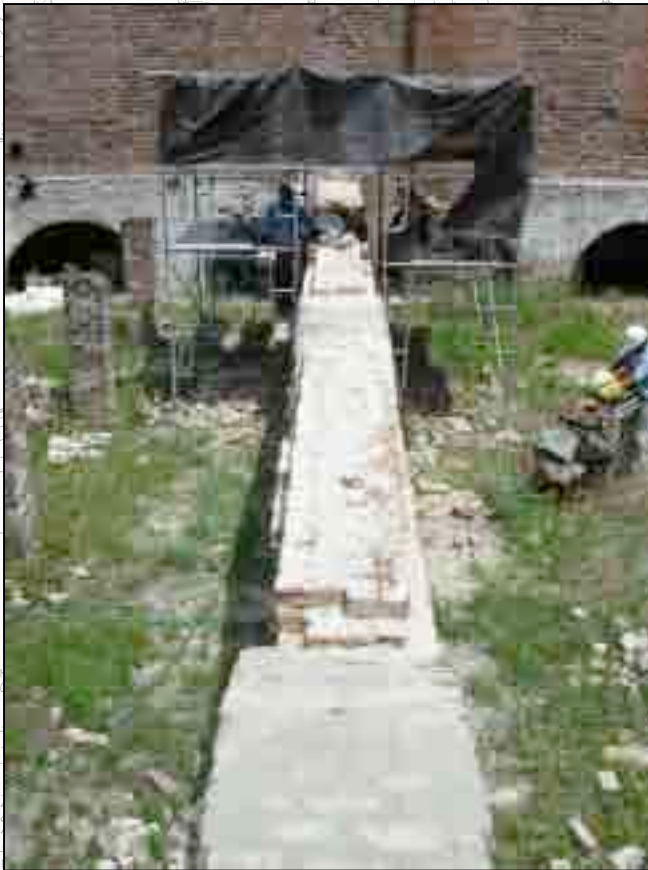
Top portion of foundation arches shortly after masonry restoration began.

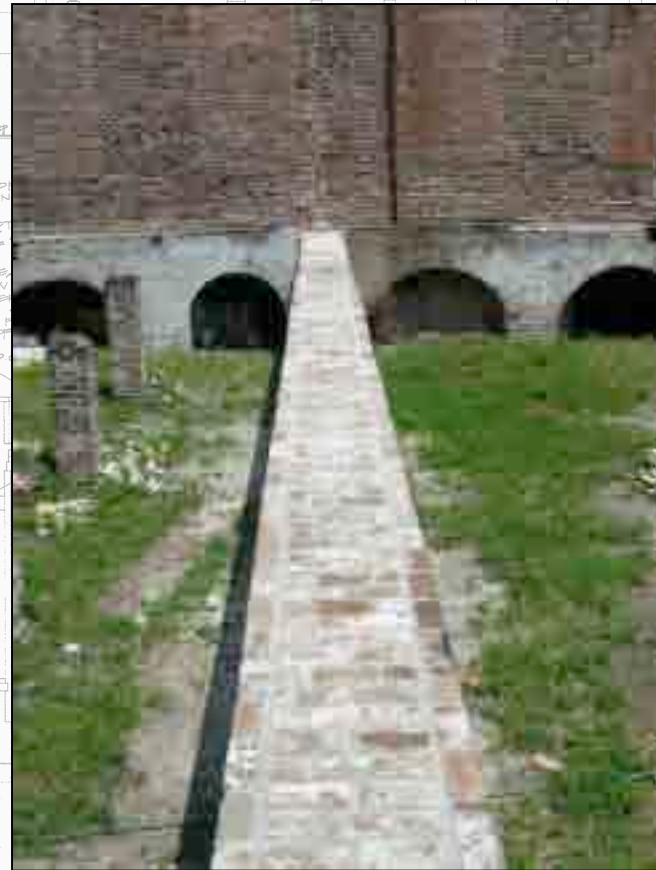
Current view of repaired and rebuilt foundation arches.

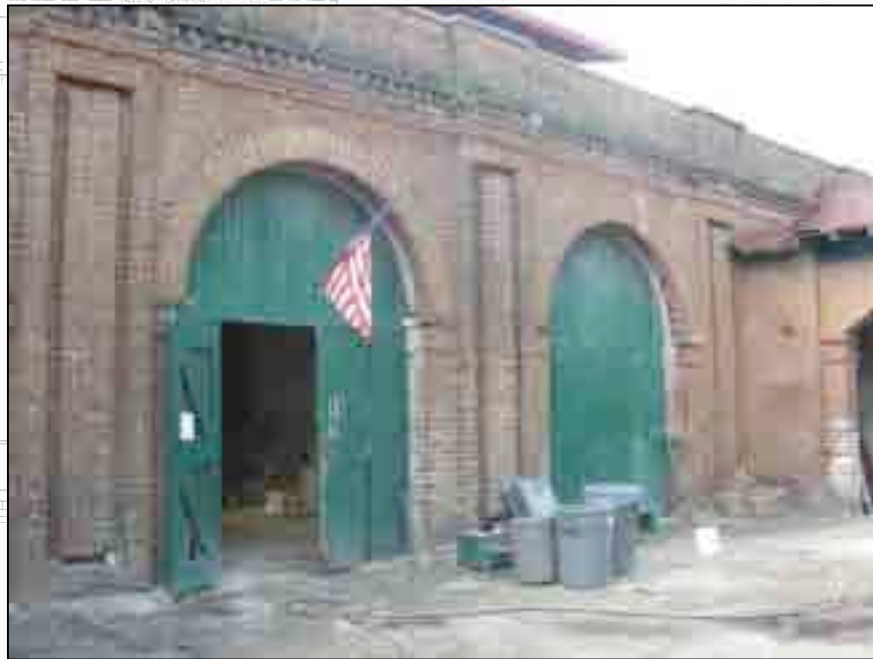
The front façade was in need of repointing and vegetation removal

The Preservation Team recently repaired and repointed the front façade of the Compressor Room.

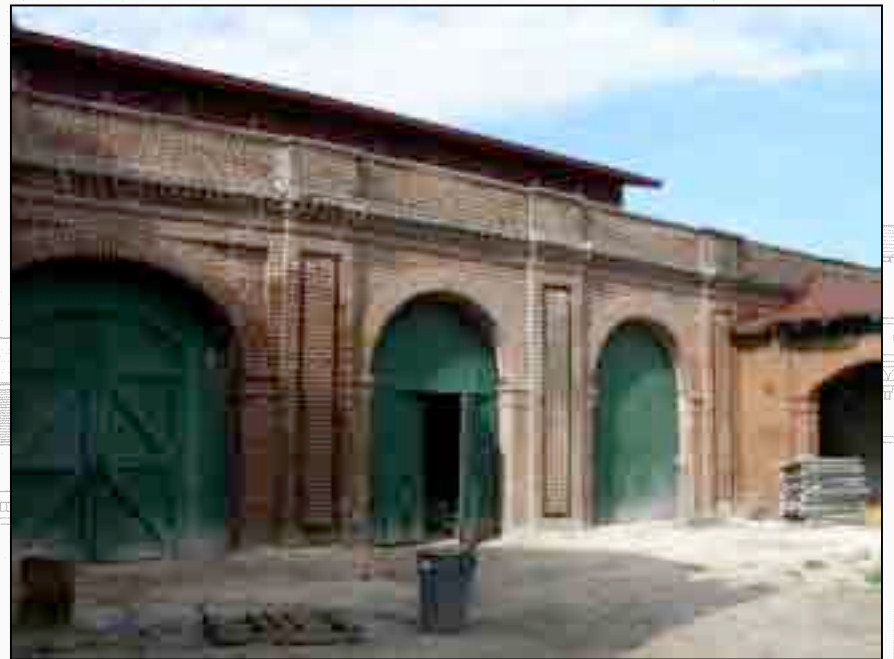
After masonry repairs. The Preservation Team used mortar mixed with Savannah River sand, similar to the lime mortar composition in the original construction.

The masonry on this façade will now be stable and without need of repair for another 50-100 years.

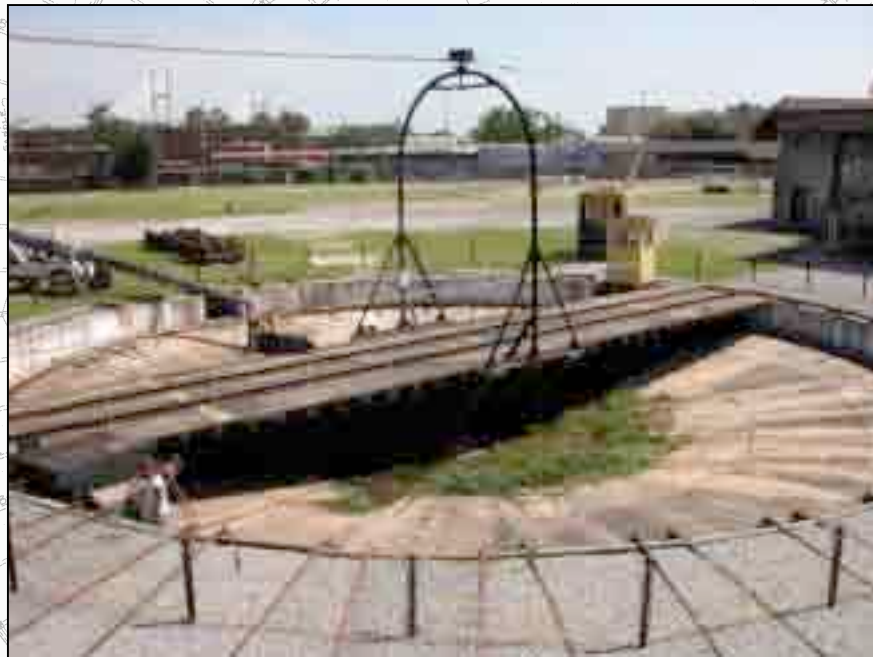
Before vegetation was removed.

RR Operations member B.J. Simms recently cleaned the turntable pit of overgrown vegetation that had accumulated over time.

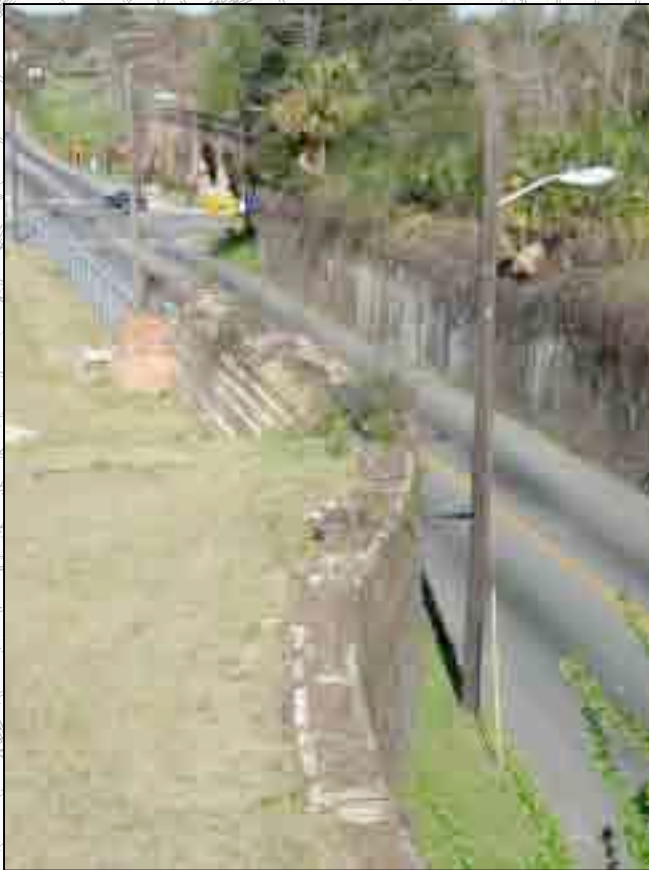
Aerial view of retaining wall overgrown with vegetation.

Preservation Team members cleared vegetation from the retaining wall along Louisville Road to facilitate future masonry repairs.

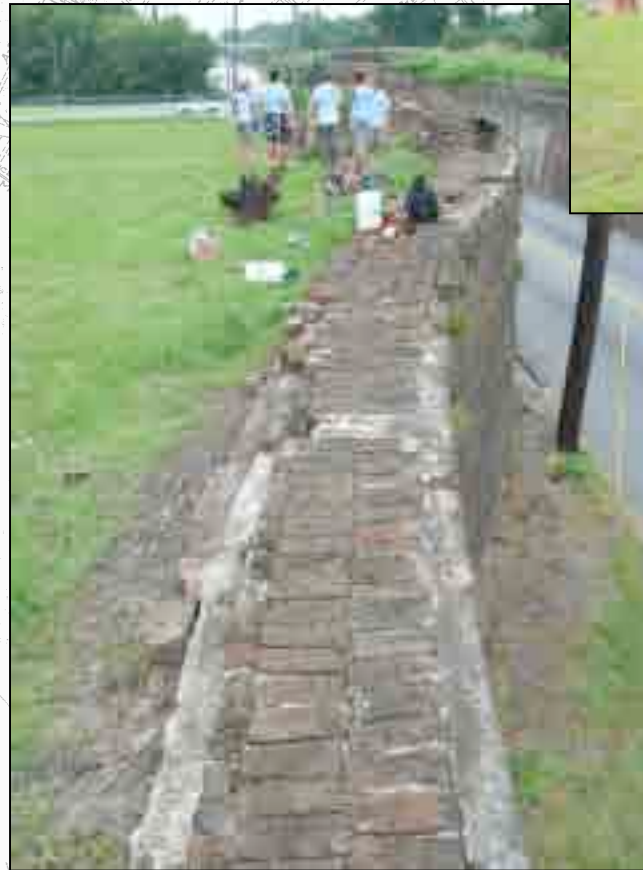
After all vegetation is removed, masonry repairs will follow.

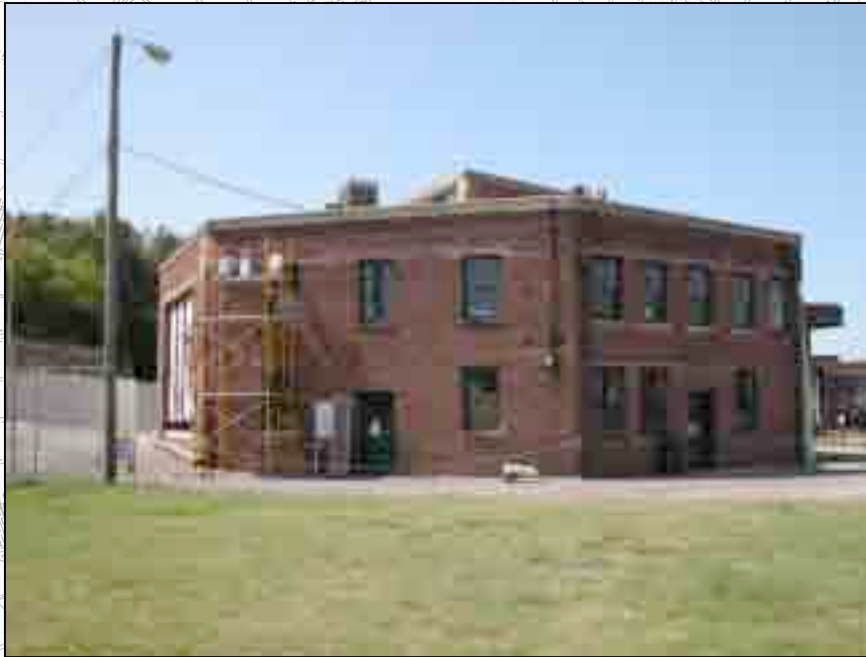
Preservation Team members are currently repairing and repointing masonry on the north façade of the Dispatch Office. The masonry crew is repointing and repairing cracks in order to stop water infiltration.

Scaffolding was set up for masonry repairs outside the main entrance of the gift shop.

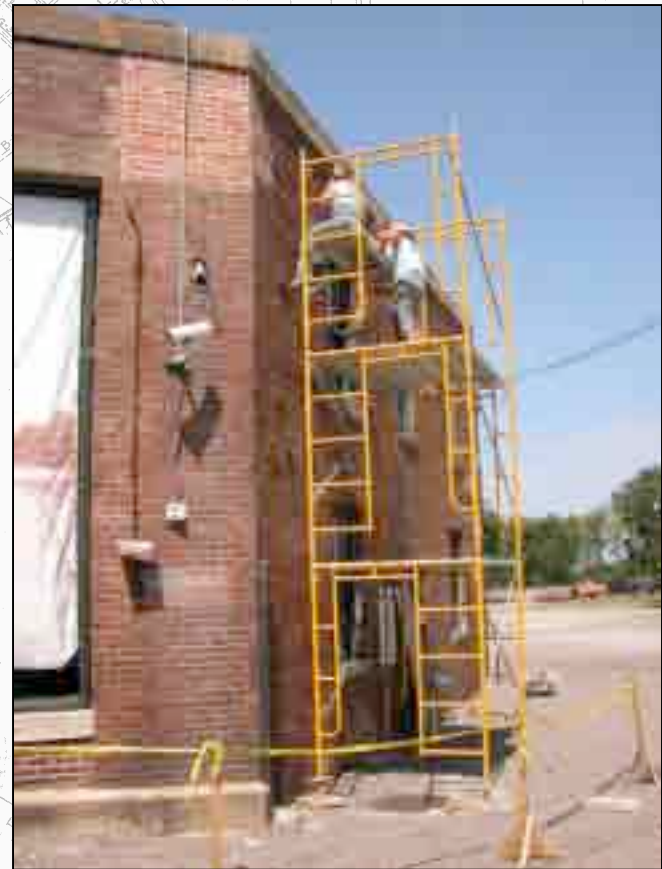
Using tungsten-tipped chisels, Brandi Hayes, Katie Purcell and Megan Kelly repair cracks in the mortar joints.
