Coastal Heritage Society

Preservation Team • Railroad Operations

November-December 2009

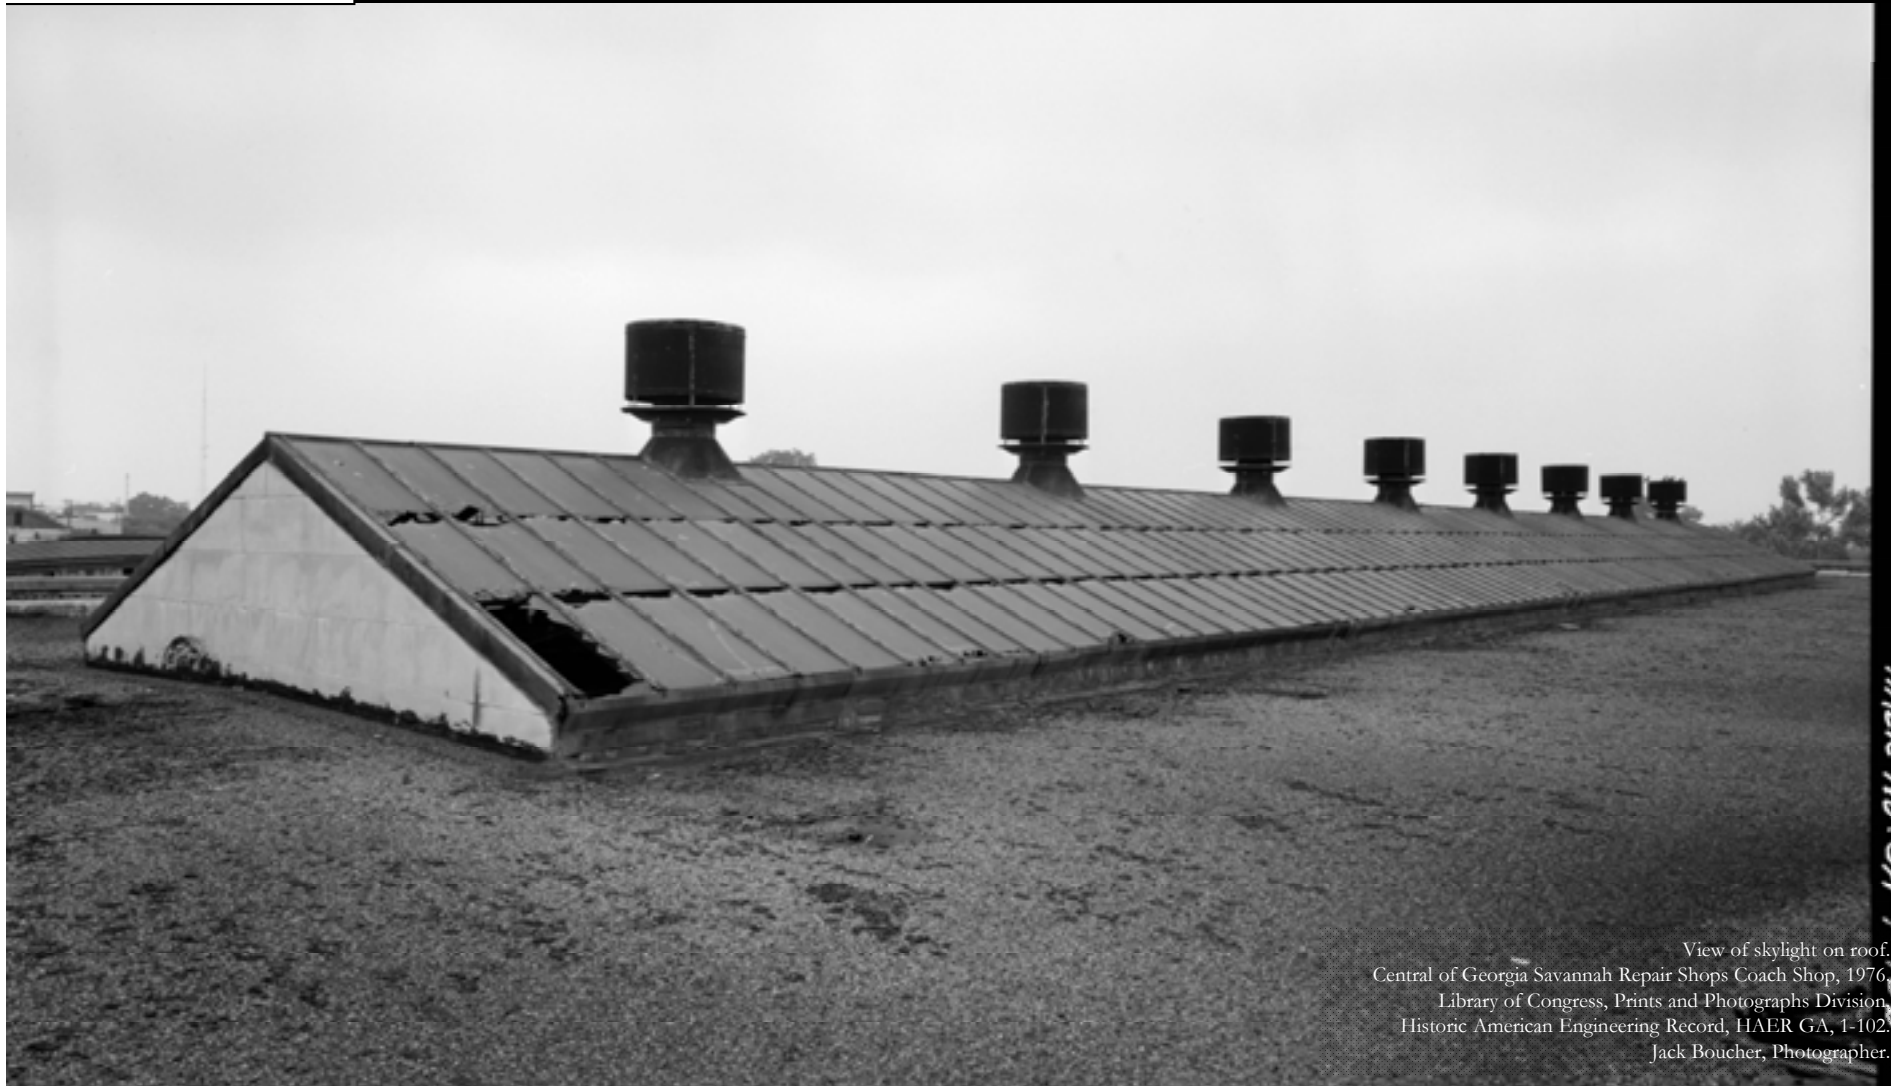
HAER NO. GA-1-102

View of skylight on roof.
Central of Georgia Savannah Repair Shops Coach Shop, 1976.
Library of Congress, Prints and Photographs Division.
Historic American Engineering Record, HAER GA, 1-102.
Jack Boucher, Photographer.

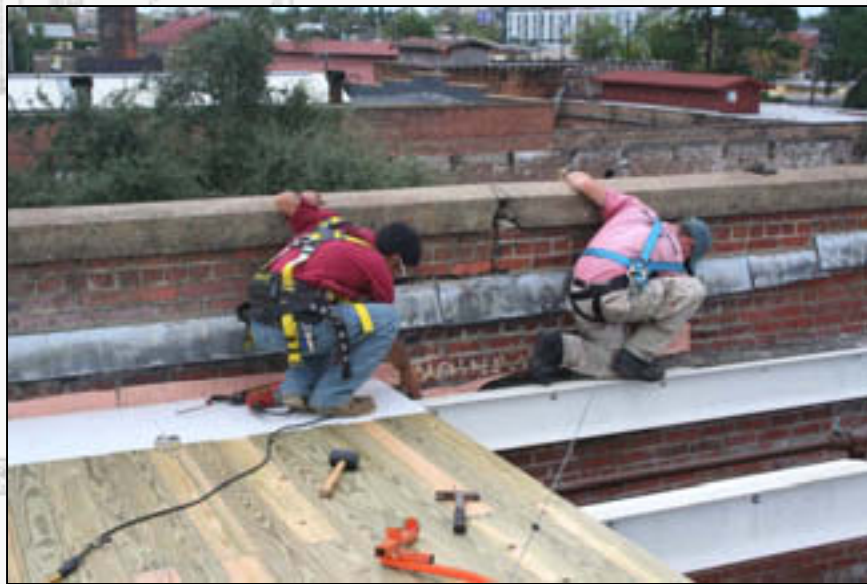
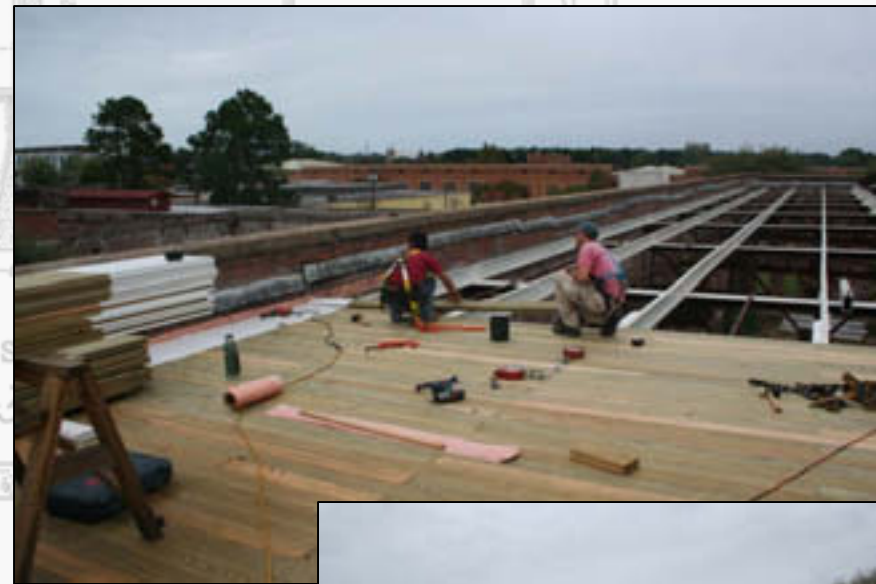
The Preservation Carpentry Team continues the installation of the Coach Shop flat roof. Kazu Takahashi and Garrett Johnson apply copper flashing to act as a barrier between the masonry shell and the wooden decking.

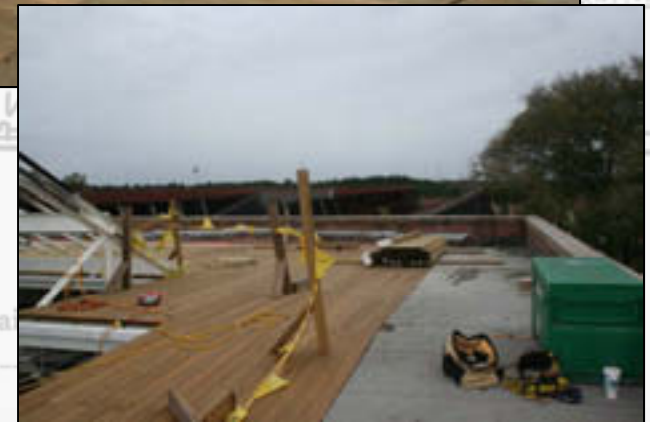
View looking towards the Paint Shop sawtooth roof.

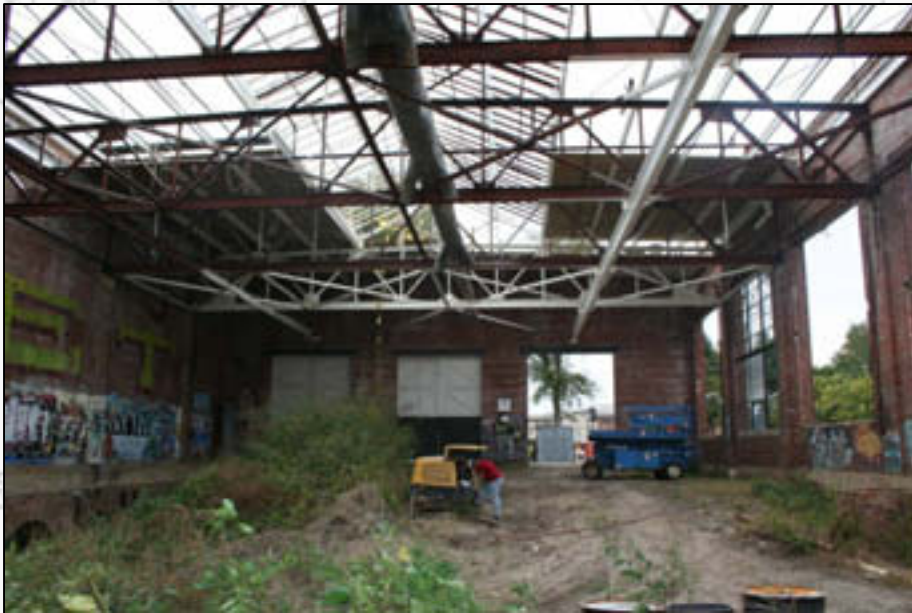
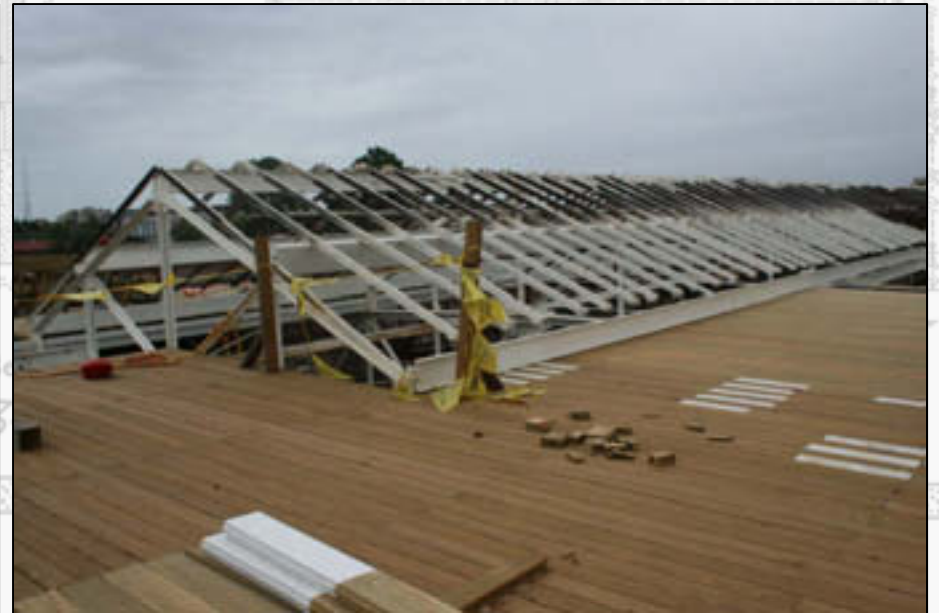
Views of the flat roof construction from below and at roof level. The decking surrounds the historic skylight which will undergo restoration in 2010.

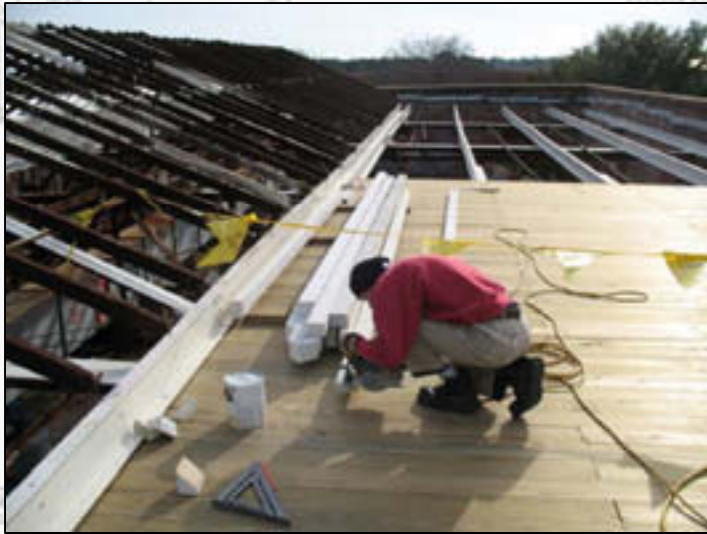
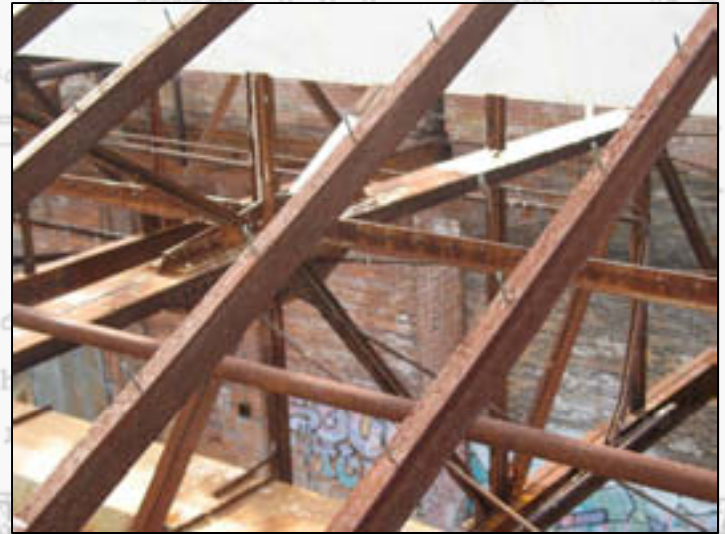
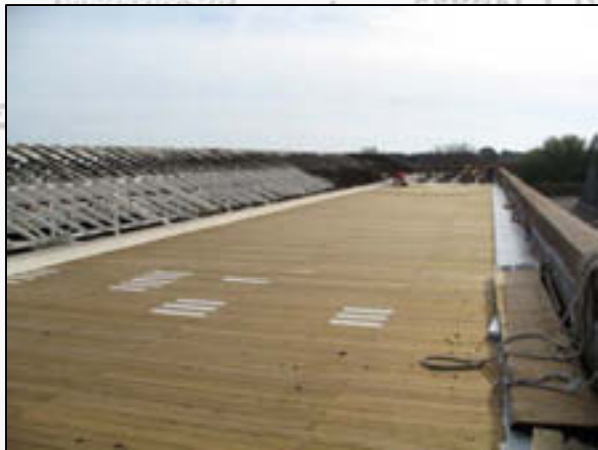
Charles Adkins cuts angles onto the ends of the nailers so that they are ready for installation. Kazu Takahashi removes elements from the skylight that fastened the original windows to the metal frame.

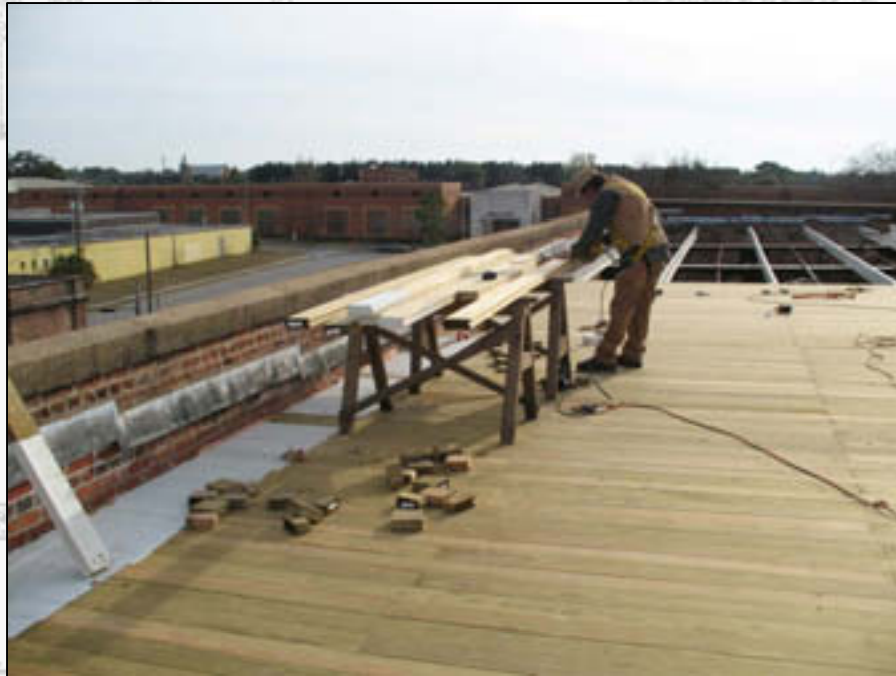
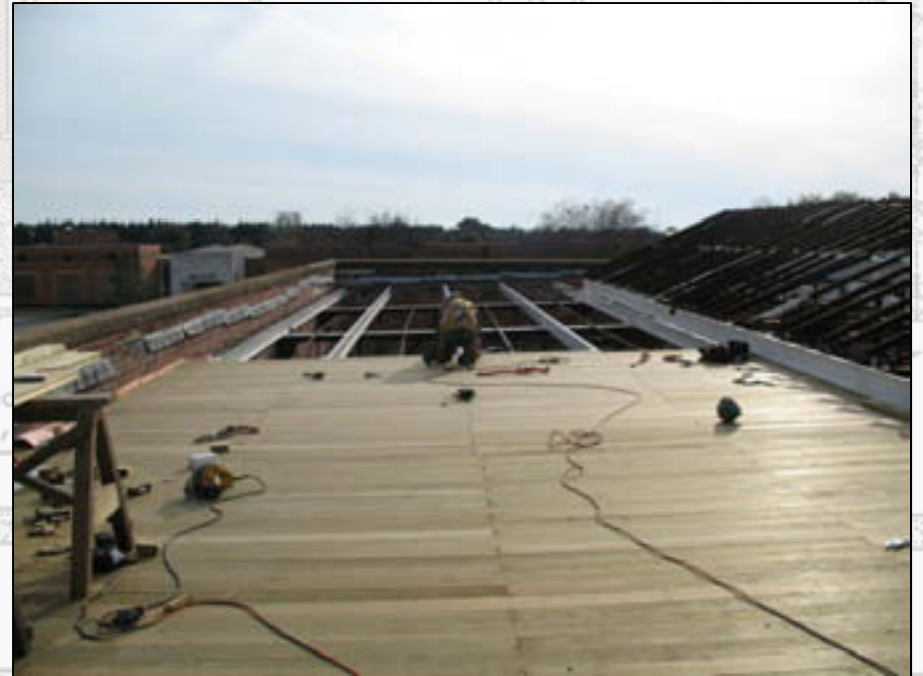
Jeff Lego measures, cuts, and installs decking for the eastern flat roof. The flat roof extends from the northern prototype area begun in January. The profile of the new roof replicates the original flat roof.

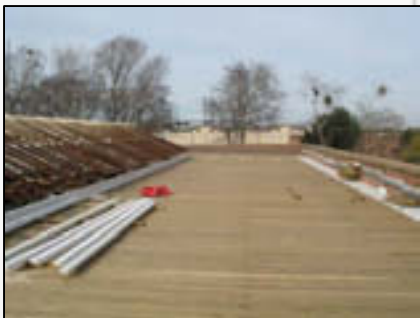
View looking north towards prototype area.

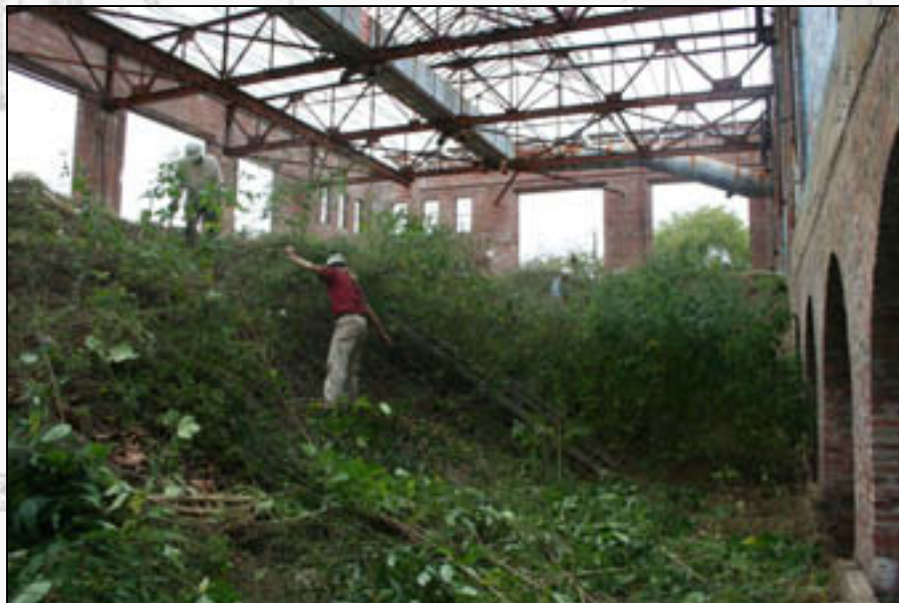
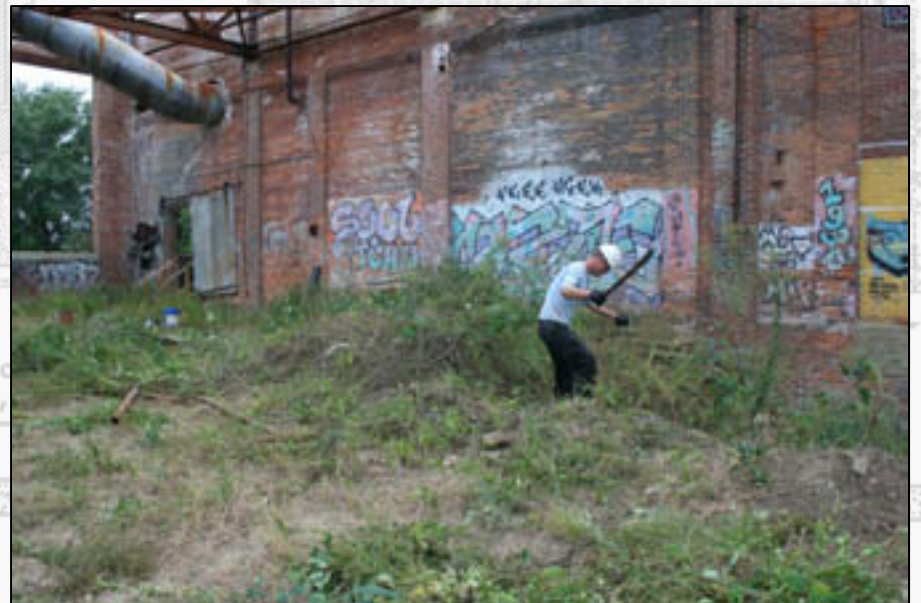
From left: Dylan Brown, Adam Davis and Frank Stokes cut down overgrowth that has developed within the Coach Shop interior. Many of the window openings including the roof skylight are not sealed against the elements. If left unattended, the vegetation could take over the building (left) as it had in the past.

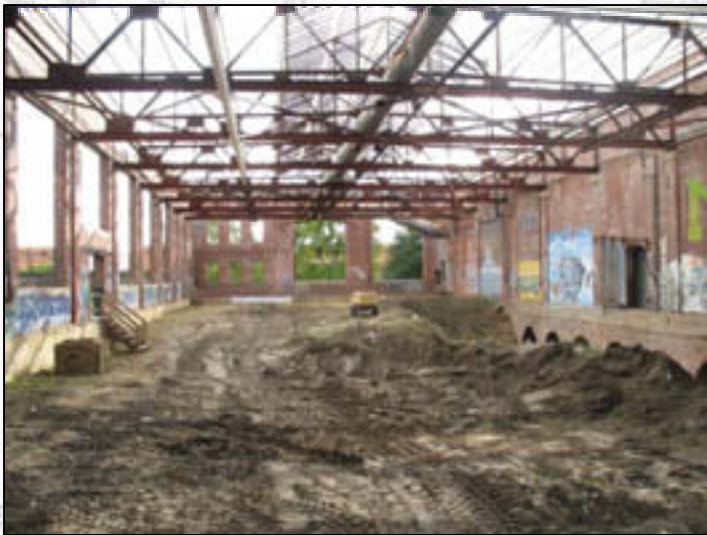
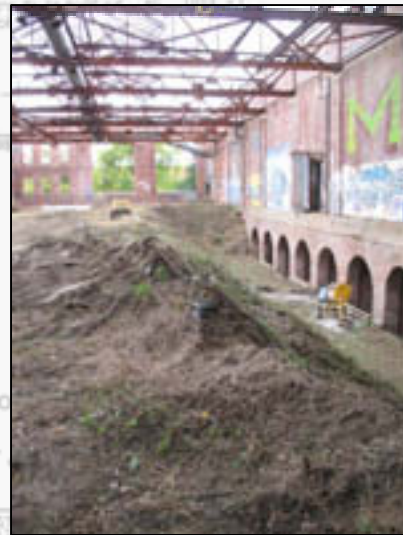
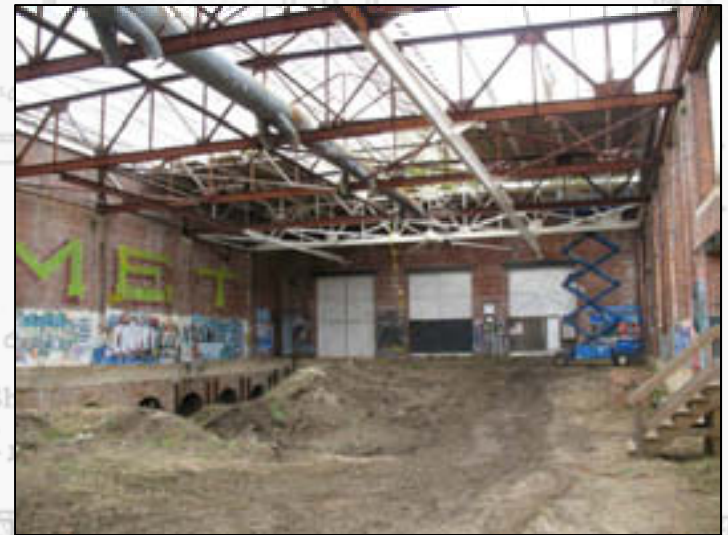
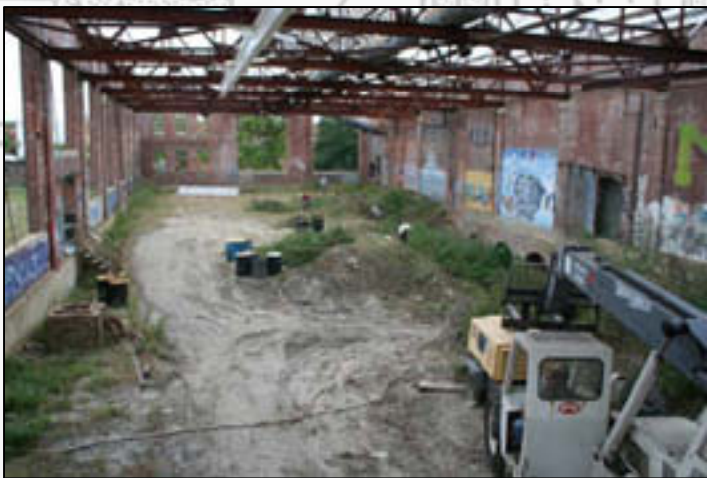
Above: views of the Coach Shop interior after massive vegetation removal performed by the Preservation Masonry Team.

Left: view from above of the area during cleanup.

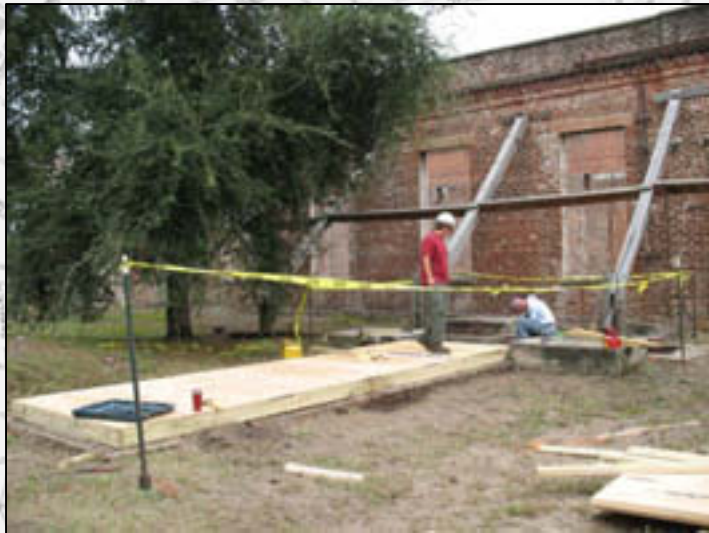
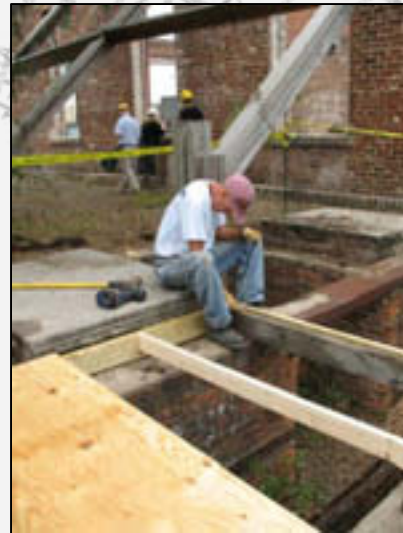
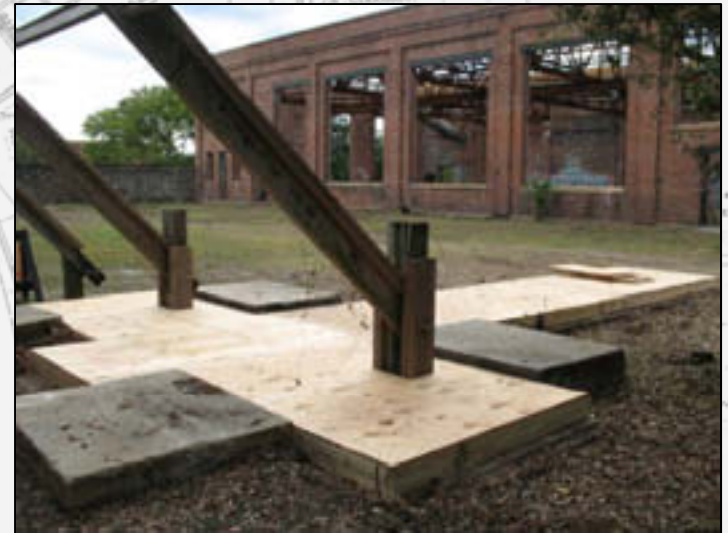
Jeff Lego and Charles Adkins construct a temporary wheel pit cover for a children's museum event. The construction of the original wheel pit dates to a period in between the two major phases of construction for the present buildings that make up the Roundhouse Railroad Museum, between 1855 and 1923.

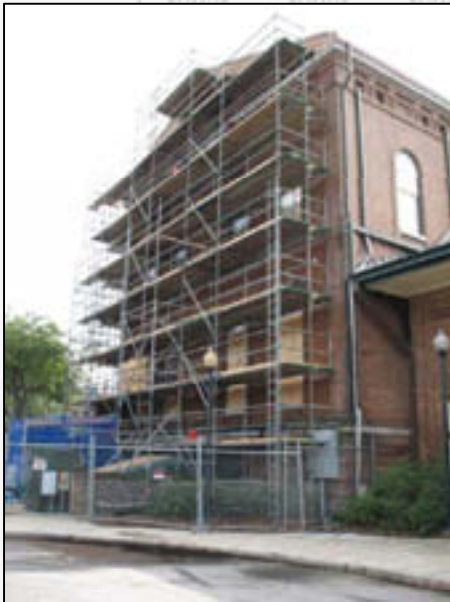
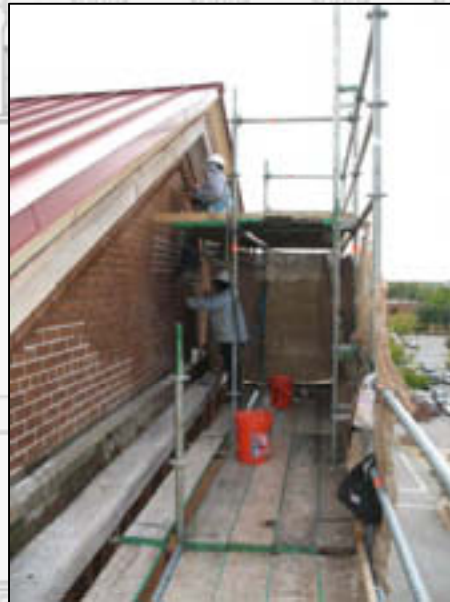
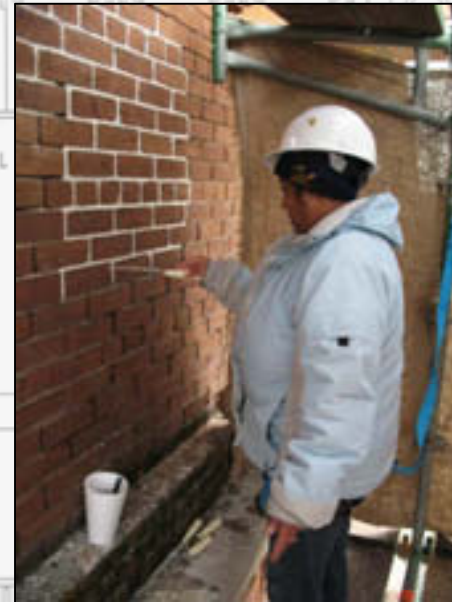
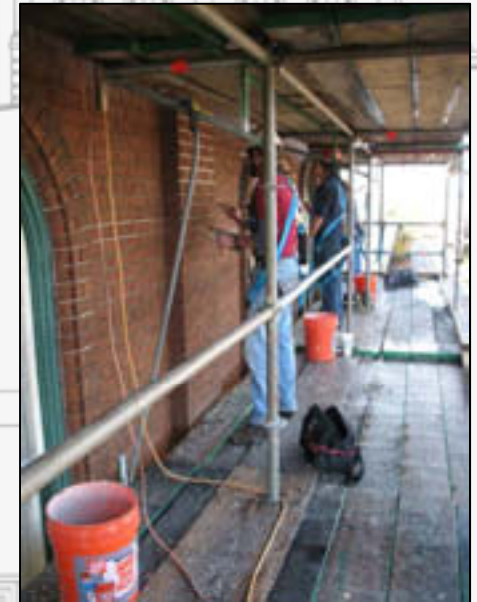
Masonry restoration on the North wall begins with a full repoint of the pediment. Mirroring the masonry restoration of the south wall, the north wall will be spot pointed only in areas of heavy deterioration, roughly 25-30% of the entire area.

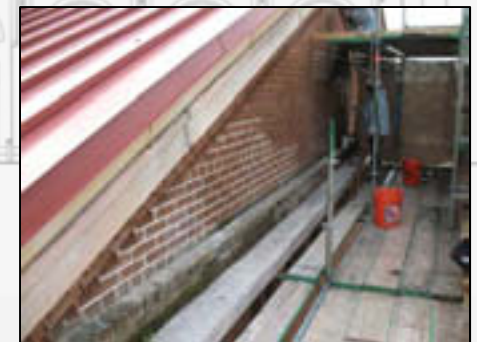
Top left: view of the north façade with scaffolding.

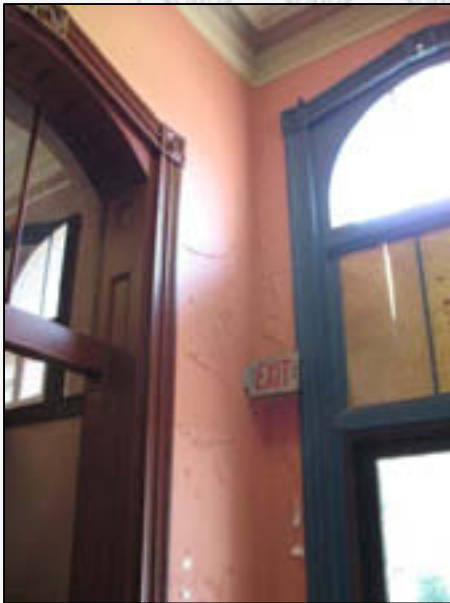
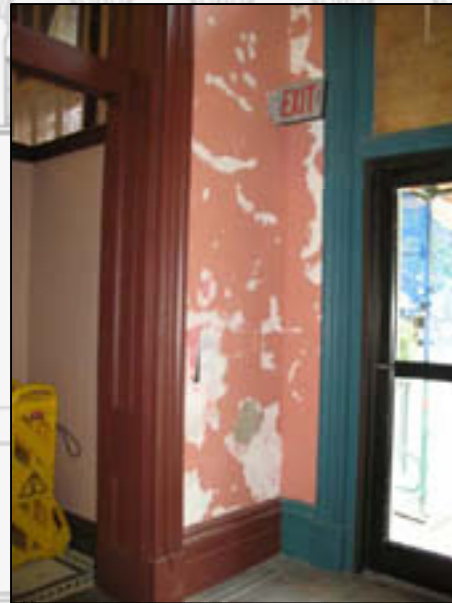
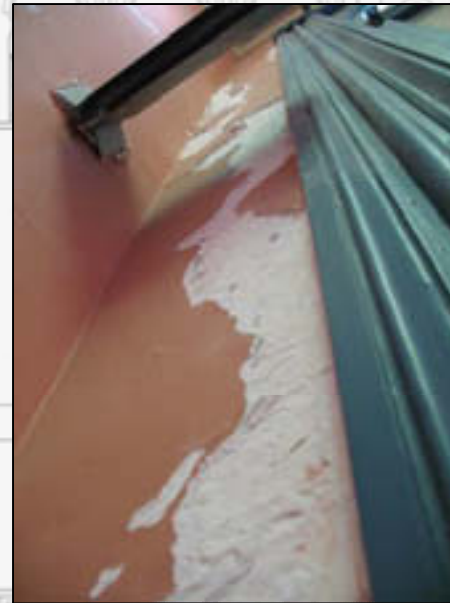
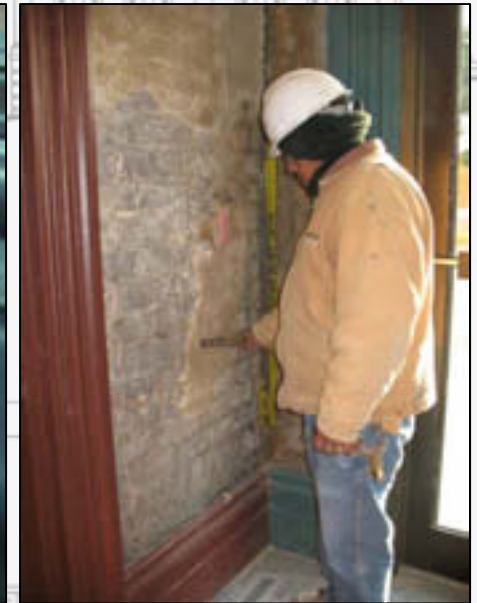
Leaky downspouts resulted in water damage to the interior plaster walls near the women's bathroom and the gift shop in the Visitor Information Center. The water infiltration caused heavy lime blooming in sections. These areas were removed in August.

Plaster blooming caused by water.

Upper Right: Vicente Herrera leads members of the Masonry Team in removing the plaster to prepare for patching.

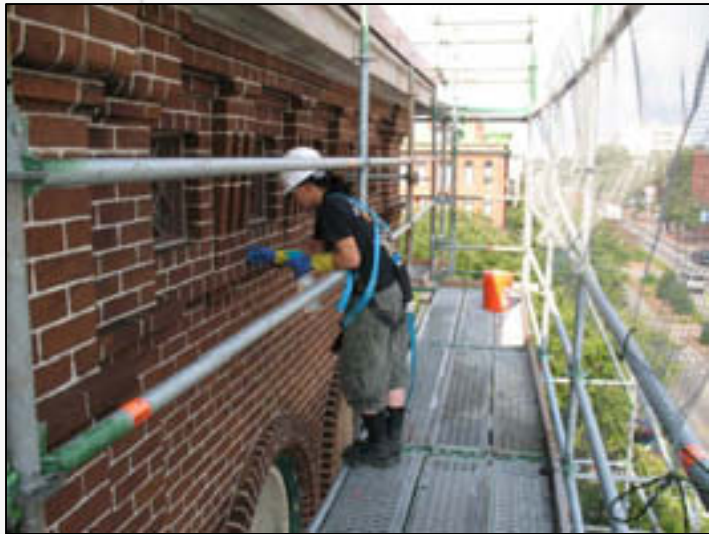
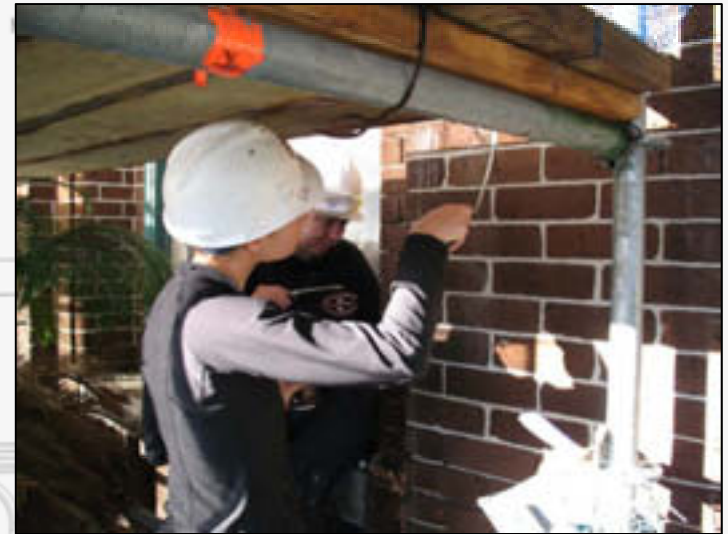
Masonry restoration of the eastern front façade of the Head House nears completion. Kelly Sowell carefully cleans the wall with an agent that removes hazing and excess mortar from the brick faces. Chris Polcar removes miscellaneous metal anchors embedded in the masonry while Lindy Gulick and Samantha Sycz repoint at pedestrian level.

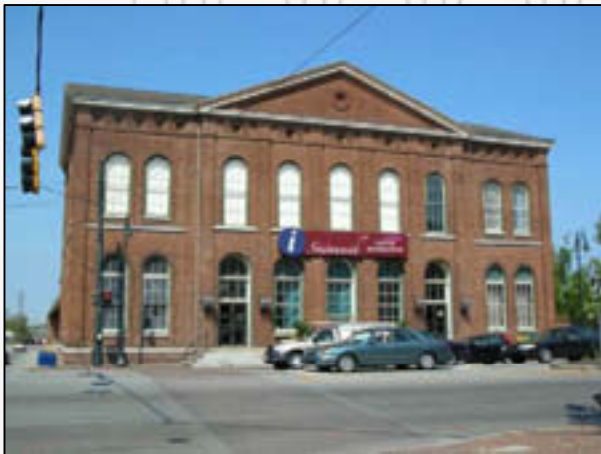
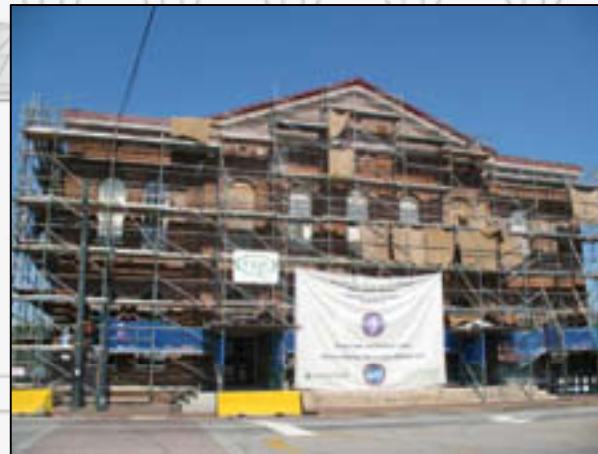
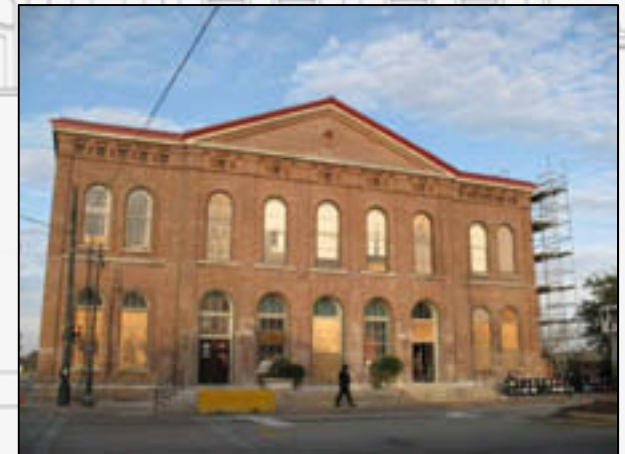
Views of the eastern façade of the former Central of Georgia Passenger Station Head House. The faded and weather-worn sign was removed in November of 2008. Restoration work began in June 2009. Window restoration and masonry cleaning will continue into the early part of 2010.

Right: the lighting fixtures adjacent to the entrance doors to the Visitor Information Center were removed to allow for better access to the masonry joints and will be replaced after masonry cleaning in the new year.

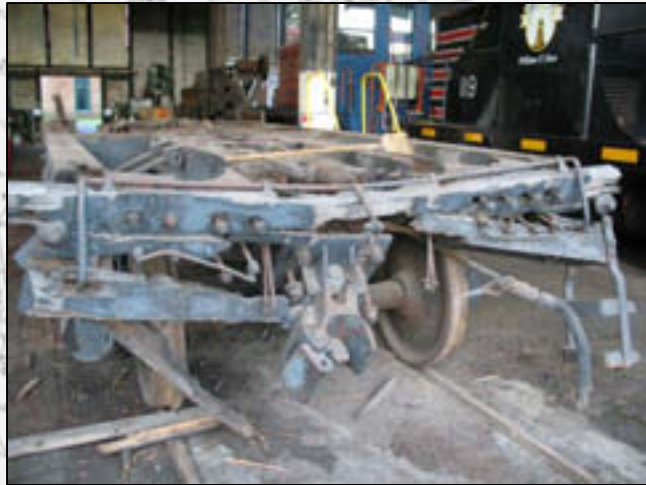
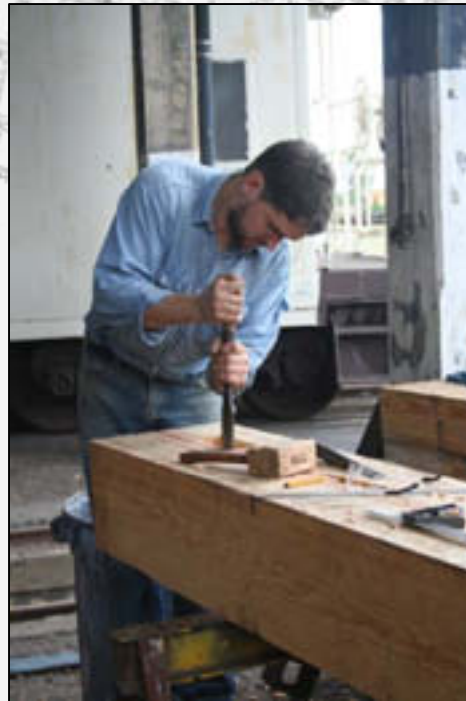
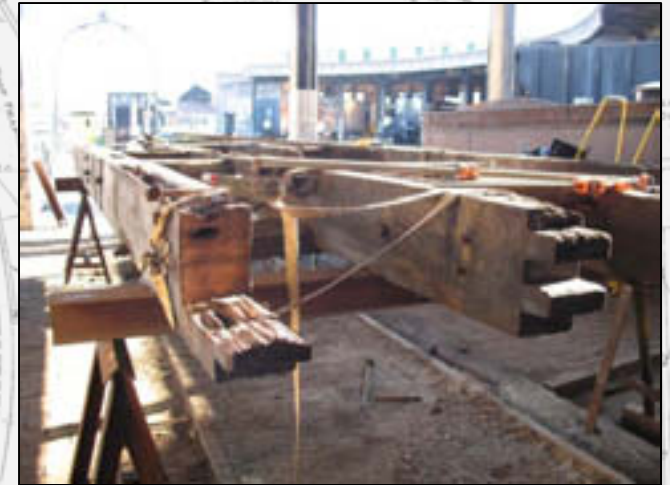
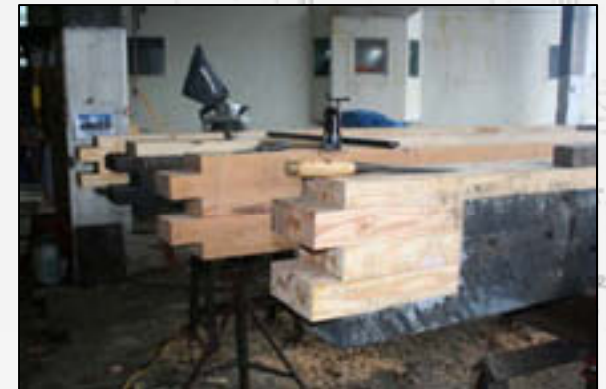
Clockwise from left: the #403 tender frame before restoration, Ian Ashenfelter chisels out the mortise of the new pilot beam, the frame cleaned out to receive new tenons, replacement tenons attached to the tender frame.

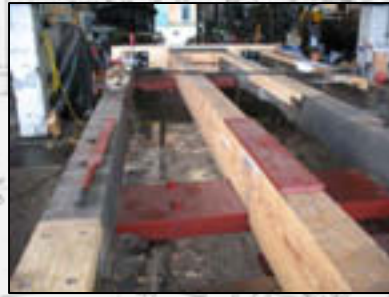
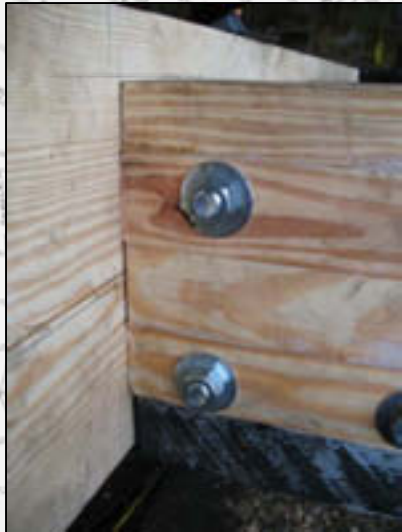
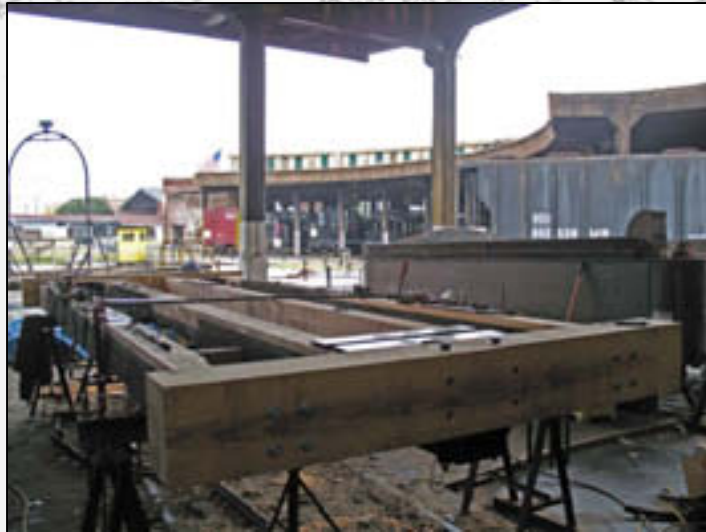
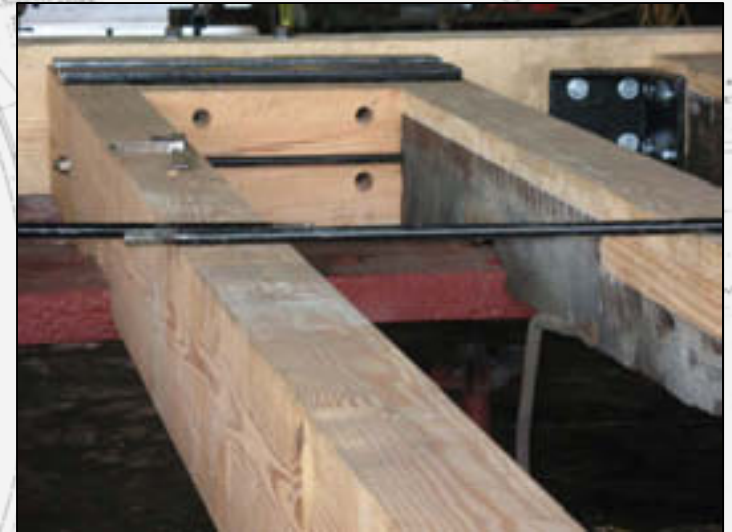
Replacement pilot beams are attached to the ends of the #403 tender frame. The originals, along with the tenons that connected the beams to the frame, were deteriorated to such an extent that replacement was the only viable option.

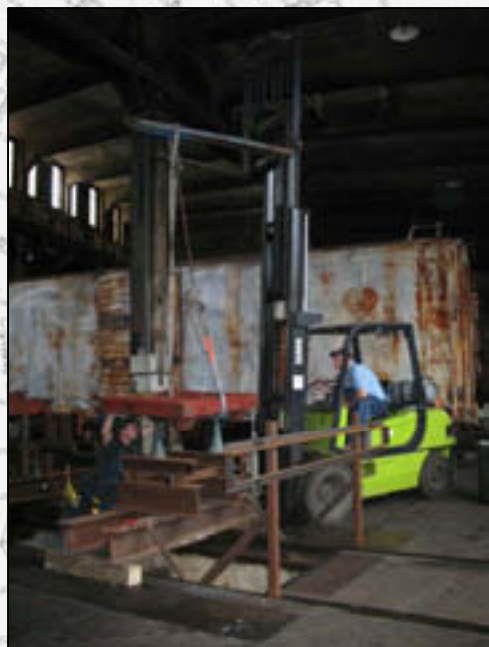
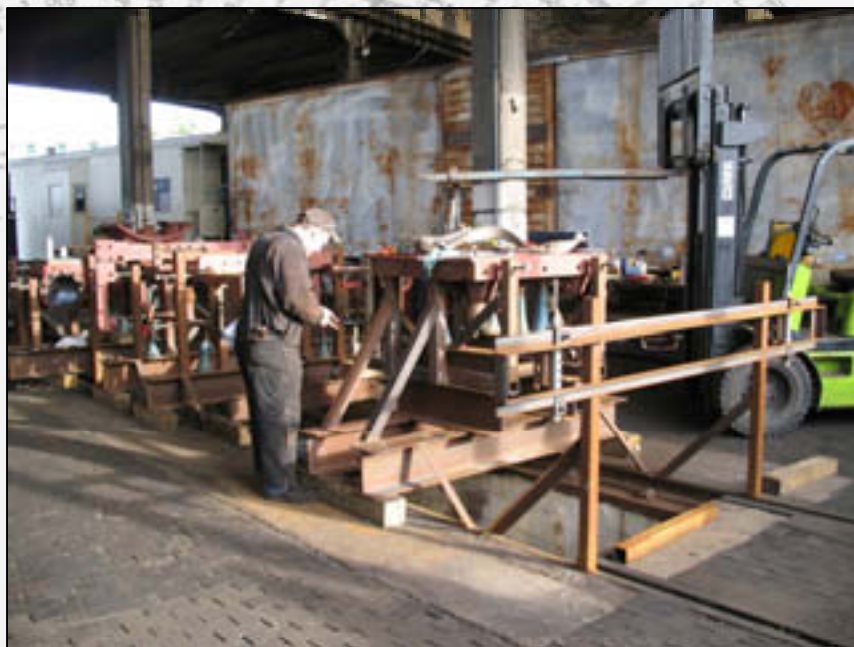
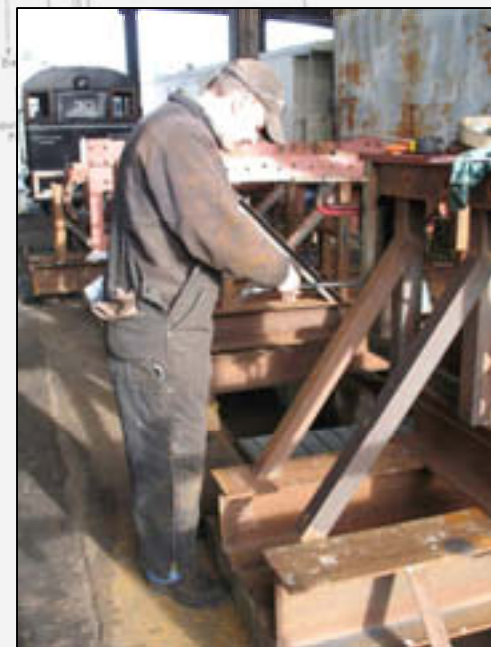
Terry Koller operates a forklift as Chris Zahrt guides a section of the partially rebuilt locomotive frame during the restoration of the #15 steam engine. Using a micrometer which allows for precise measurement, Chris Zahrt makes minute adjustments to the frame alignment.

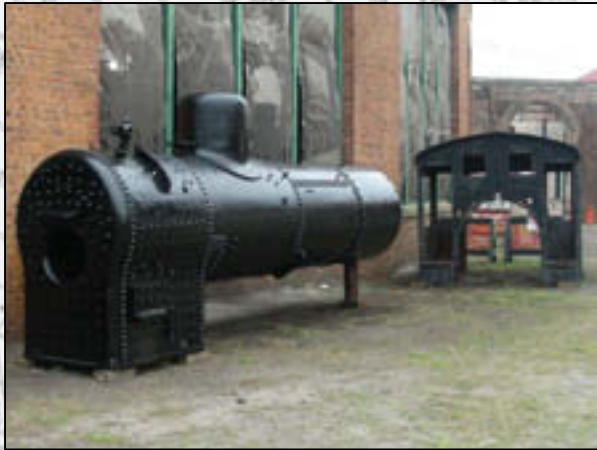
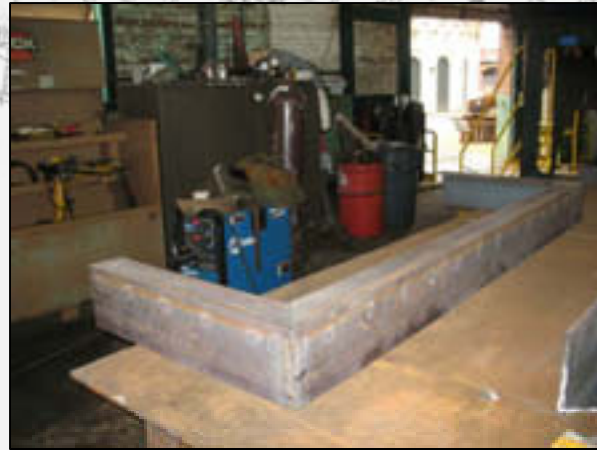
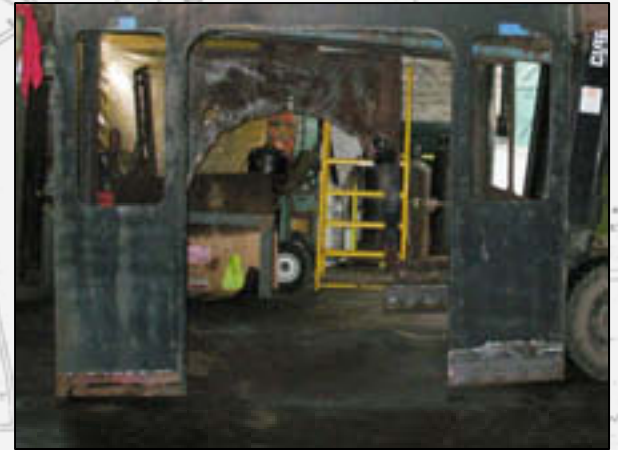
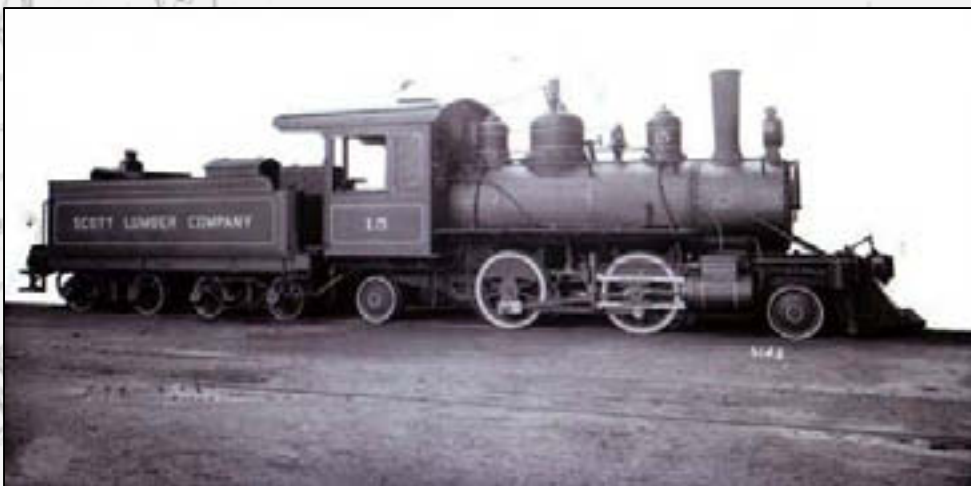
Brett Kicklighter makes repairs to areas that had severely deteriorated as a result of rust on the cab of the Holly Hill #15. The cab repairs are in conjunction with the total rebuild of the steam engine by the Railroad Operations Team.

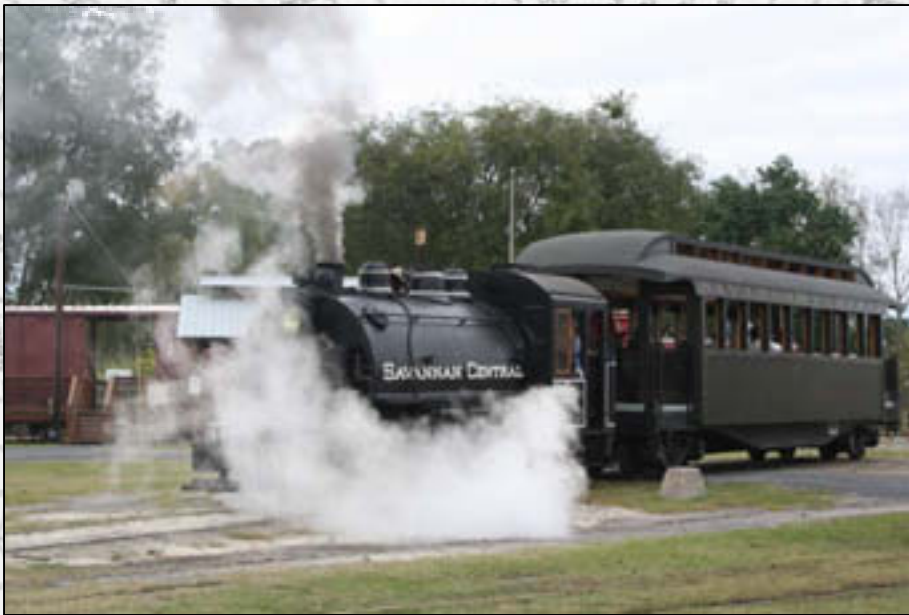
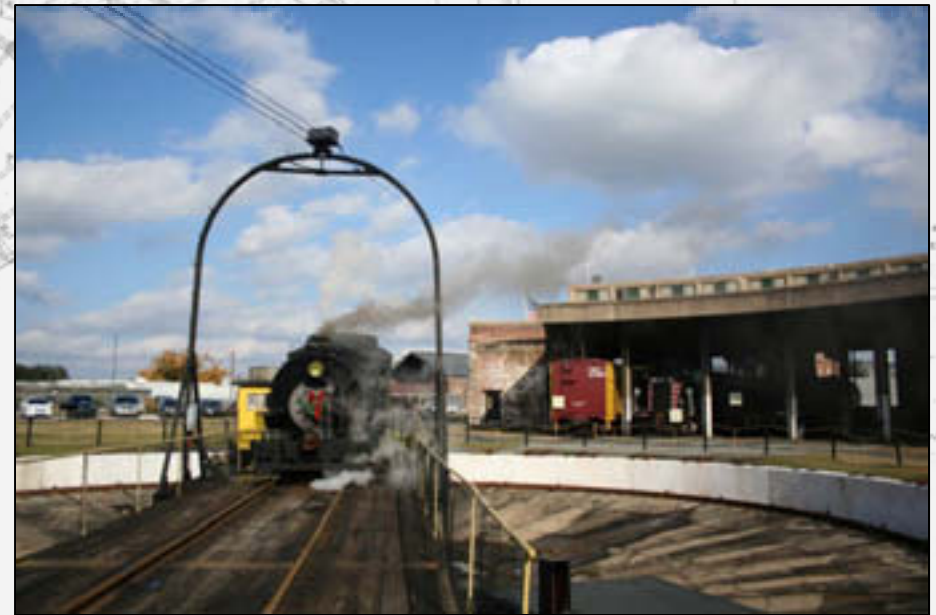
After a brief rest, the Railroad Operations Team fired up the Savannah Central #30 steam engine for daily steam rides on the Savannah Central Passenger coach. This locomotive was built by American Locomotive Works at their Rogers Plant in Paterson, New Jersey and restored on site in 2005.

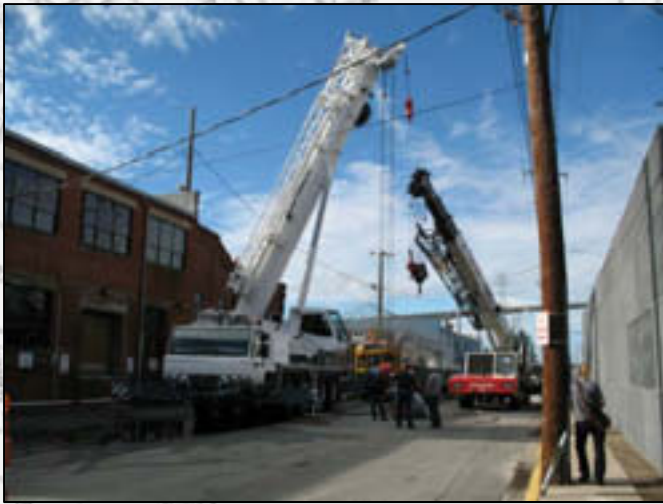
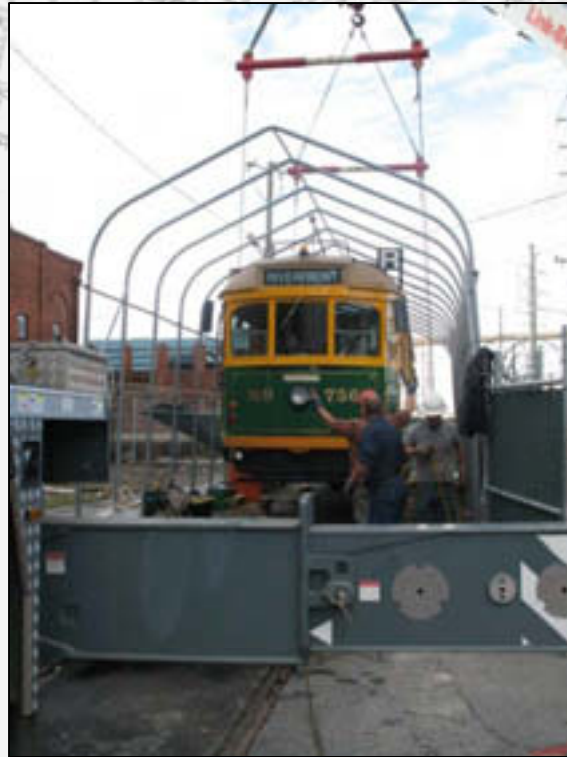
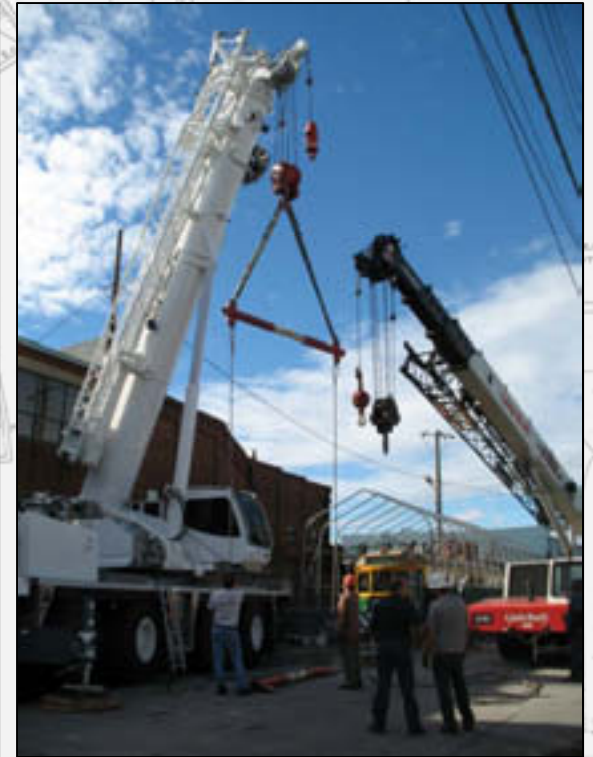
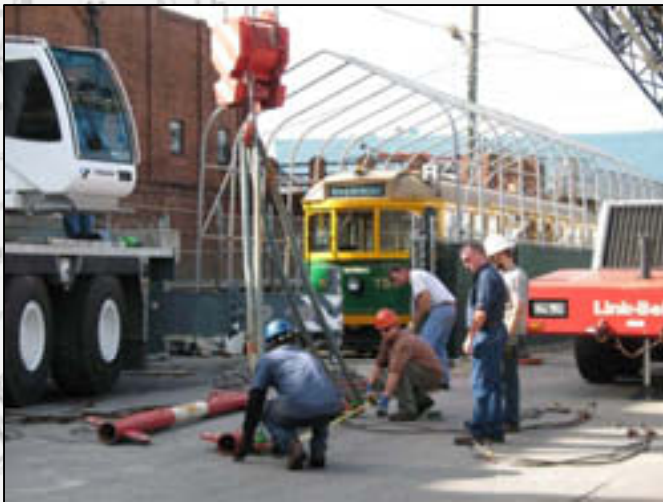
The Railroad Operations Team uses two cranes to lift the River Street streetcar off of its trucks.

Above: Railroad Operations Manager Terry Koller signals the crane operators as the streetcar is raised from its trucks.
