Coastal Heritage Society

Preservation Team • Railroad Operations

November-December 2009

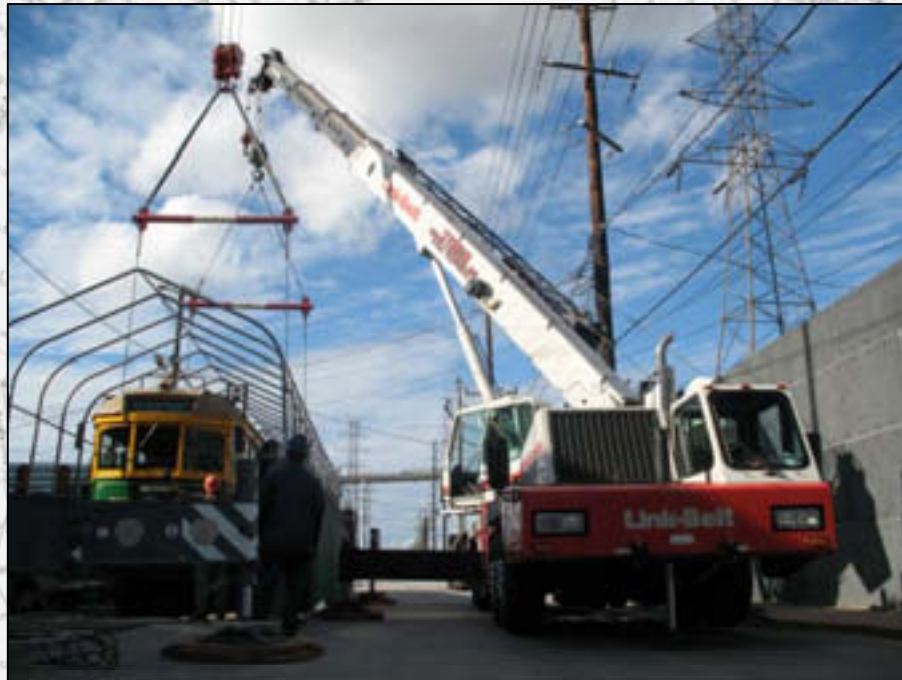
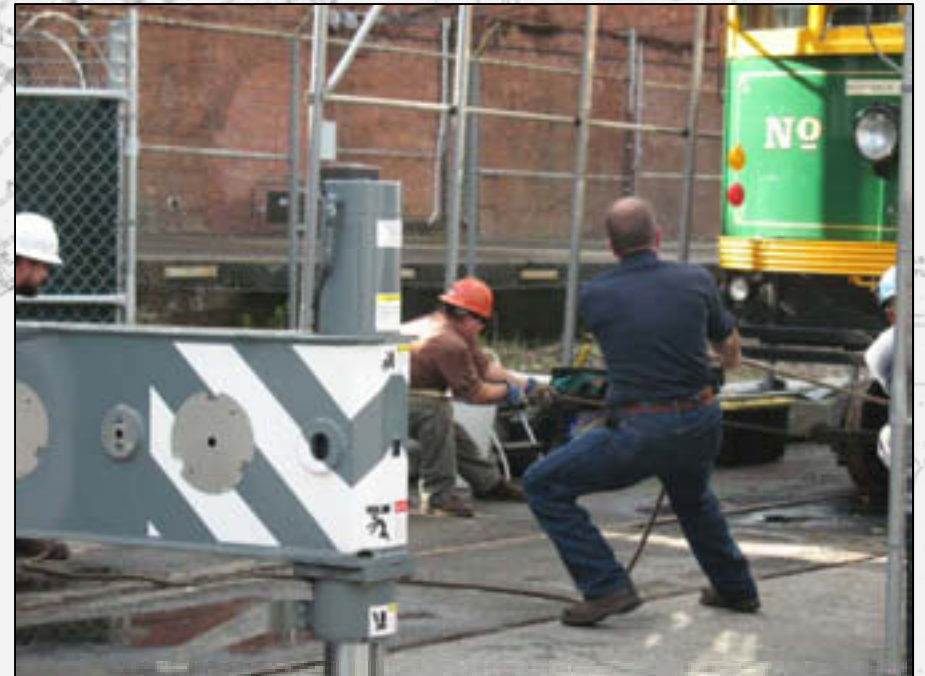
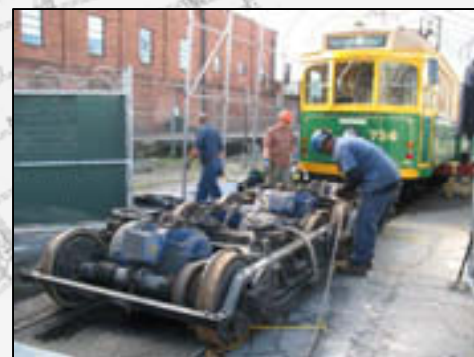
The trucks will be shipped to Altoona, PA for repairs to the mechanical system and wheels. The streetcar, nicknamed "Dottie," has been running on River Street courtesy of the Savannah D.O.T.

The trucks are secured for passage to Pennsylvania.
