Coastal Heritage Society

Visitors Center • Roundhouse Railroad Museum • Old Fort Jackson

Preservation Team • Railroad Operations • Archaeology

October 2006

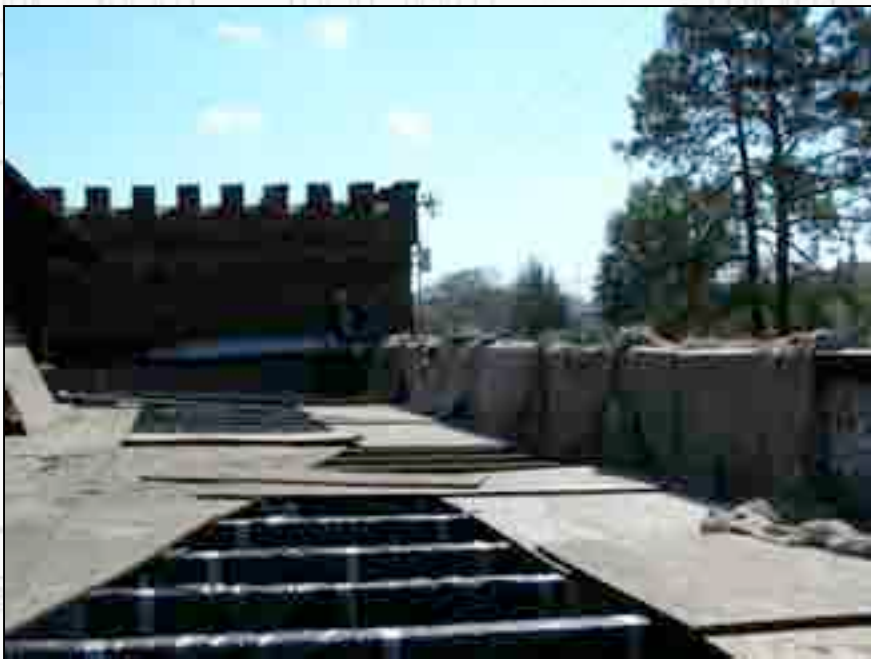
Compressor Room roof shortly after project began.

The Compressor Room roof nears completion as CHS Preservation Team members, Ian Ashenfelter, Nathan Harris, and Jack Tyson continue to rebuild it.

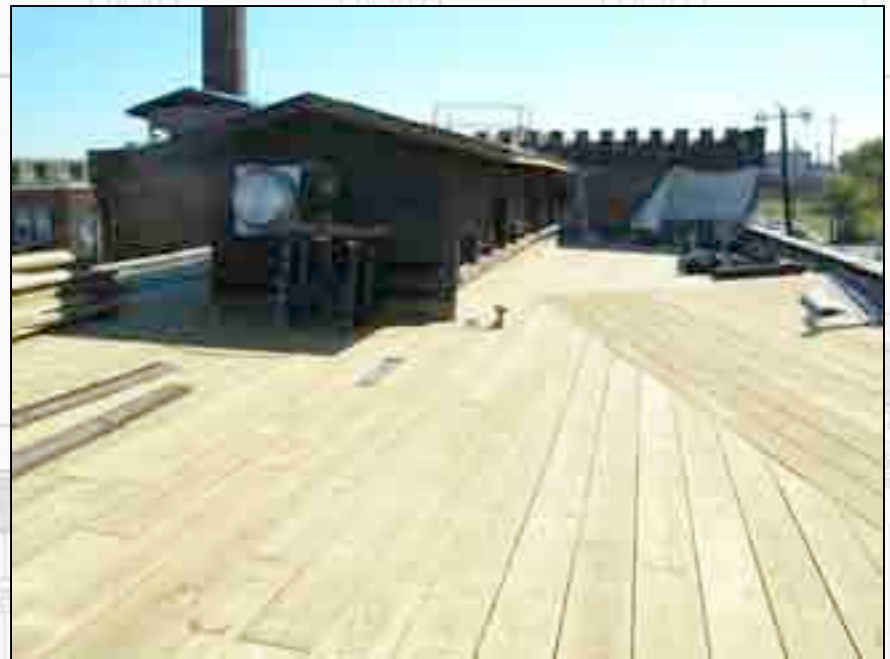
Current view of the roof looking east.

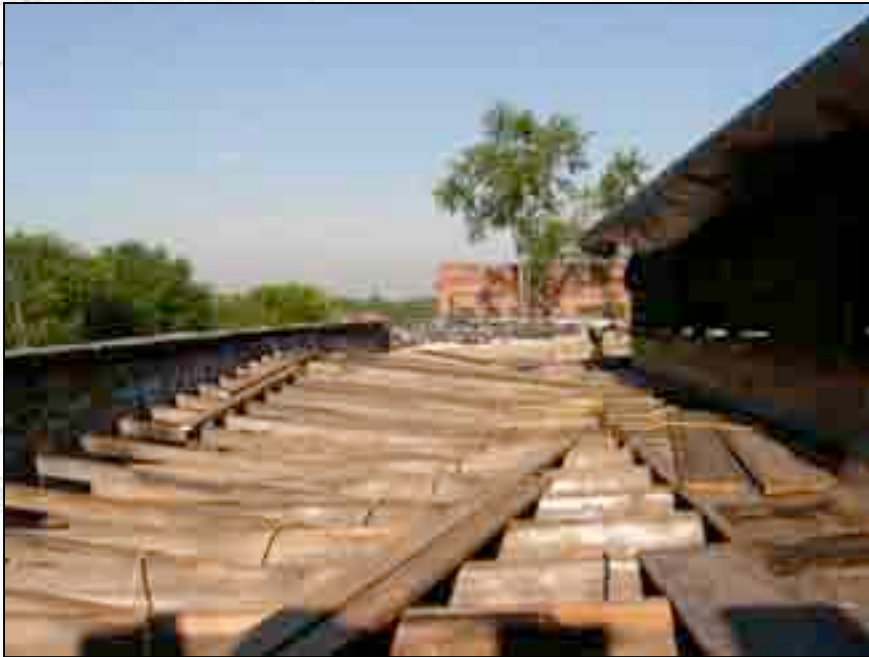
Compressor Room cricket roof shortly before decking was installed.

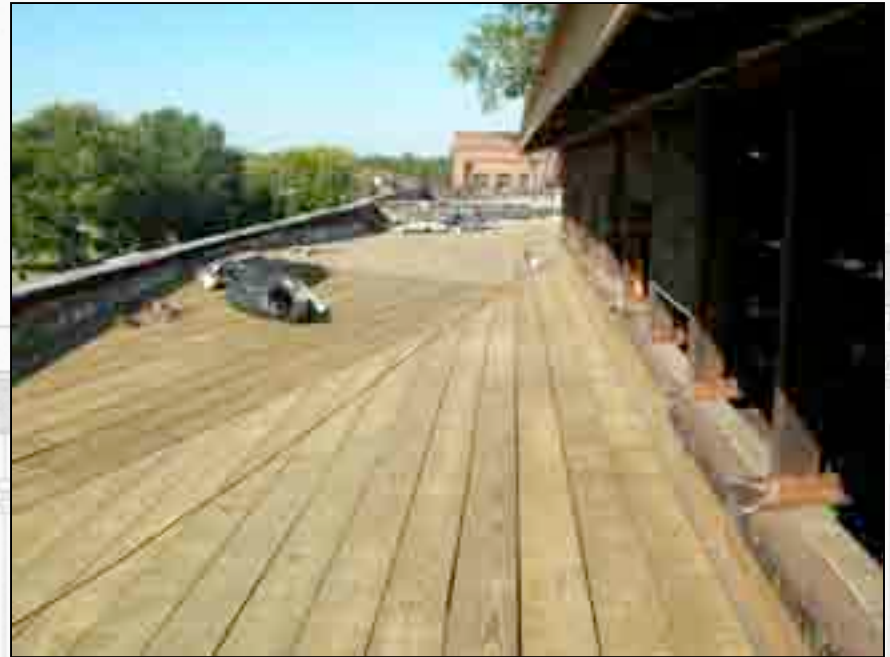
Roof decking.

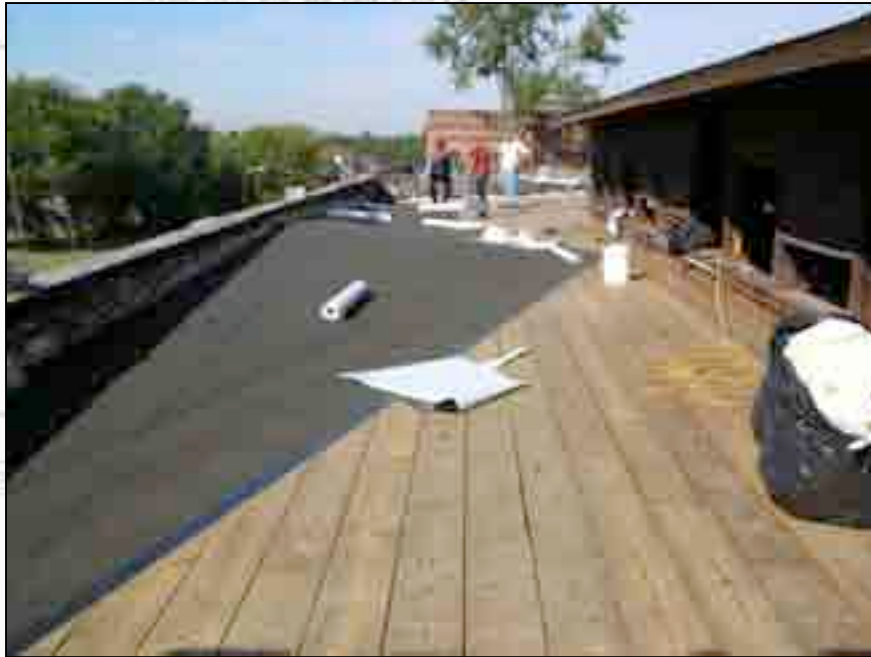
A roofing membrane was installed with the assistance of John Herdina, roofing consultant.

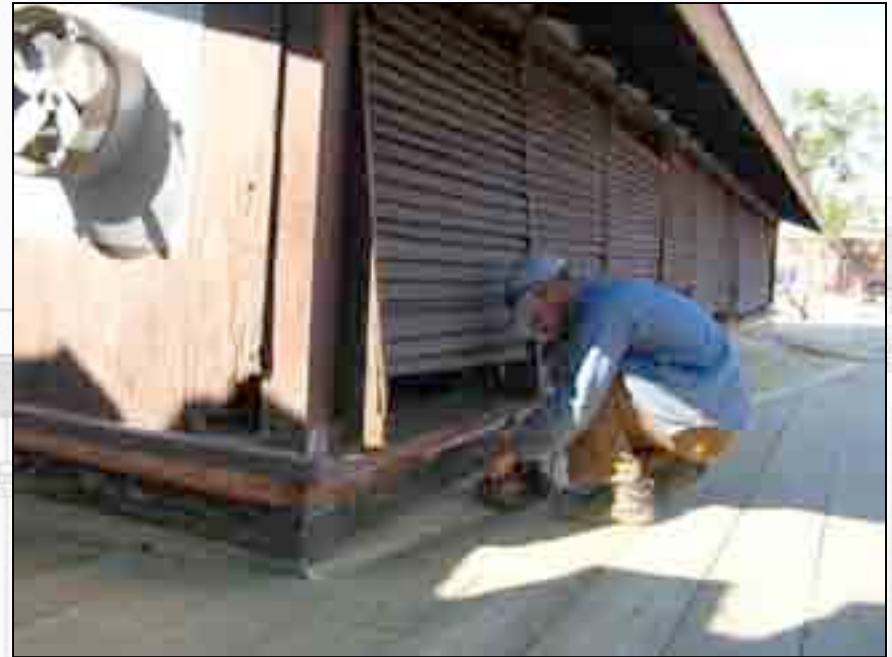
Nathan Harris installs a cricket on the north side of the monitor.

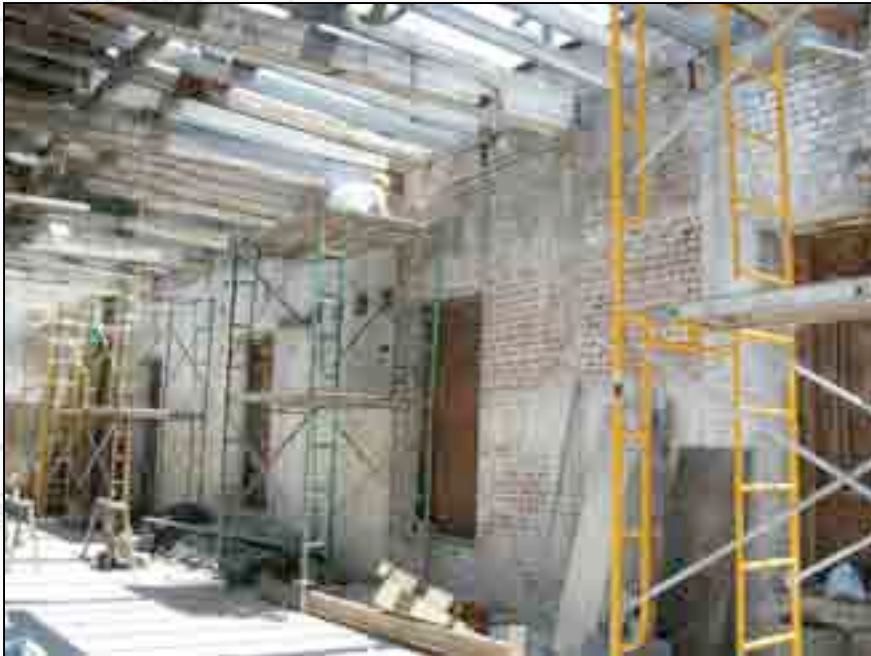
Interior view of the south wall before roof was completed.

The interior of the Compressor Room has also changed with the addition of the new roof.

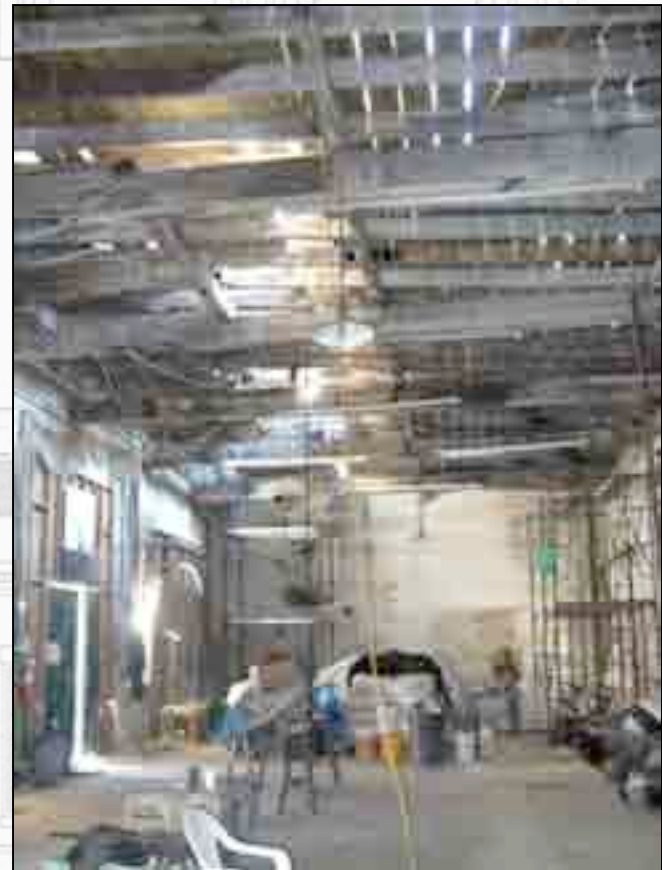
Current interior view.

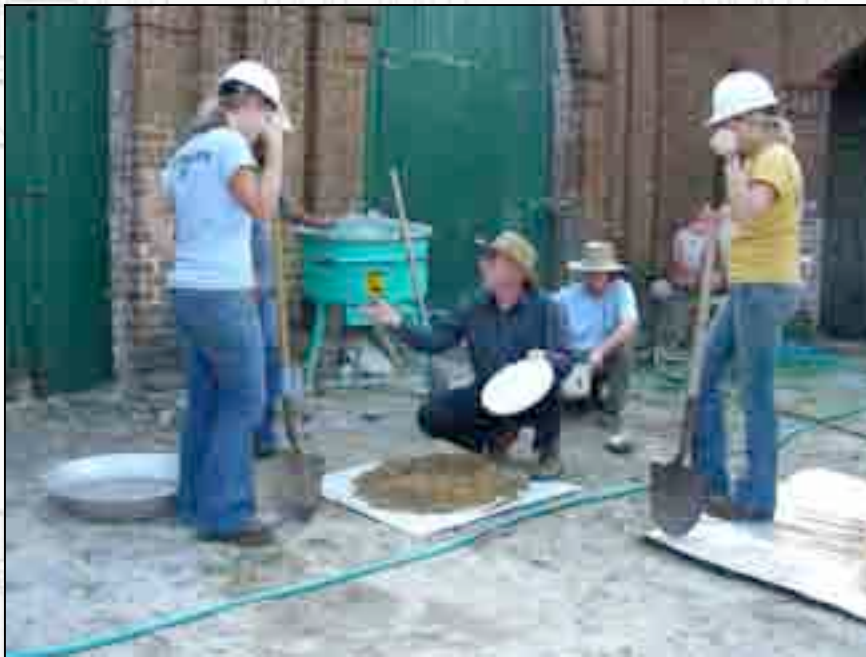
Gerard Lynch starts off by explaining the difference between traditional and ready-made mortar. A mound of Savannah River sand is prepared for the hands-on demonstration.

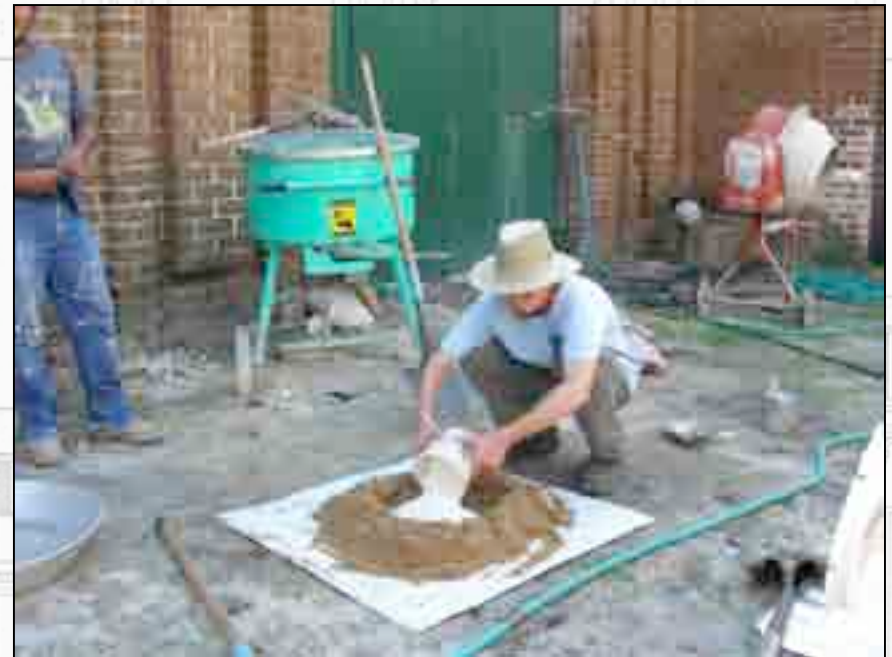
Travis Brown pours quicklime into the center of the mound of sand.

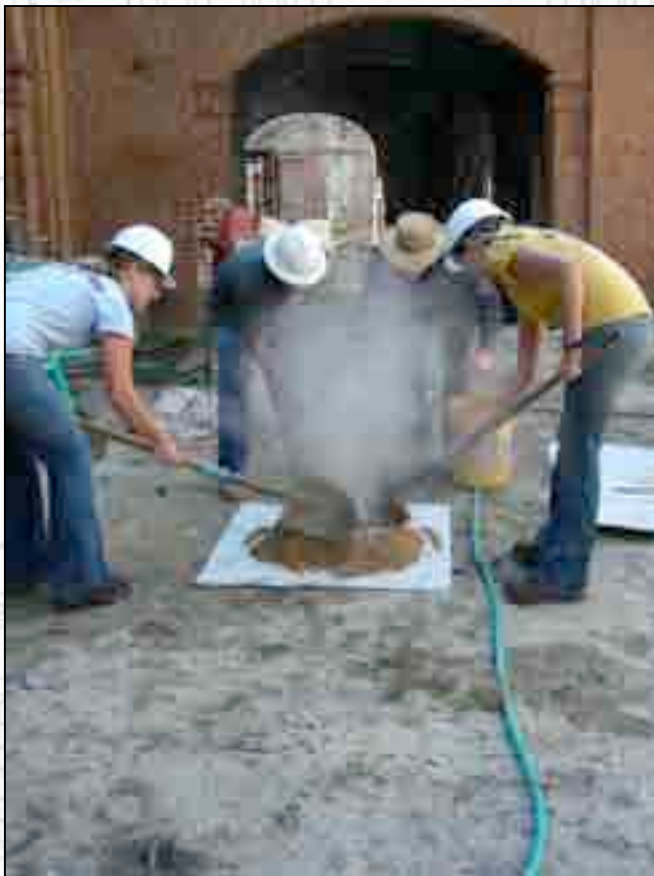
Steam is produced when Lynch and team members mix sand and lime together.

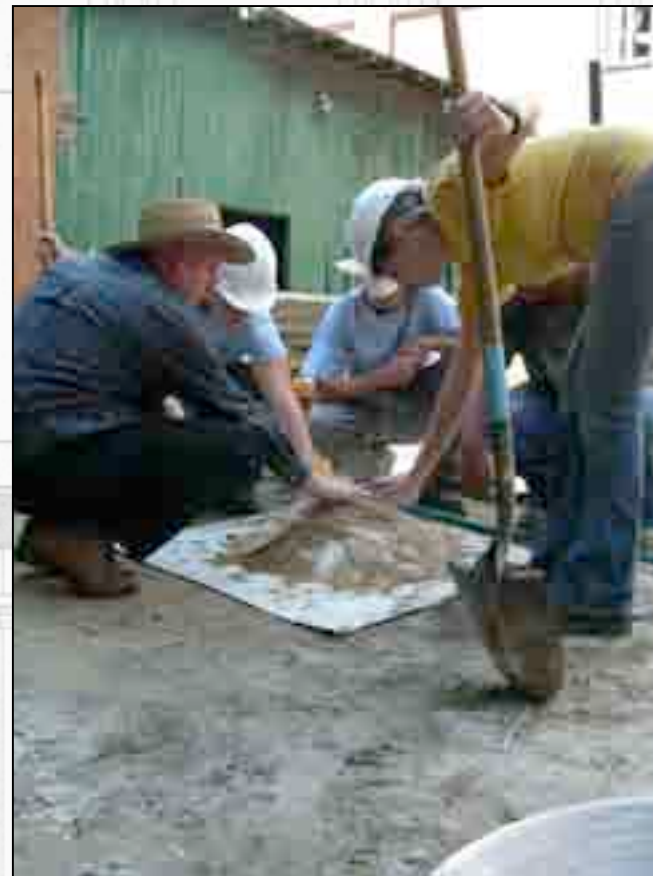
Lynch invites team members to feel the heat coming from the exothermic reaction between the sand and lime.

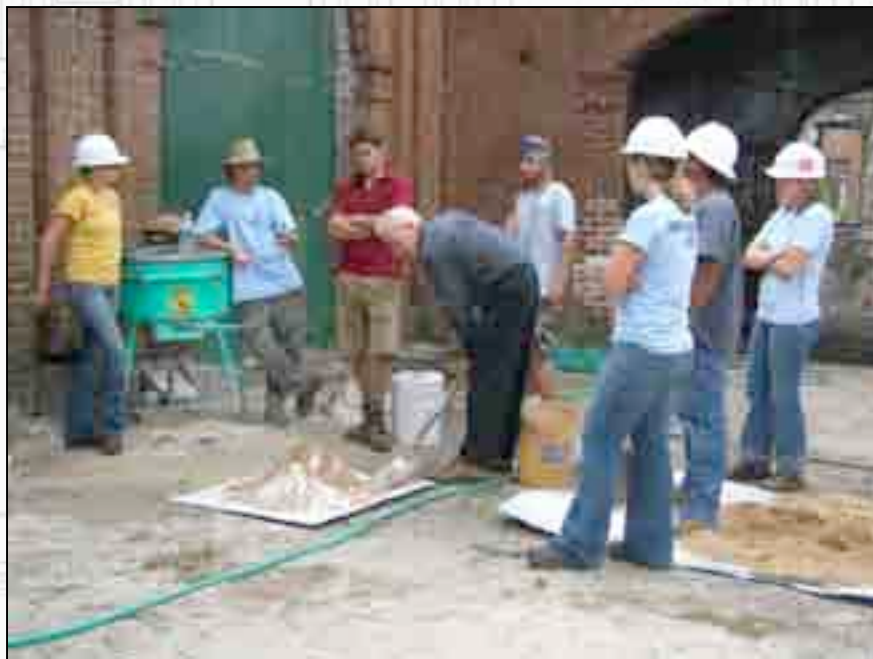
Lynch prepares the mixture of sand and lime for the addition of water.

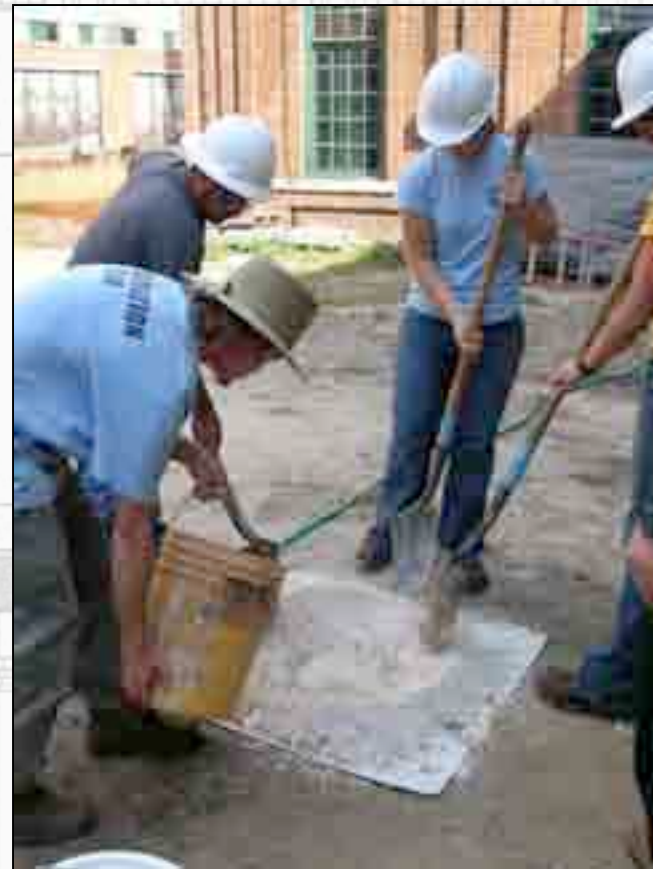
Travis Brown pours water into the mixture while team members stir.

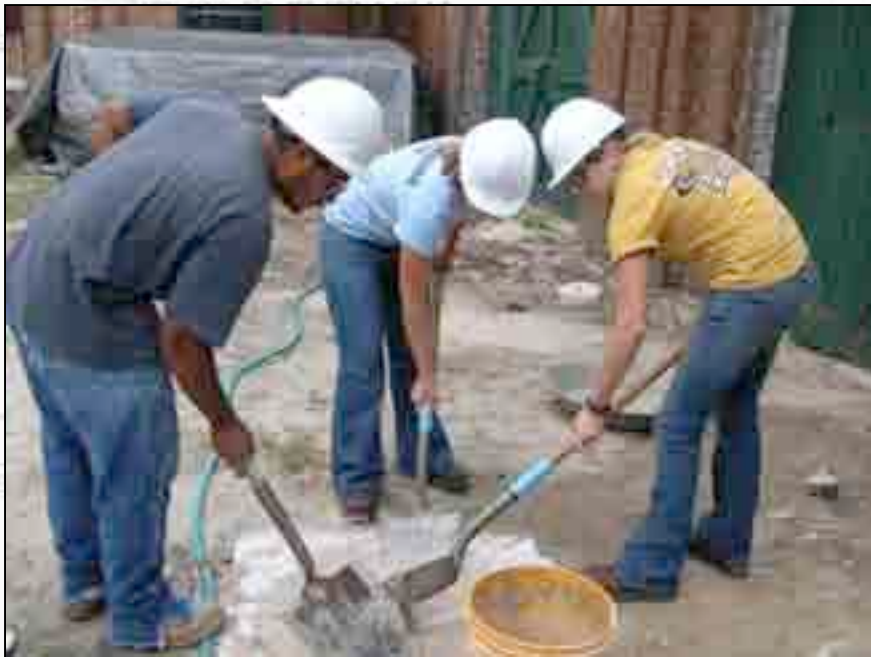
Preservation team members mix lime, sand, and water to make mortar.

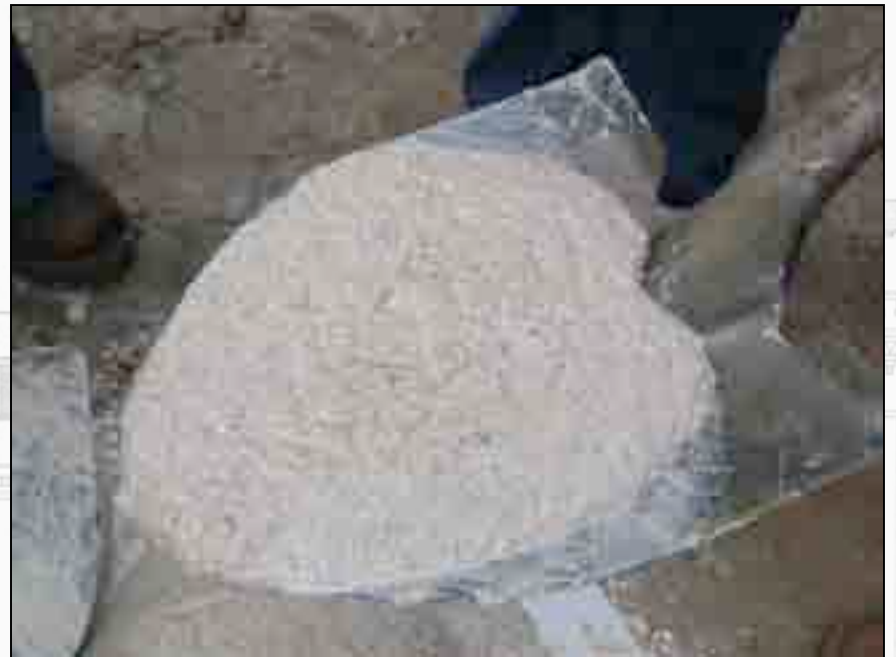
Close-up view of the finished product.

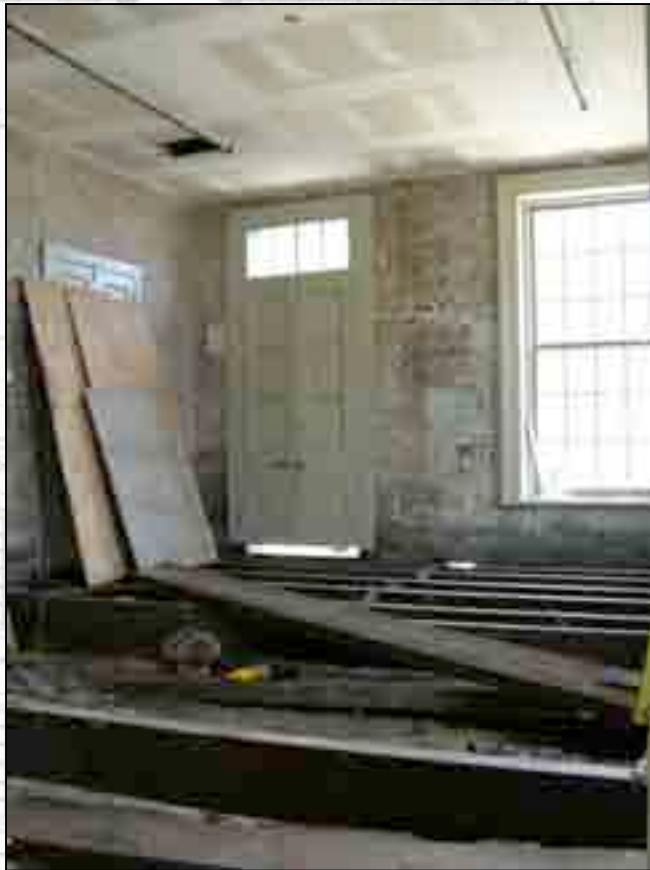
View of southeast room shortly after project began

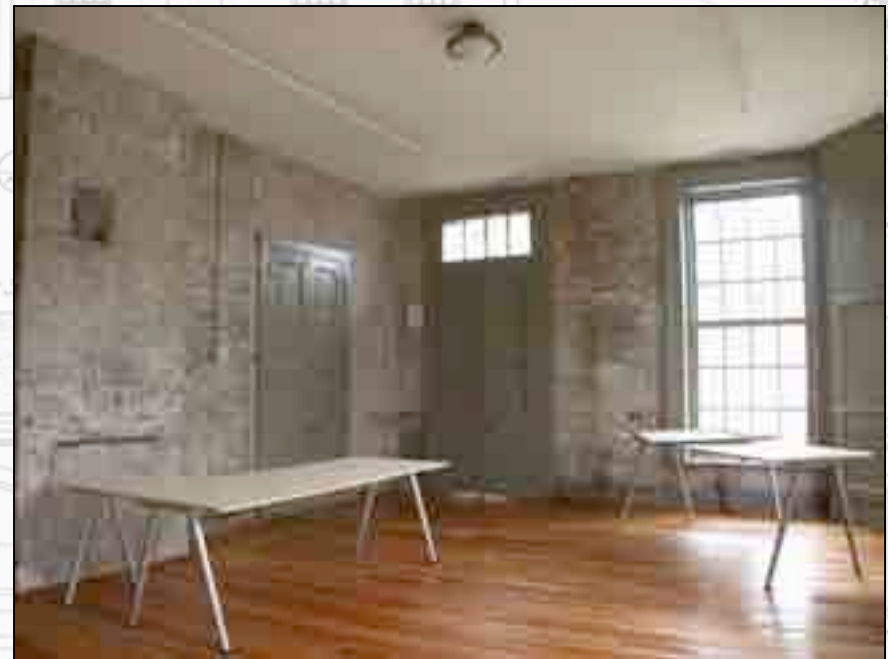
View of room after completion.

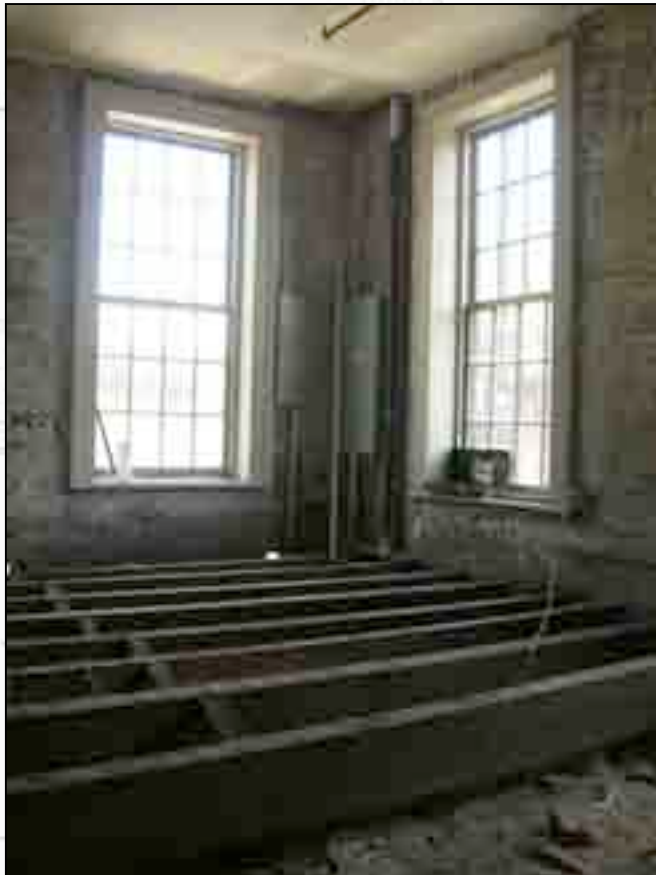
View of southeast corner of the room shortly after project began

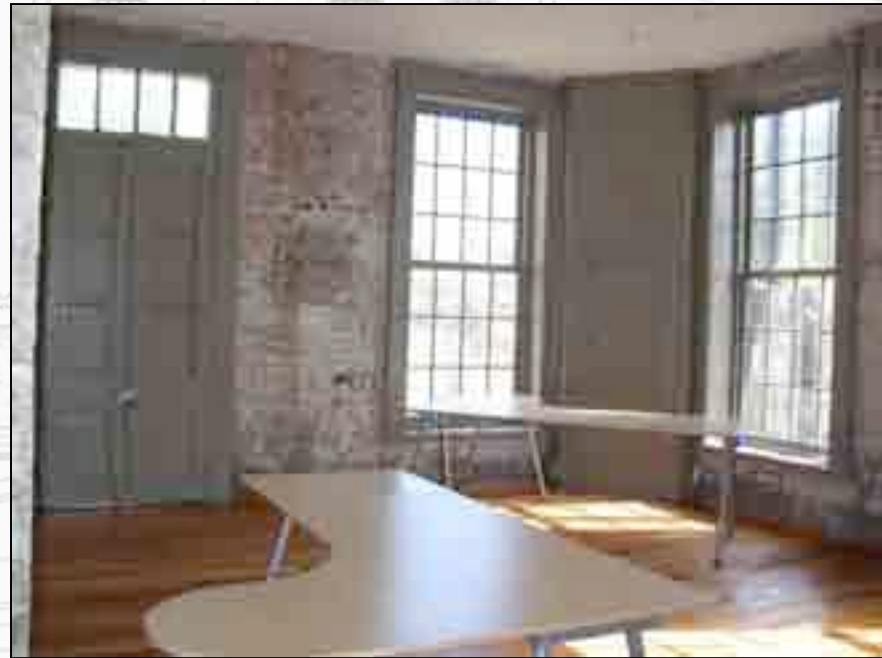
After completion.

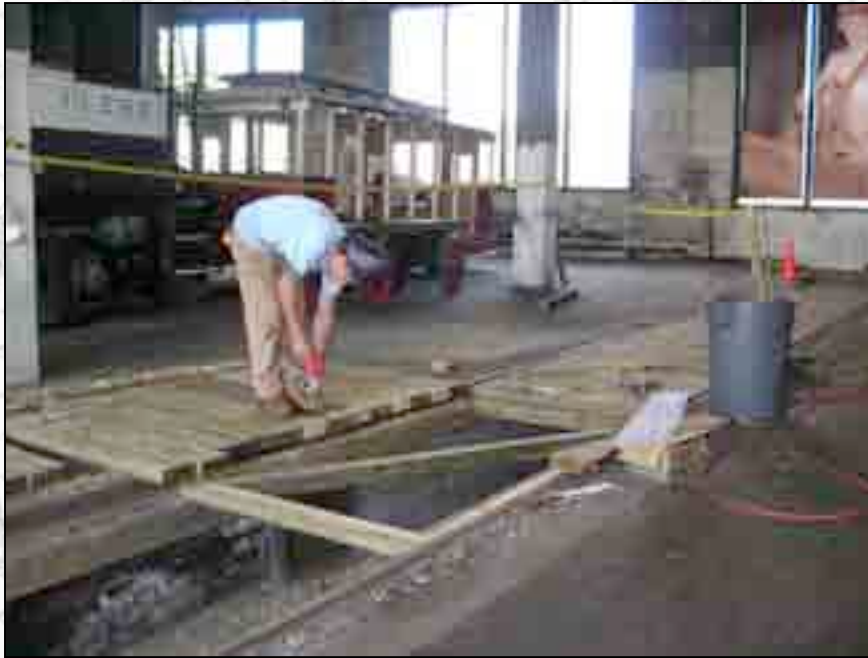
Preservation Team member Joe Lyons helps construct a pit cover for one of the lanes.

The two existing plywood pit covers were unstable and needed replacing. Preservation Team Members Charles Adkins, Jack Tyson, and Joe Lyons constructed new ones.

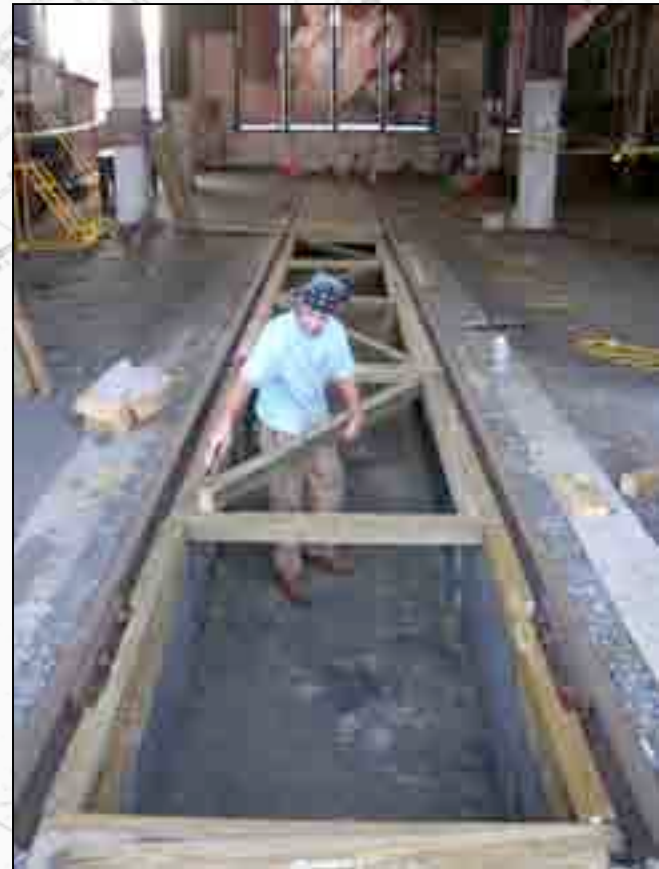
View of pit cover as it is being built.

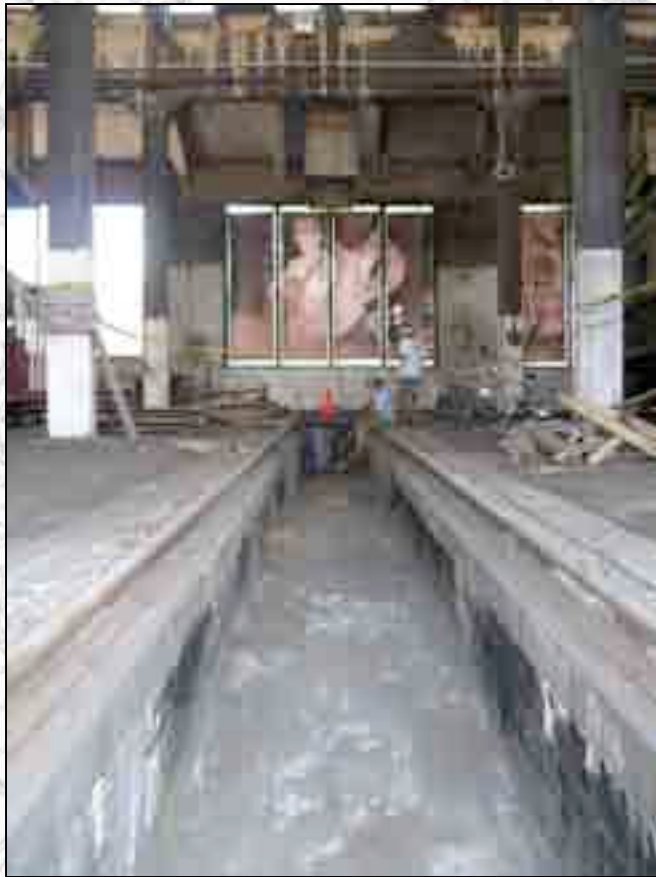
View of lane pit before construction of new pit cover.

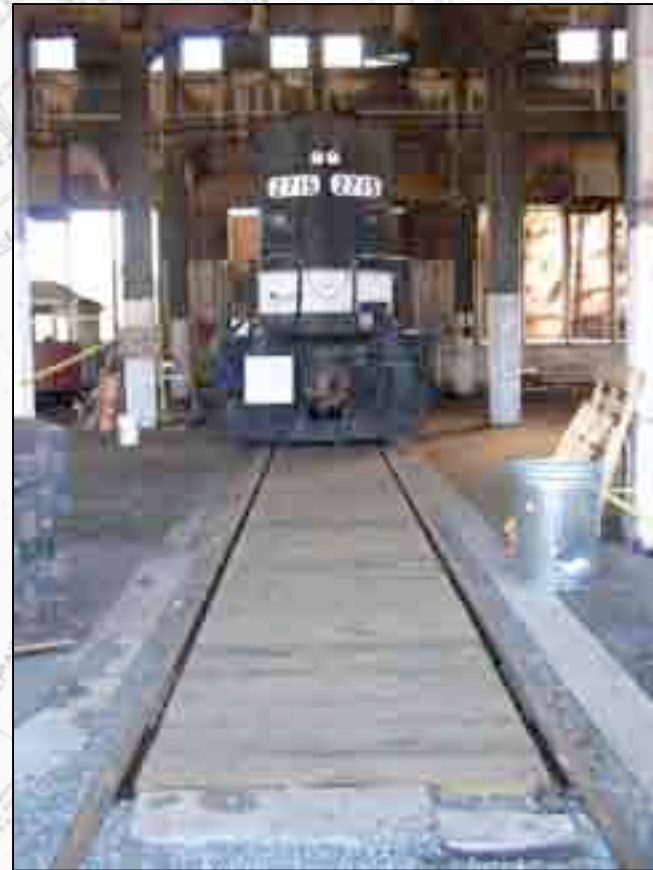
View of pit cover after completion.

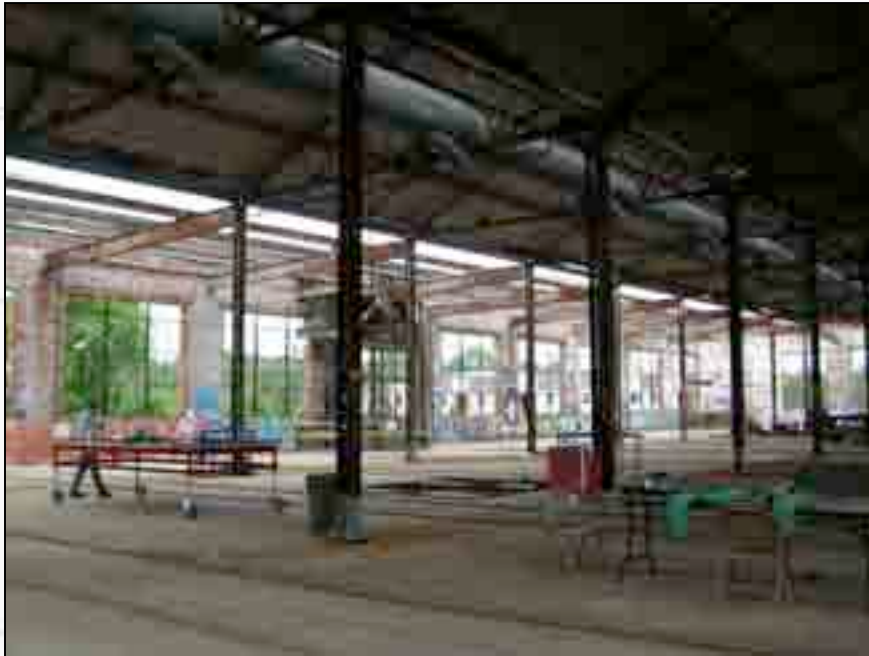
Steel columns during repair work.

The steel columns in the historic Paint Shop are currently being restored. Recently some of the repaired columns were painted Central of Georgia Bottle Green on the bottom and white on the top. The way these columns were painted is historically-based on how they originally looked upon the building's completion in 1924-25.

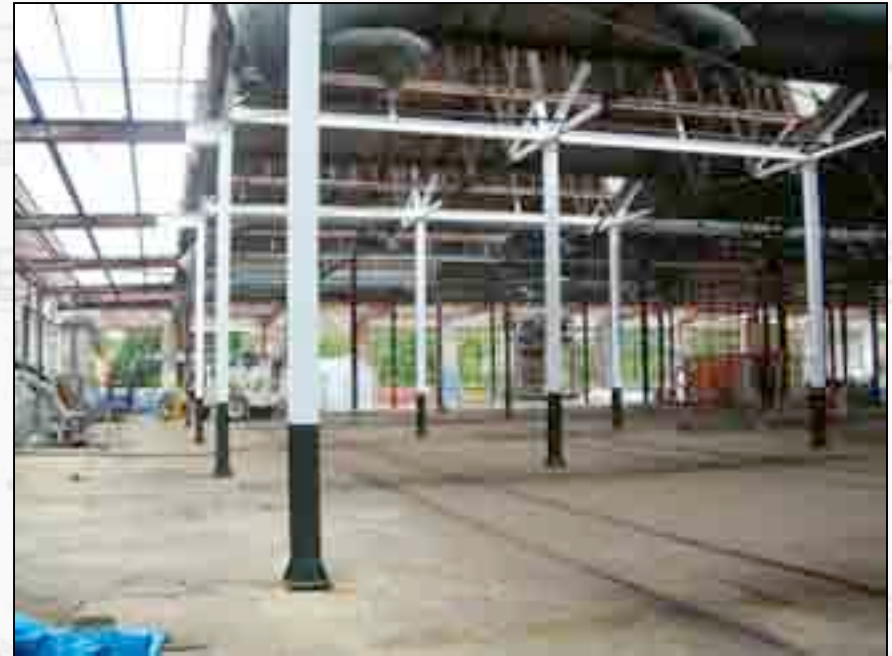
Steel columns after painting.

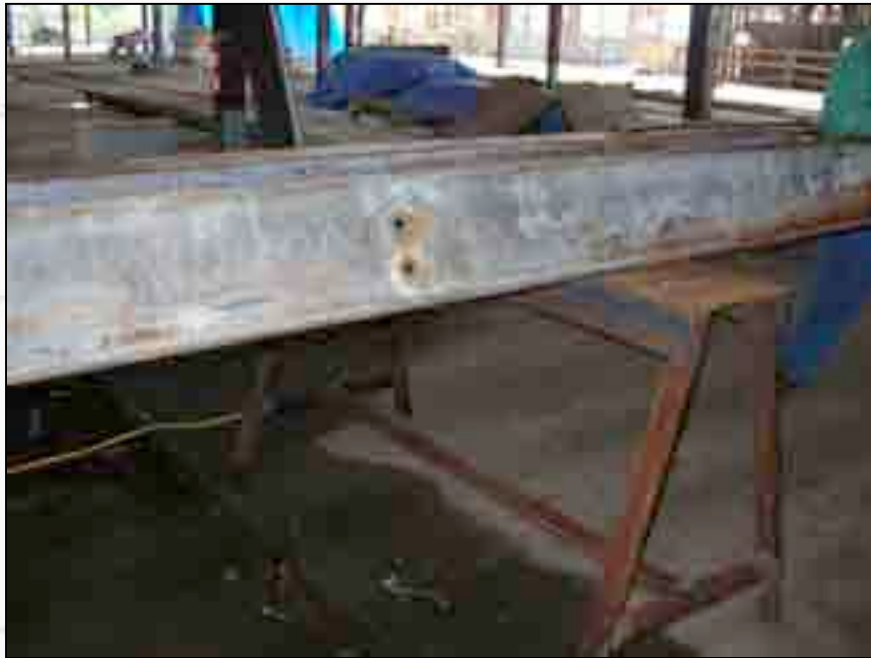
Steel column signed on January 13, 1937.

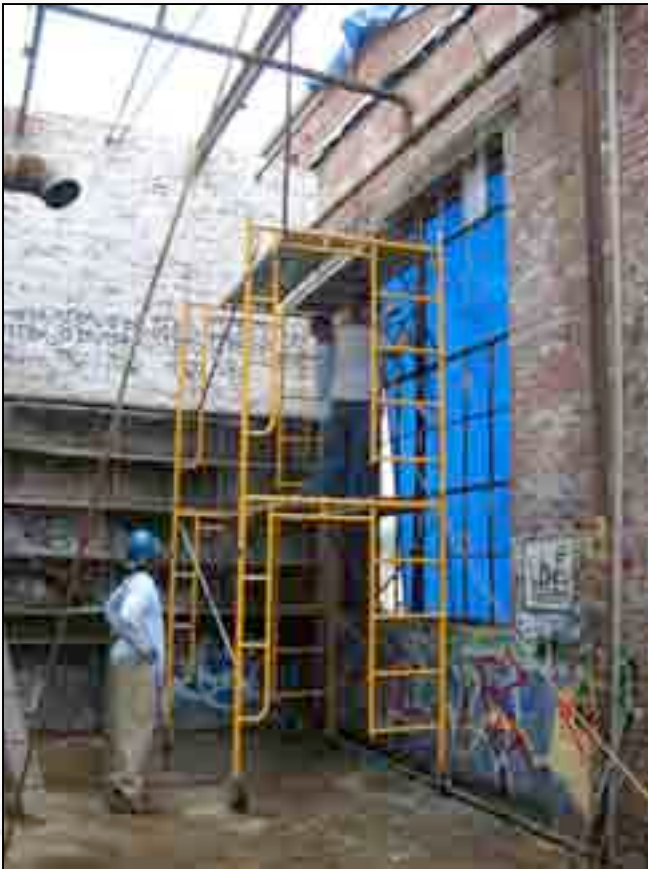
Chris Latson, Joe Rothwell, and Tim Gaffney remove a window from the interior west wall of the Paint Shop.

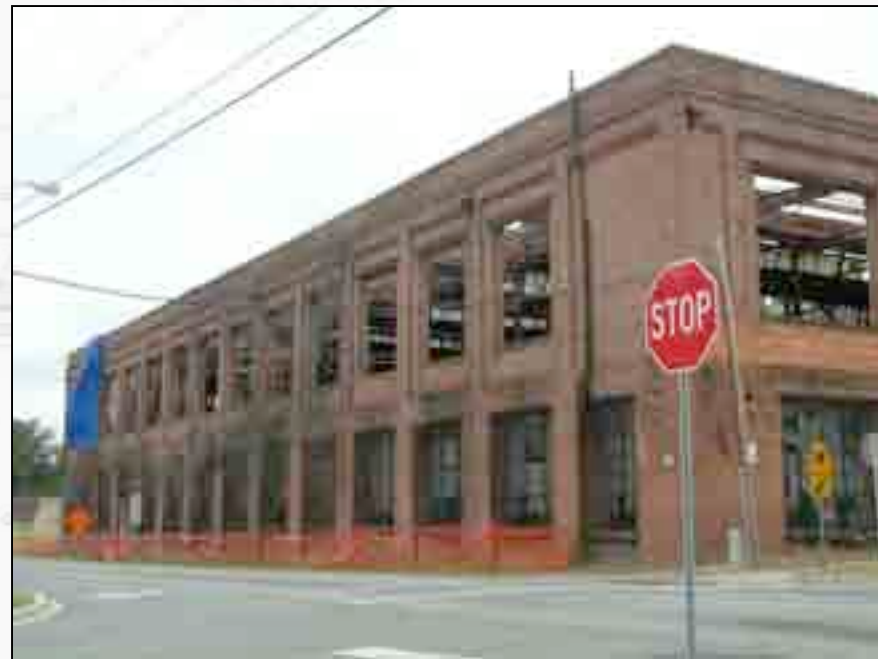
Current view of west façade with most of the main floor windows removed.

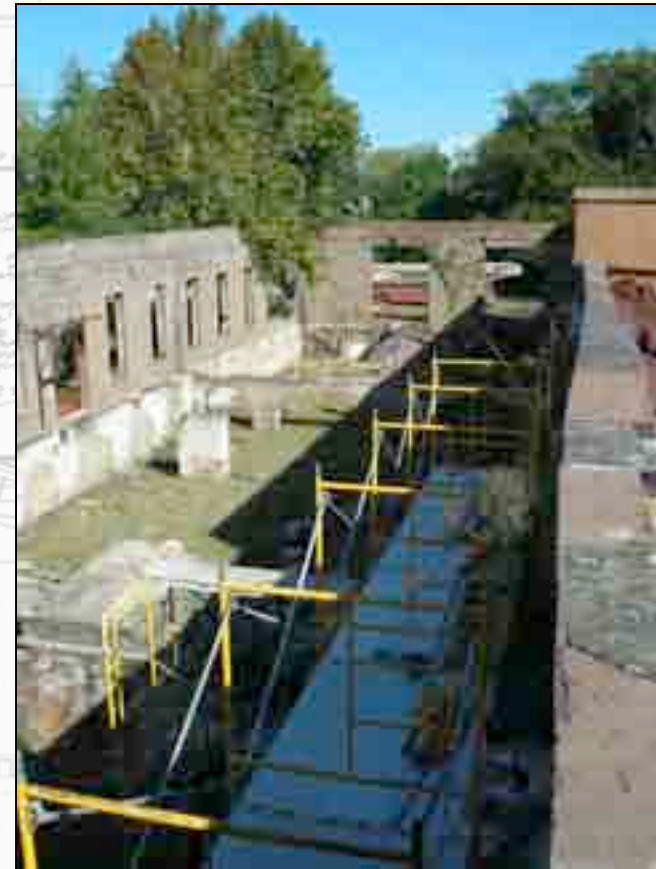
Current aerial view with scaffolding set up for fifth phase of repointing on the east wall.

The CHS Preservation Team has started the fifth phase of repointing on the east wall of the Carpentery Shop.

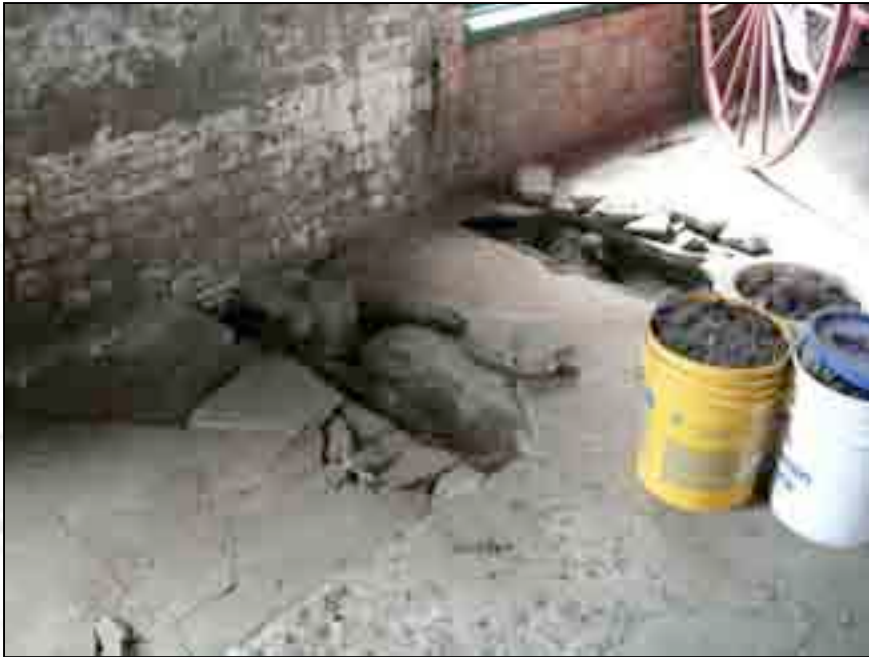
The concrete floor in the southwest end of the Blacksmith Shop was cracking due to numerous factors including uneven settling from previous repairs.

CHS Preservation Team members recently repaired the concrete floor in the Blacksmith Shop.

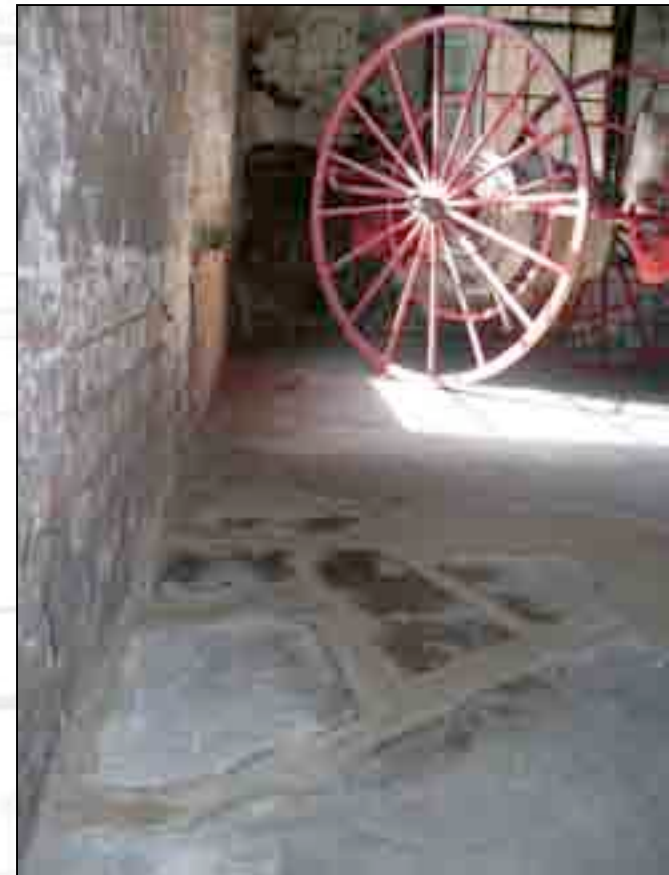
View of the repaired concrete floor.

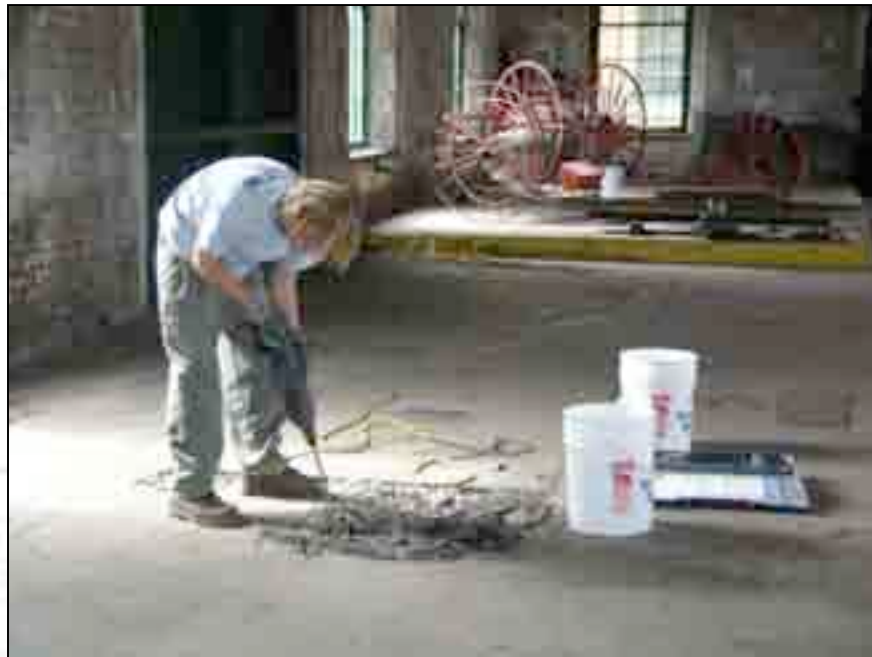
Historic Masonry Specialist Travis Brown drills away deteriorated concrete in order to repair it.

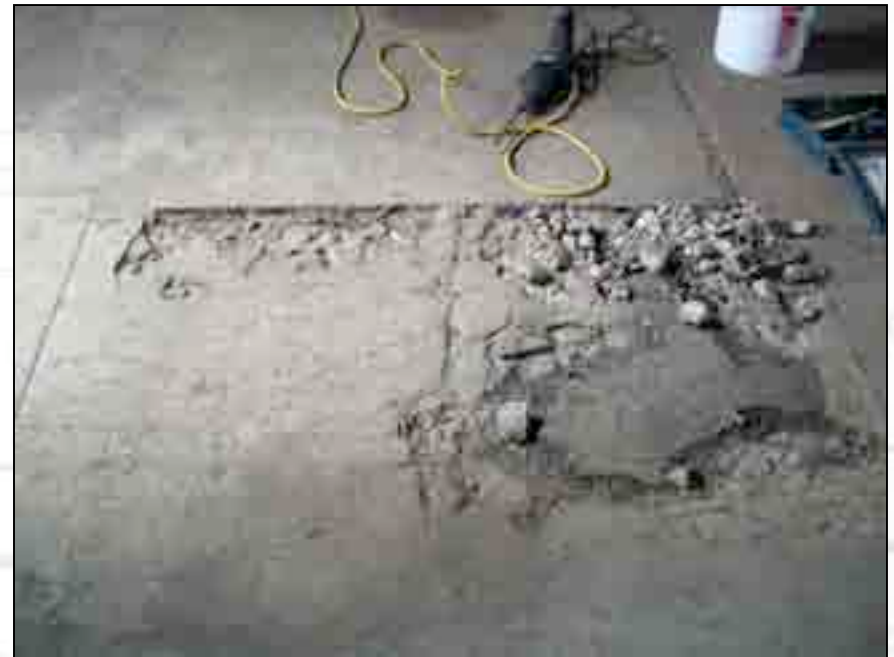
Close-up view of deteriorated concrete.

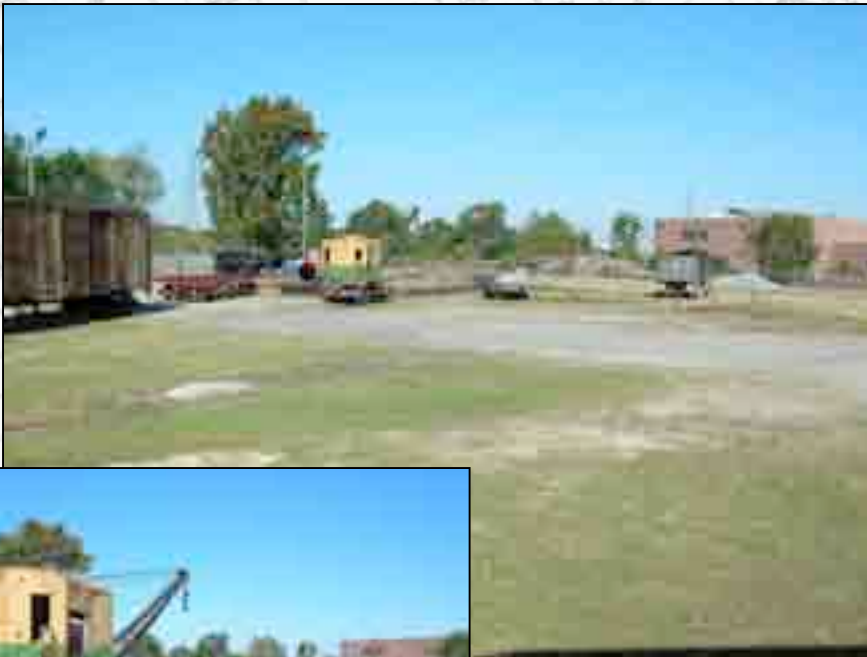
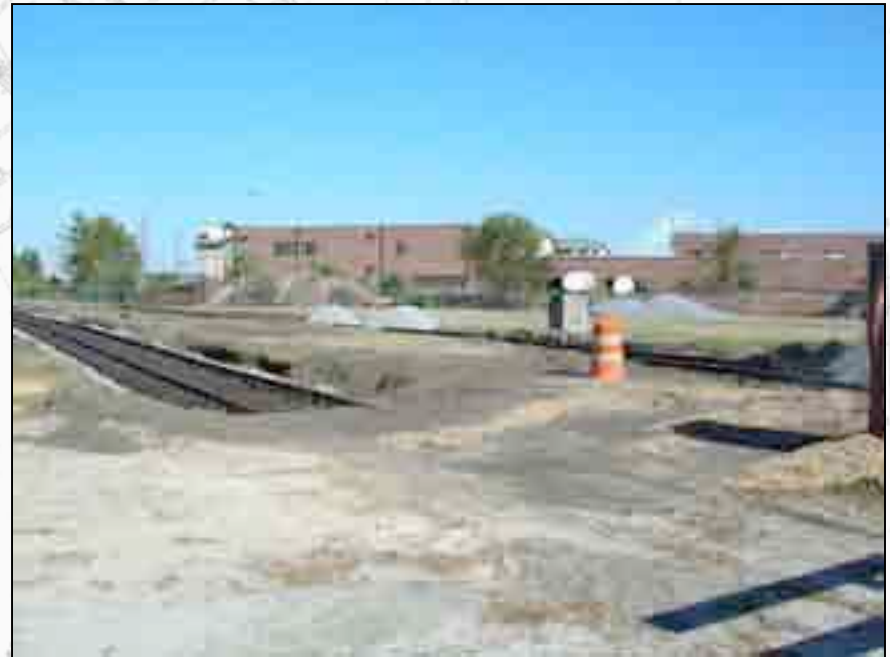
Views of the new tracks being laid

Tracks are currently being laid on the northwest end of the site.

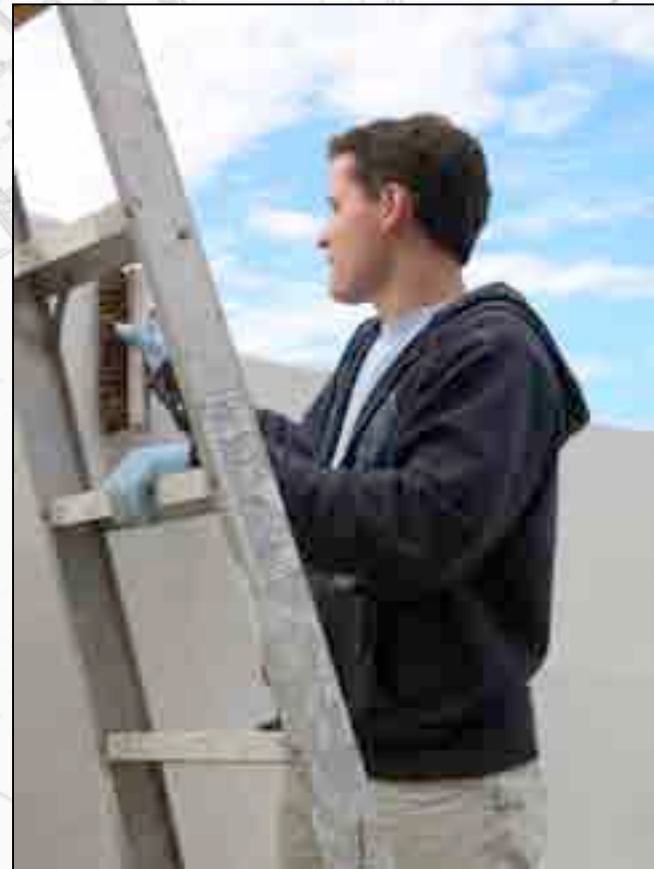
Jason Cobb applies whitewash to the wall.

Preservation Team members continue whitewashing the retaining wall on Purse Street.
