Roundhouse Railroad Museum

CHS Preservation Team Projects

April 2006

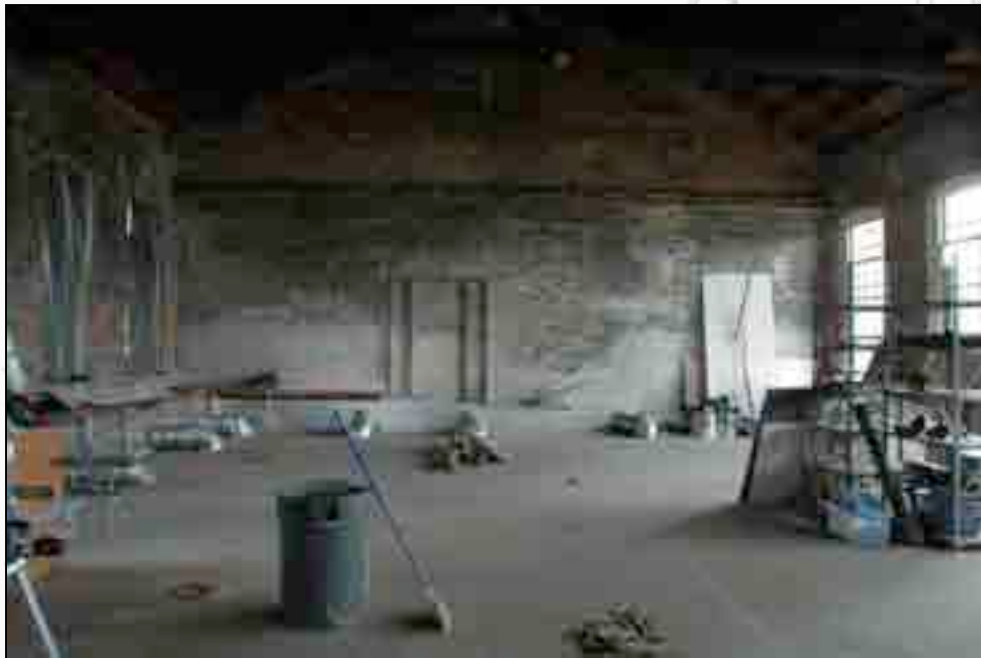
Before restoration work started.

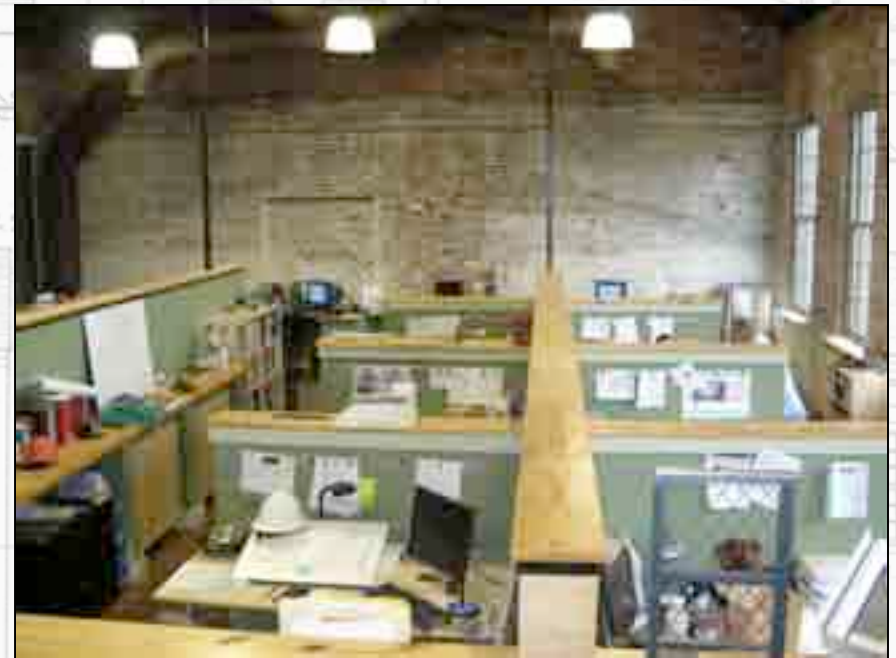
After work was completed.

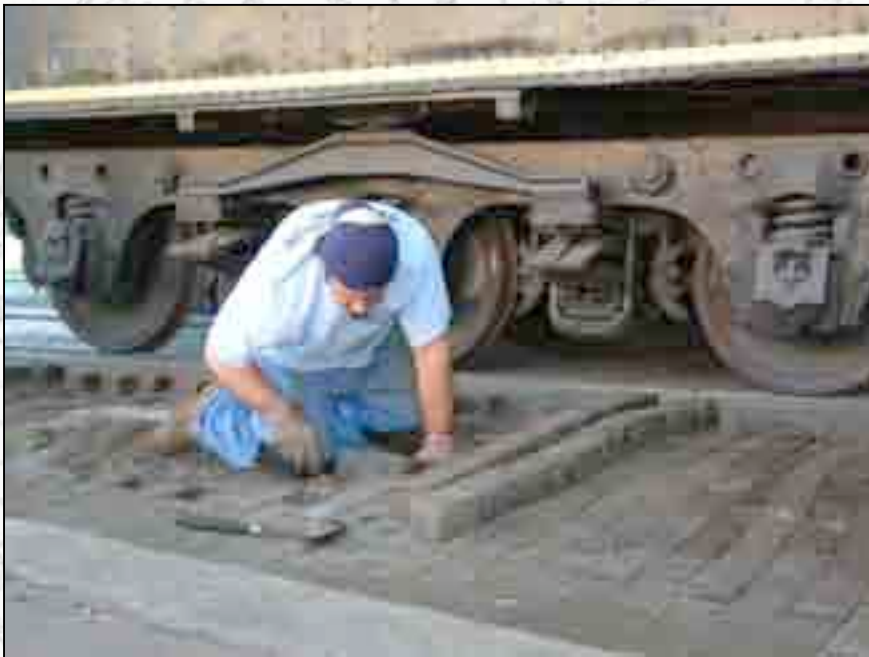
Woodblock Floors

Present woodblocks are removed to make test patches before the full restoration process begins. Various mastics and sealers are being tested.

Views of several test areas.
