Roundhouse Railroad Museum

CHS Preservation Team Projects

May 2006

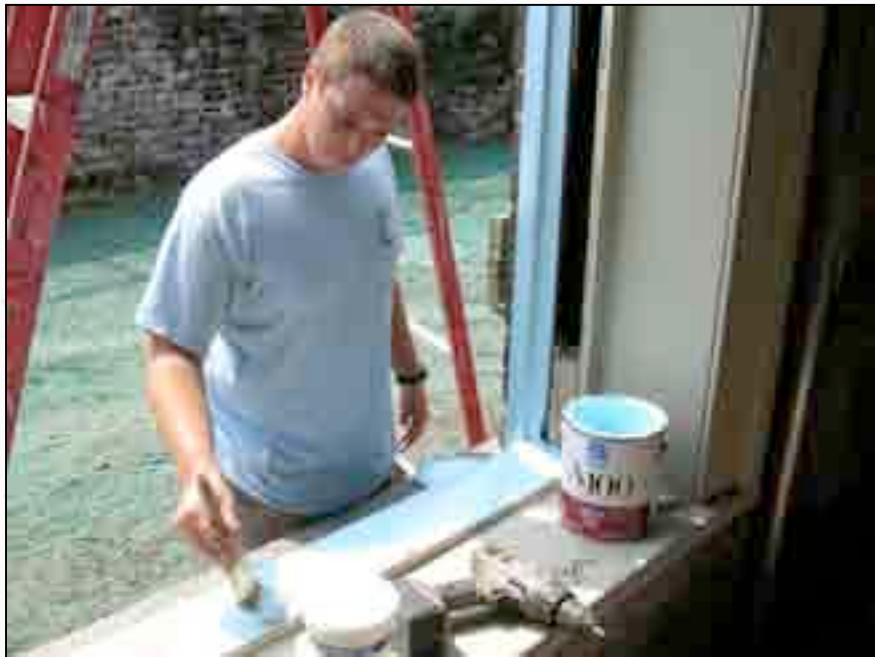
Ryan primes the window casing before the restored window is reinserted.

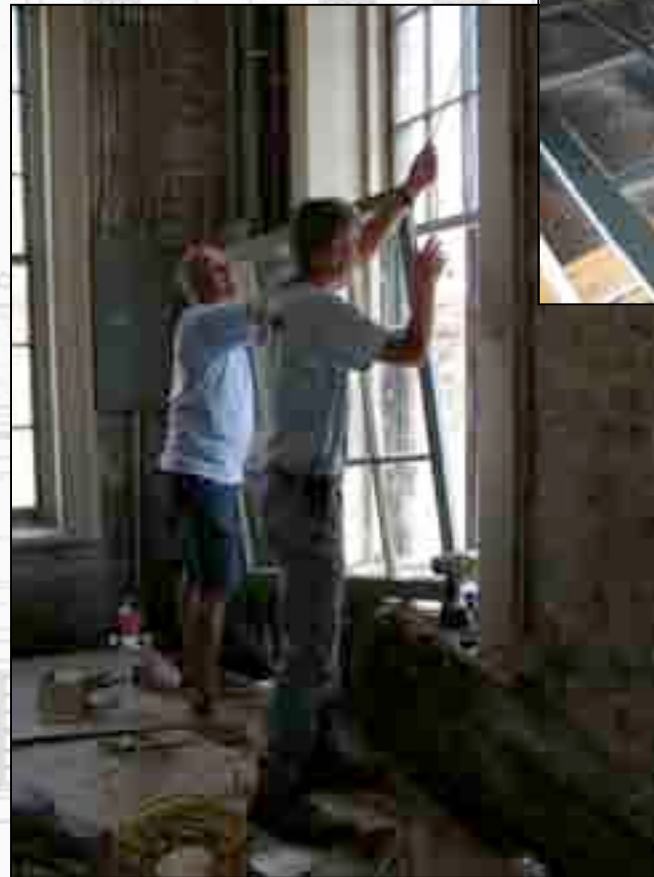
Kurt and Charles install a newly restored window.

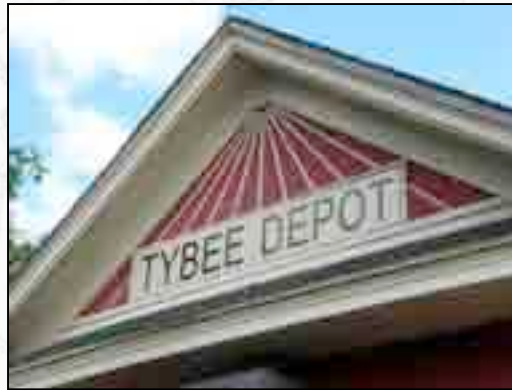
Close-up views of
the freshly painted
Tybee Depot.

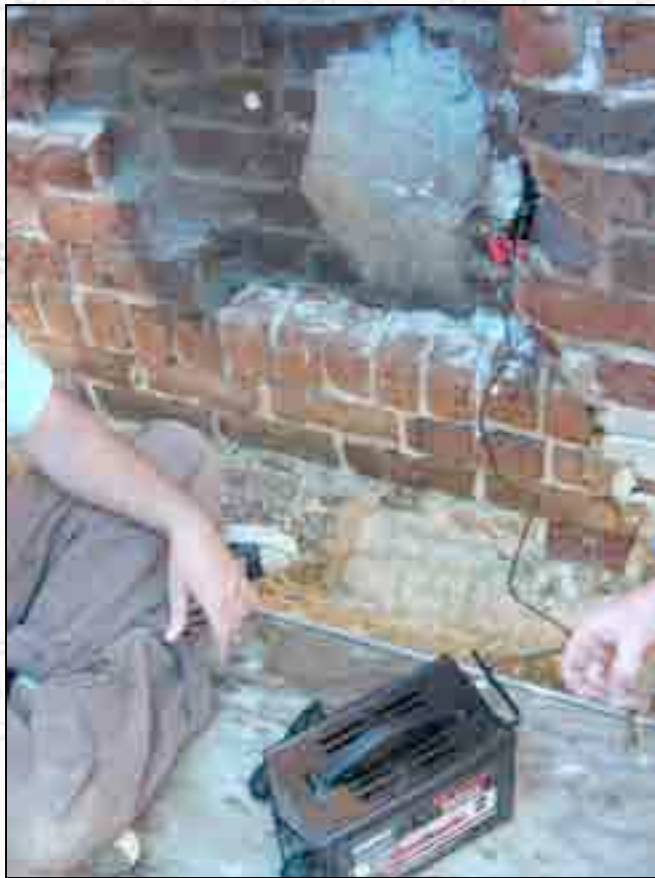
A low-voltage electrical charge was then applied to the area.

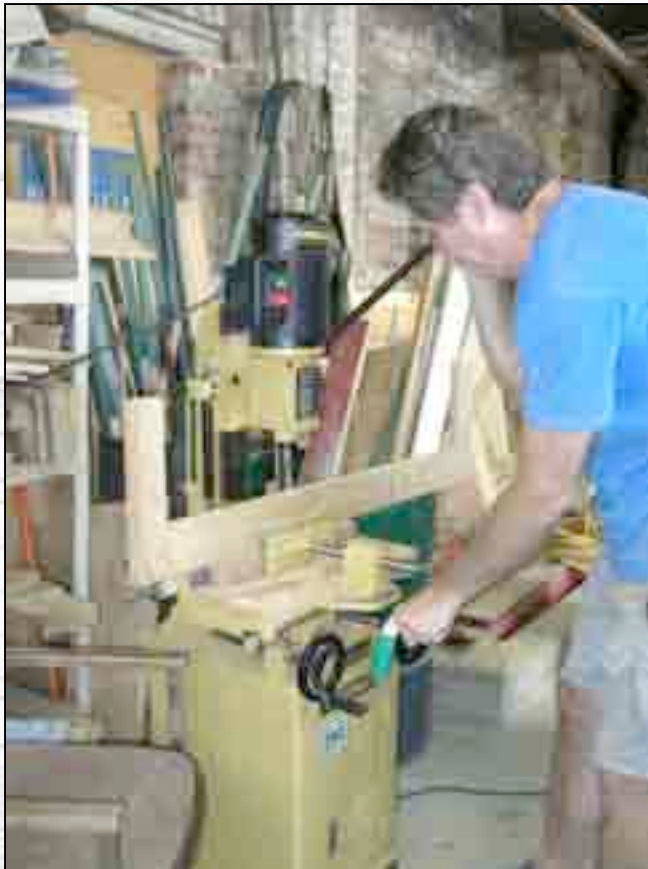
Don uses a mortis drill to insert mortises into a window frame.
