Roundhouse Railroad Museum

CHS Preservation Team Projects

April 2006

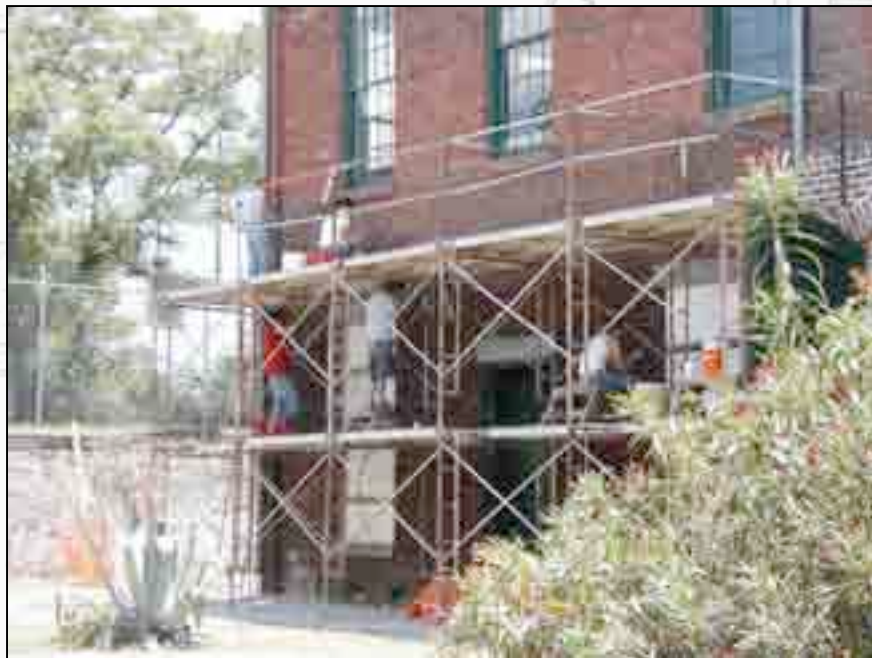
Before

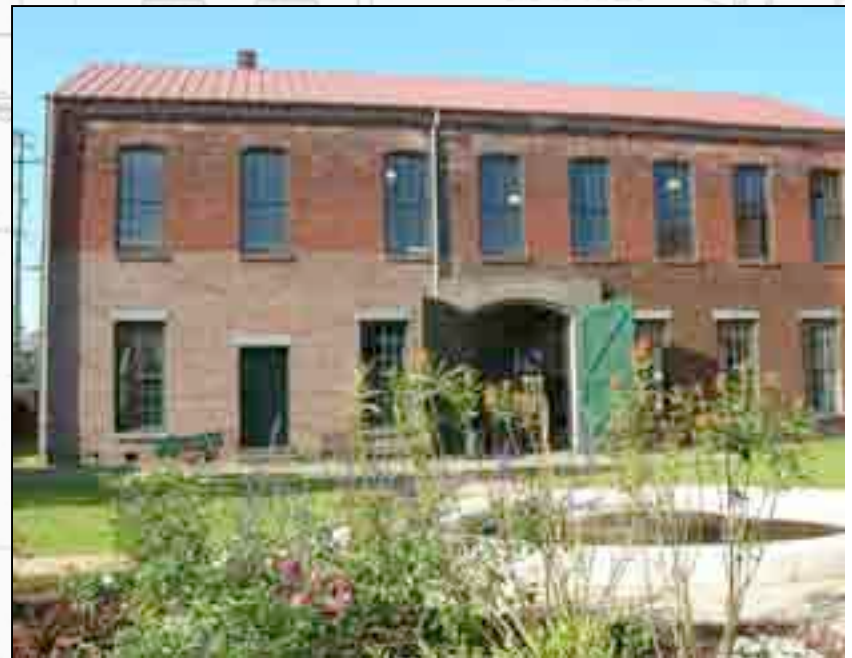
After

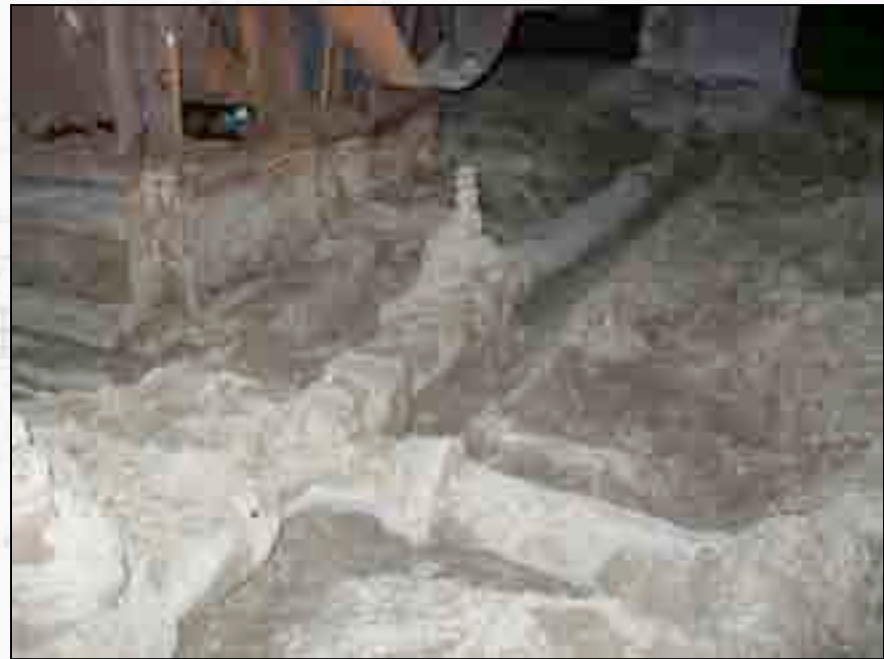
Views of the heating unit and its foundation.

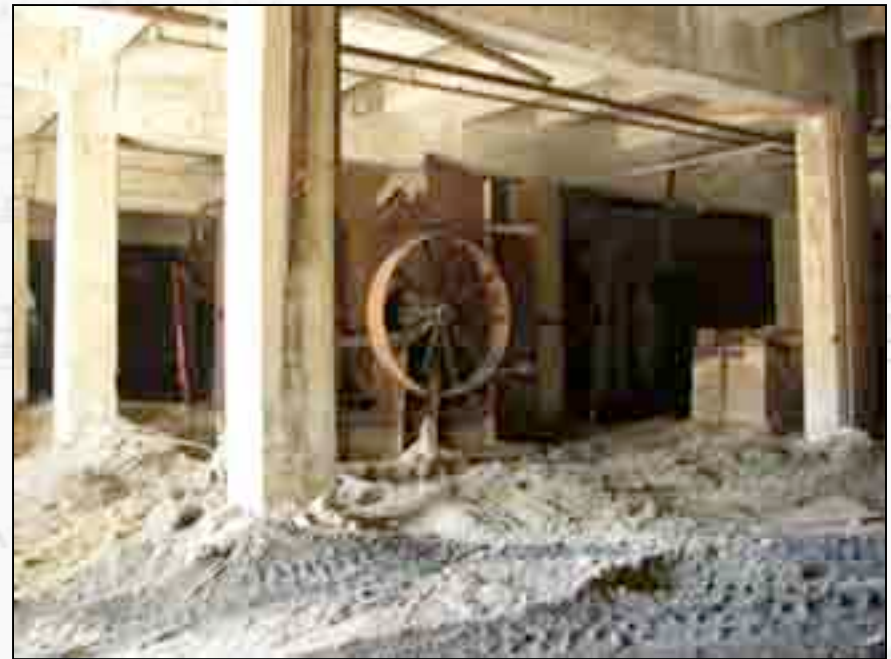
After.

A wall in the basement of the Paint Shop was removed to facilitate preconstruction activities related to the heating unit.

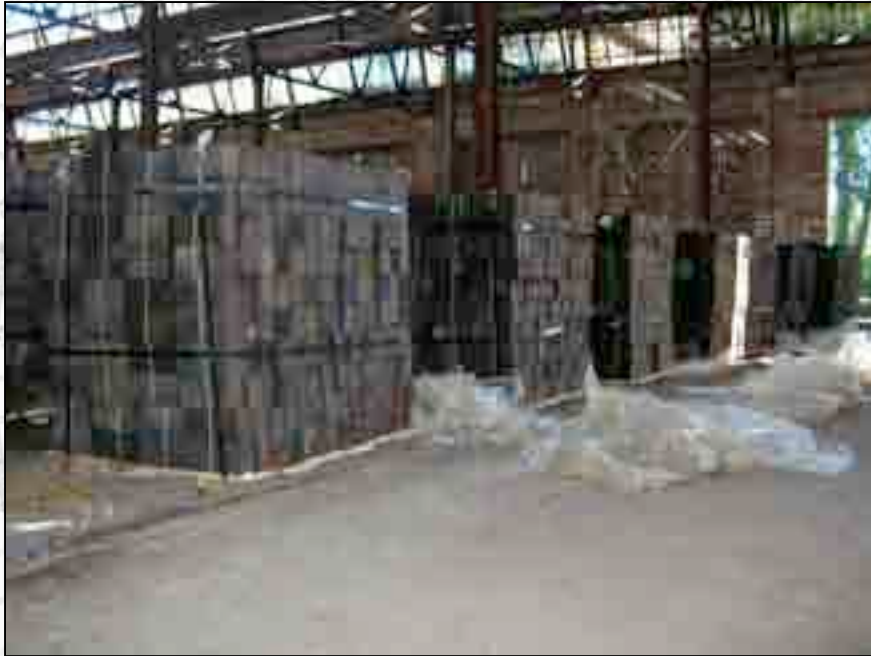
Woodblock Floors

Replacement woodblocks are being stored in the Paint Shop.

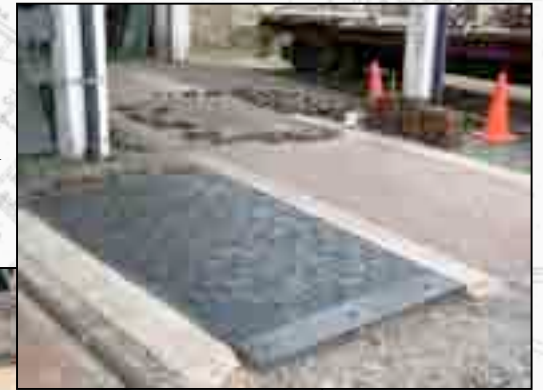
Woodblock Floors

Present woodblocks are removed to make test patches before the full restoration process begins. Various mastics and sealers are being tested.

Views of several test areas.

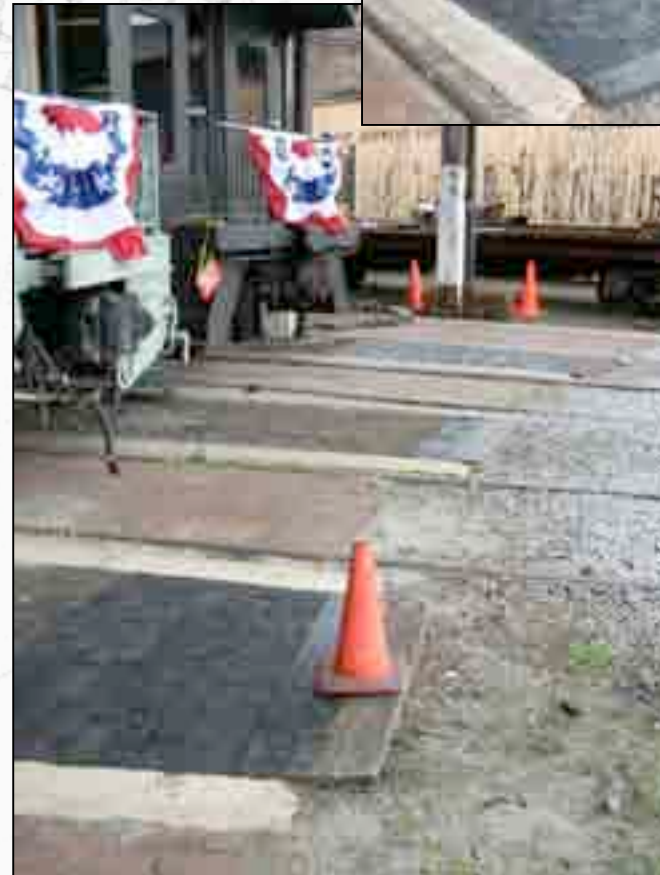
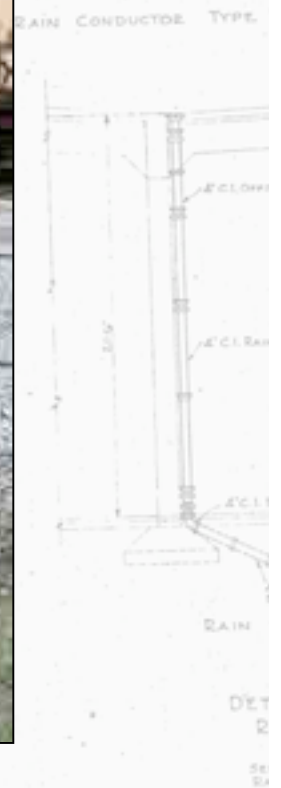
Bill Hersch removes the original woodblocks to prepare the area for testing.
