Roundhouse Railroad Museum

CHS Preservation Team Projects

May 2006

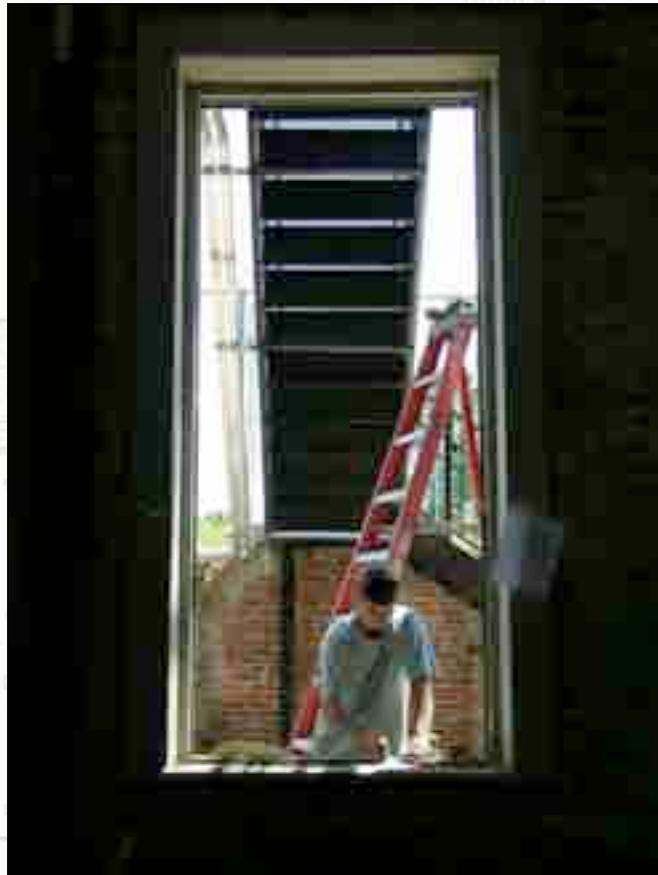
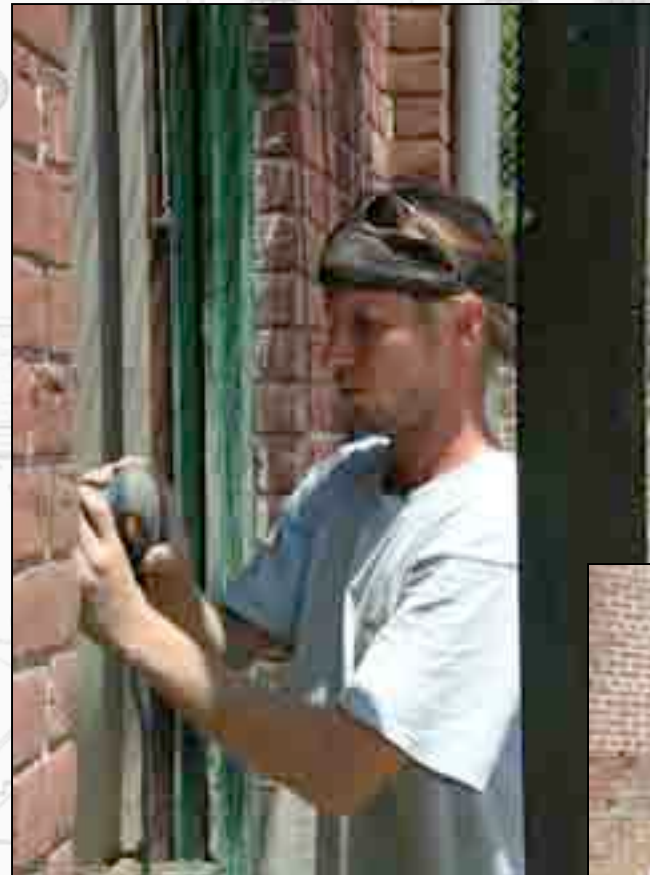
Nathan is sanding the casings where the restored windows will be reinserted on the south side of the Tender Frame Shop.

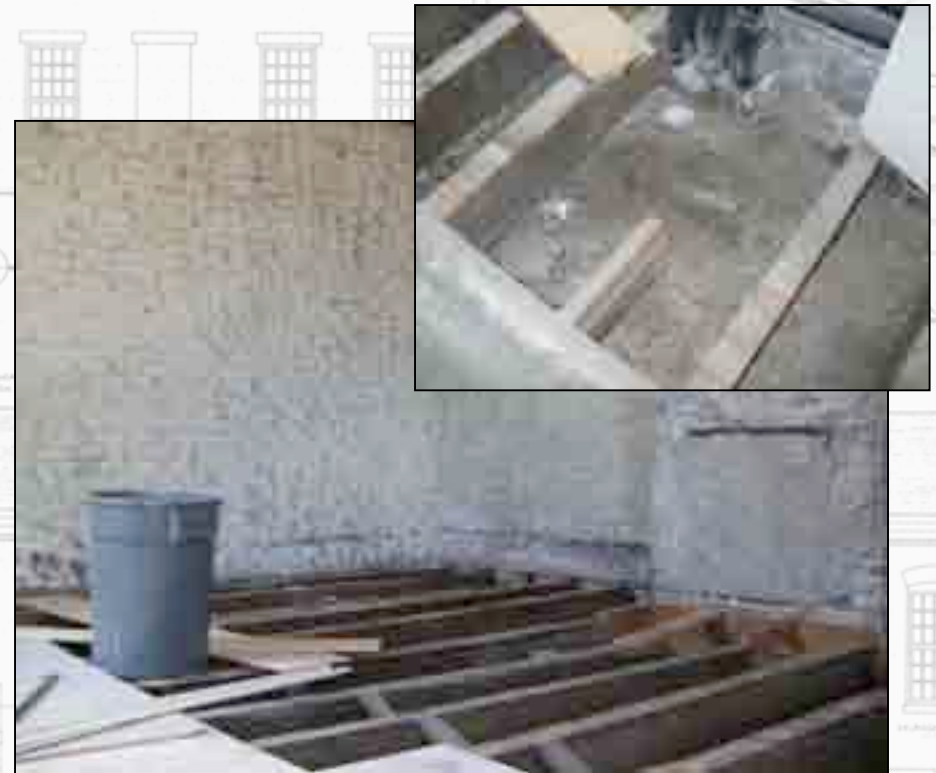
Chris, Jeanne, and Ryan remove the floorboards of the first floor of the Tender Frame Shop to access the rotted and termite damaged floor joists.

The CHS Preservation Team is repairing the joists that can be saved and replacing the others in kind. The floor boards were numbered so they can be reinstalled in the same order as they were taken out.

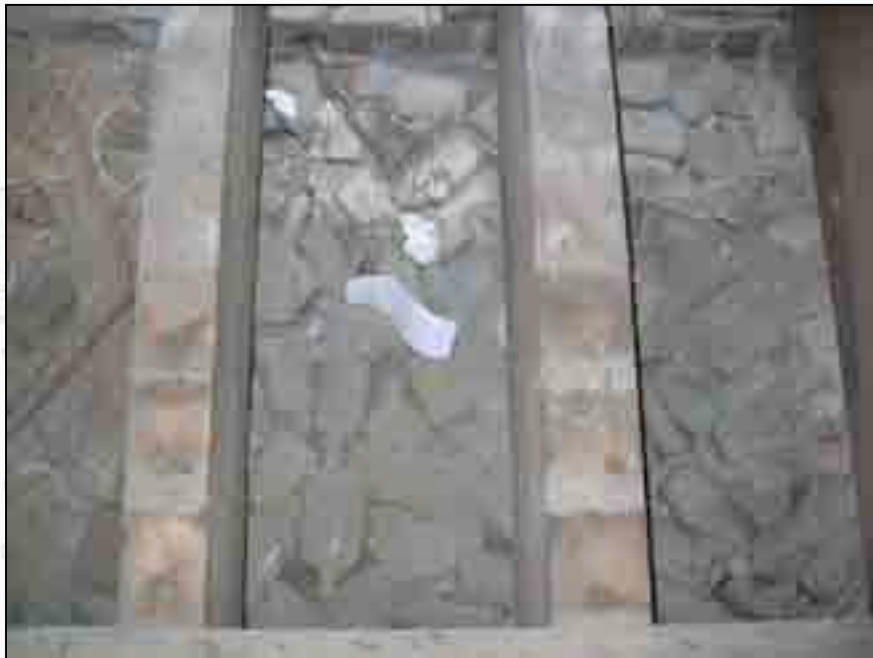
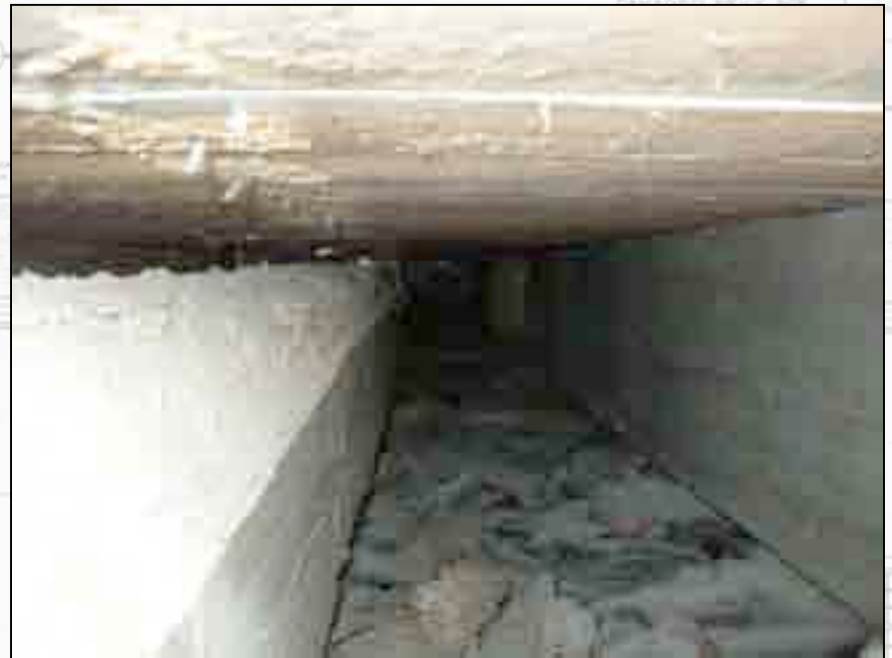
While uncovering the floor joists of the first floor, the CHS Preservation Team discovered a large amount of glass bottles that will be researched and documented by CHS Archaeologist, Rita Elliot.

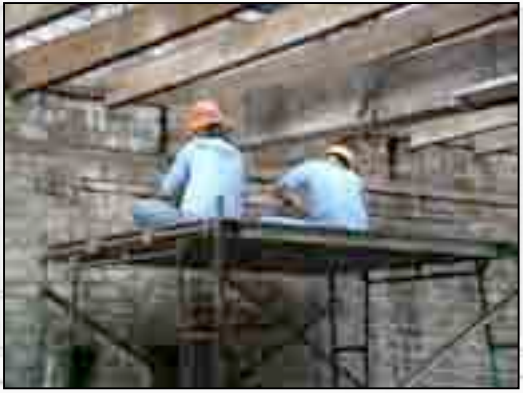
South wall

The CHS Preservation Team continues to repoint all walls of the Compressor Room.

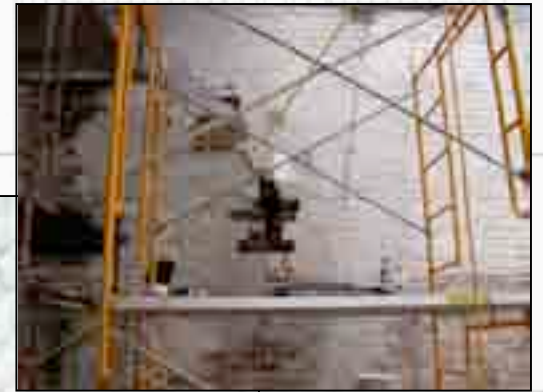
Extensive repointing is taking place along a major crack in the east wall of the Compressor Room.

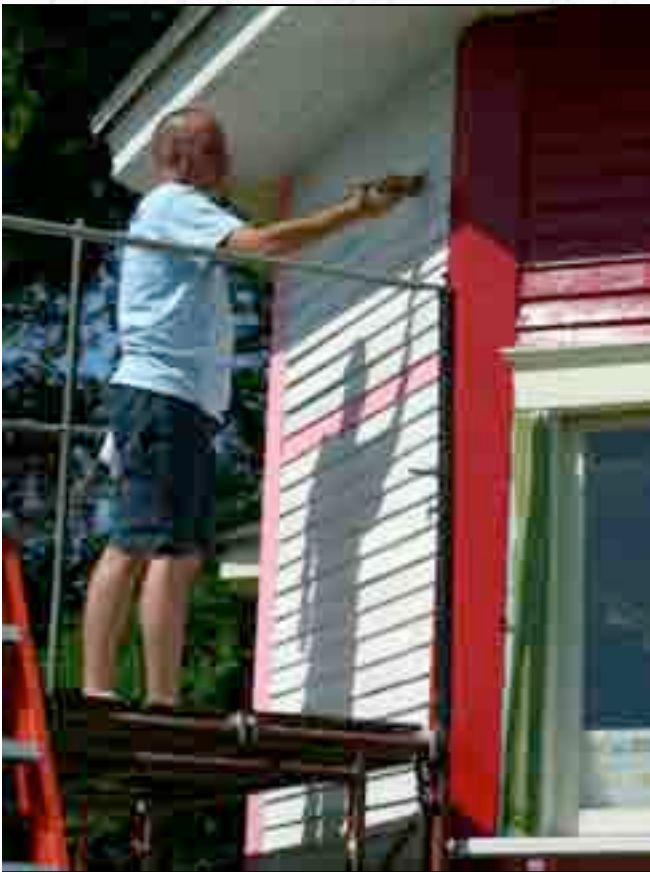
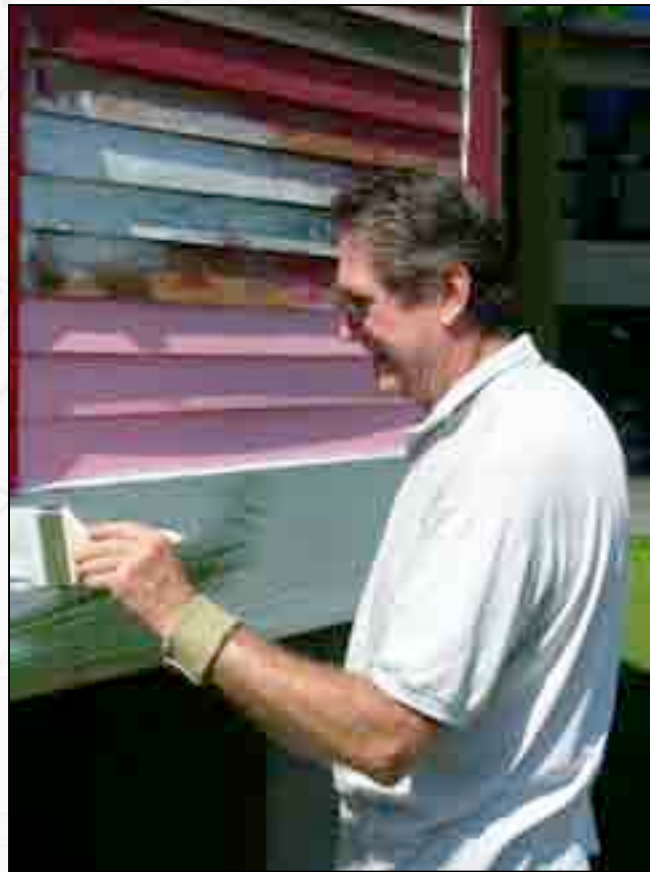
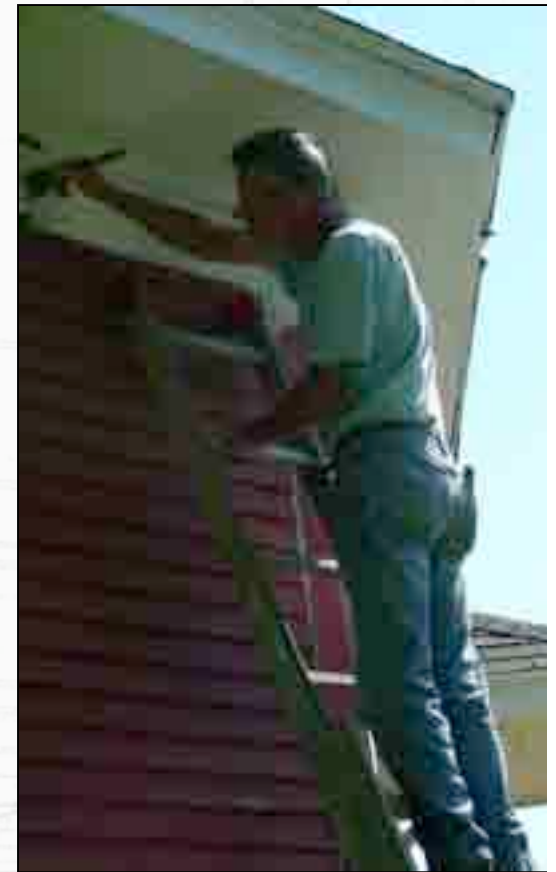
Don, Charles, and Kurt give
the Tybee Depot a facelift.

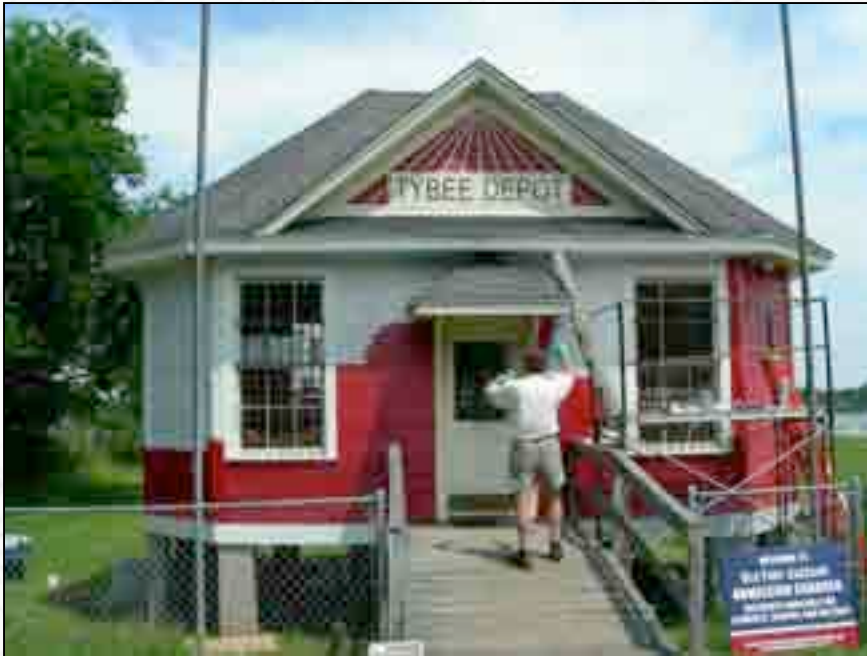
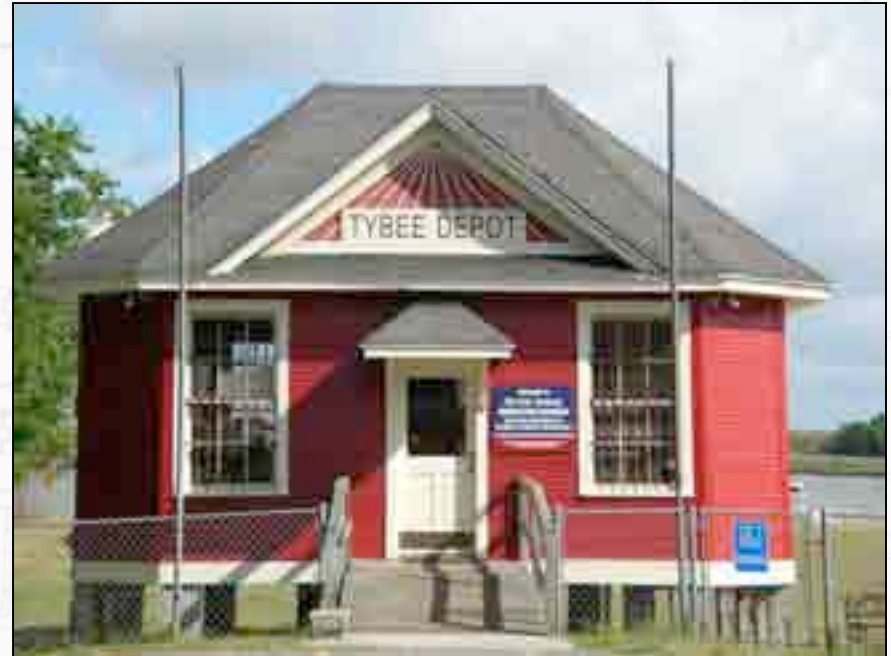
The finished product.

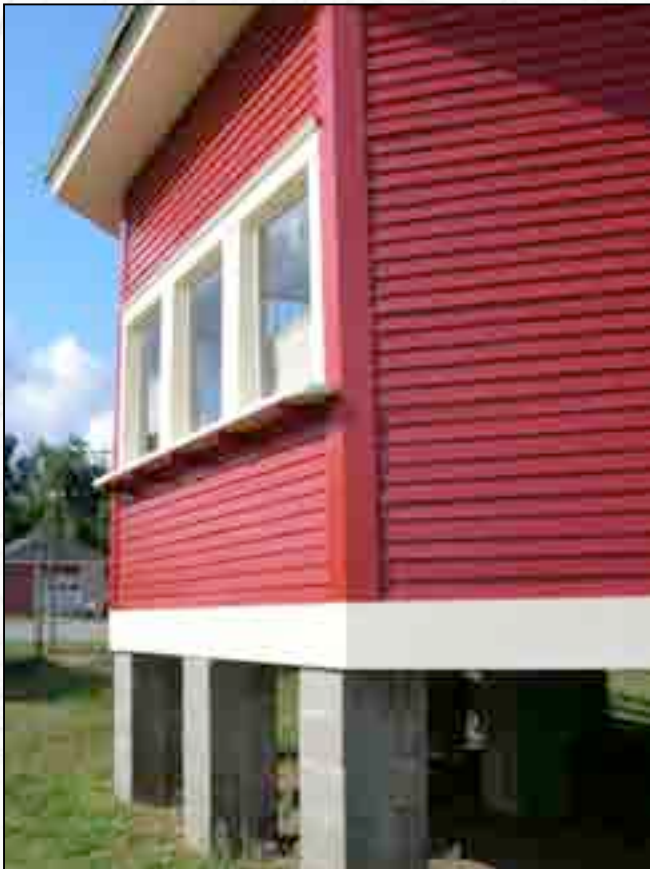
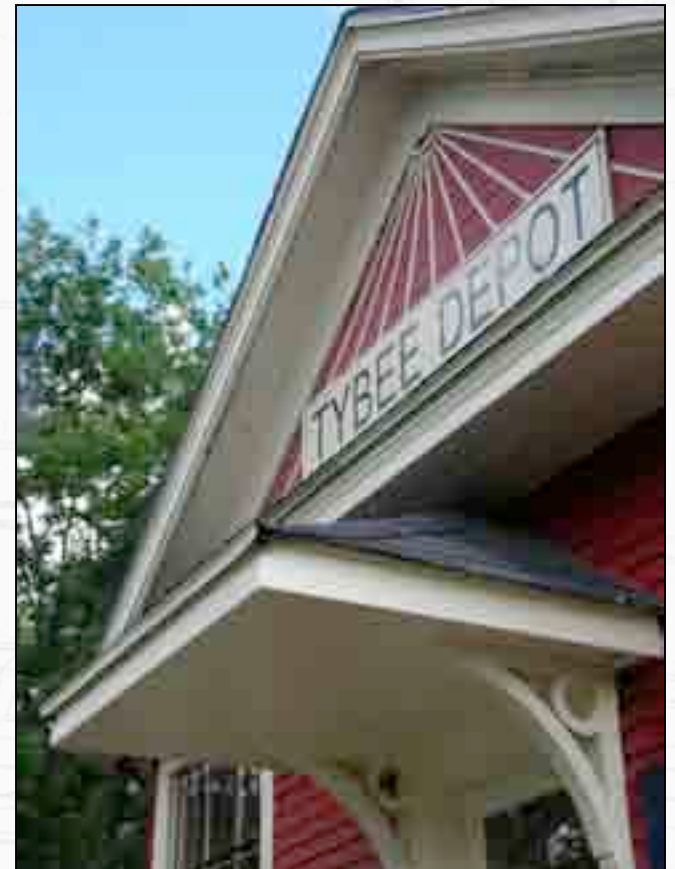
Close-up views of
the freshly painted
Tybee Depot.

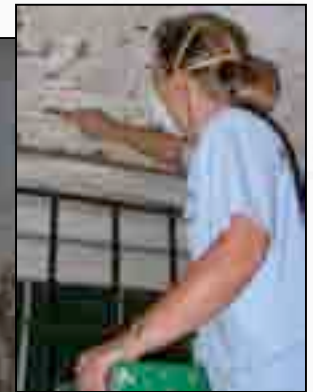
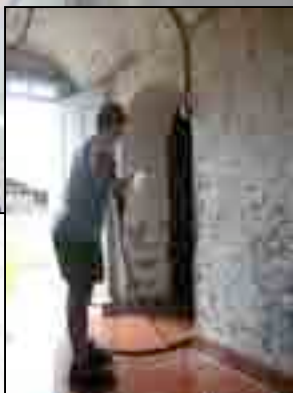
Patricia removes the mold with a mild cleanser and brush before gently rinsing it away with a low-pressure water spray.

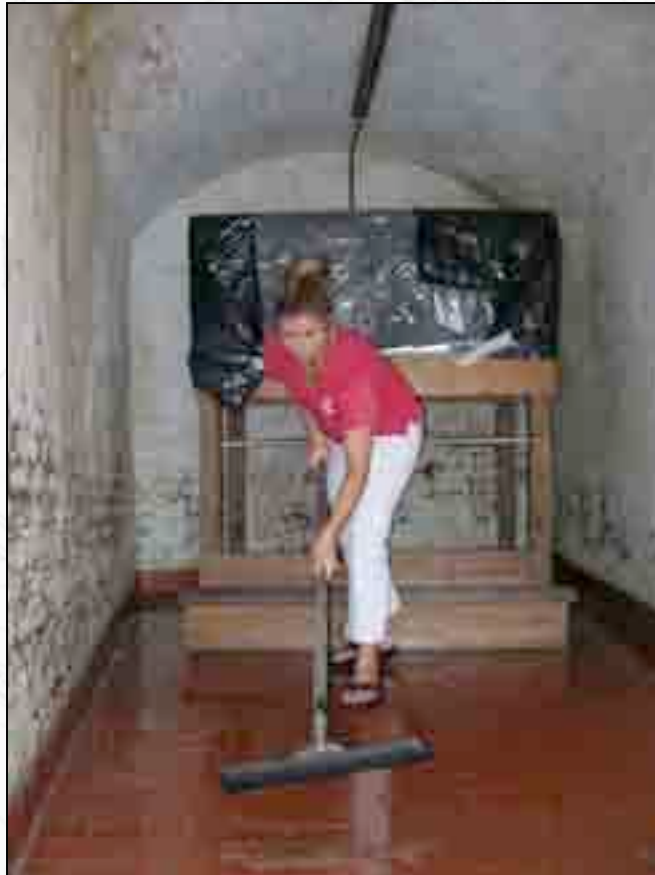
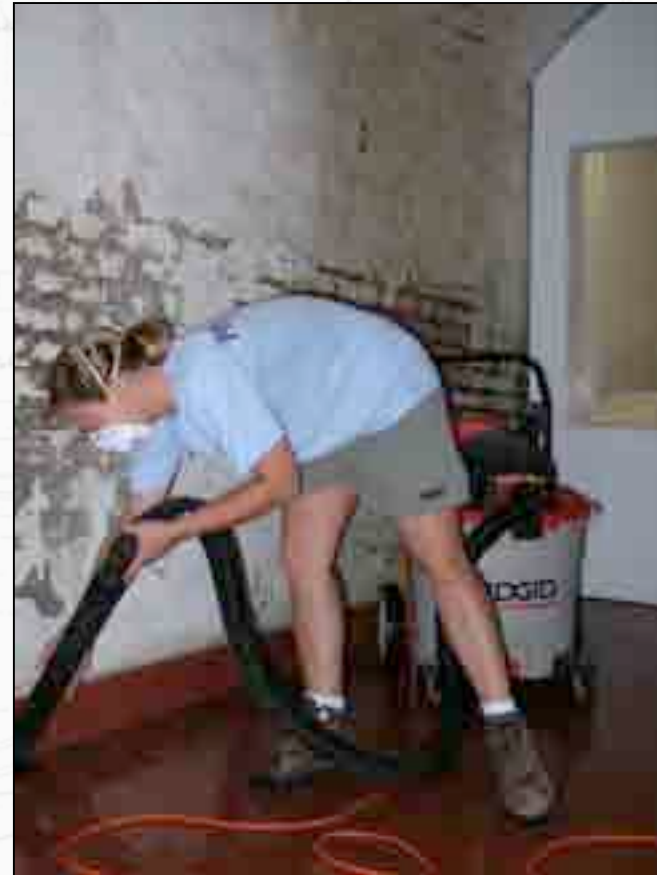
After removing and rinsing mold from the wall, Krystal squeegees the water as Patricia vacuums it with a wetvac.

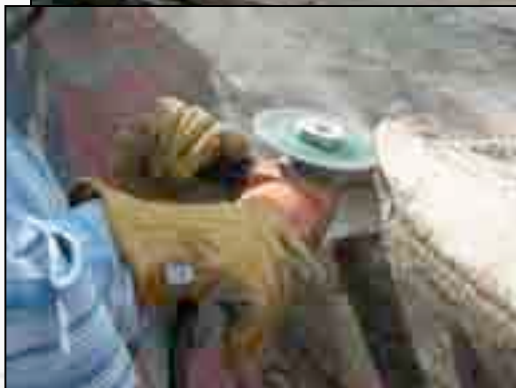
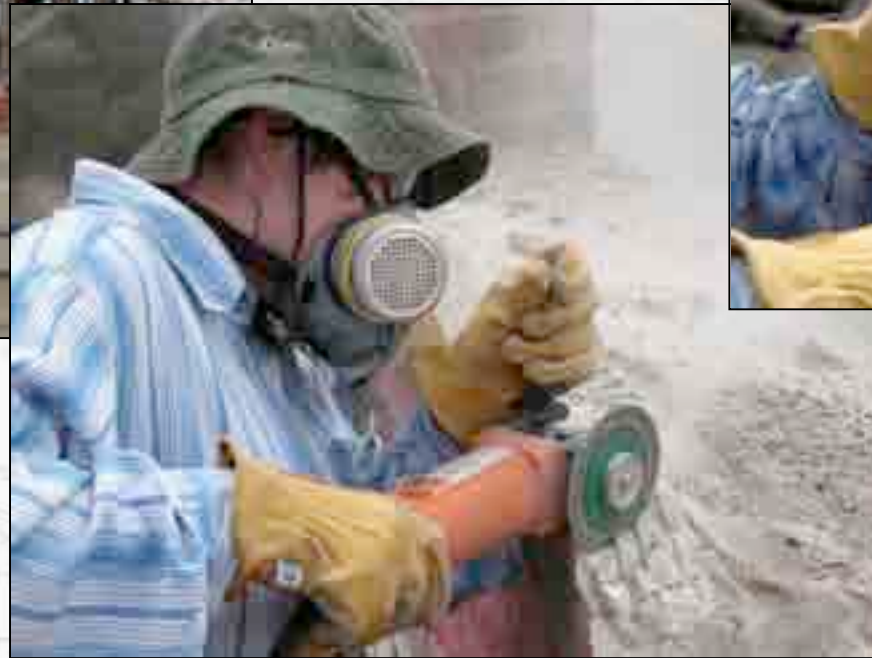
Amy Grace cuts hatch marks into the concrete sill in order to remove areas of rust jacking.

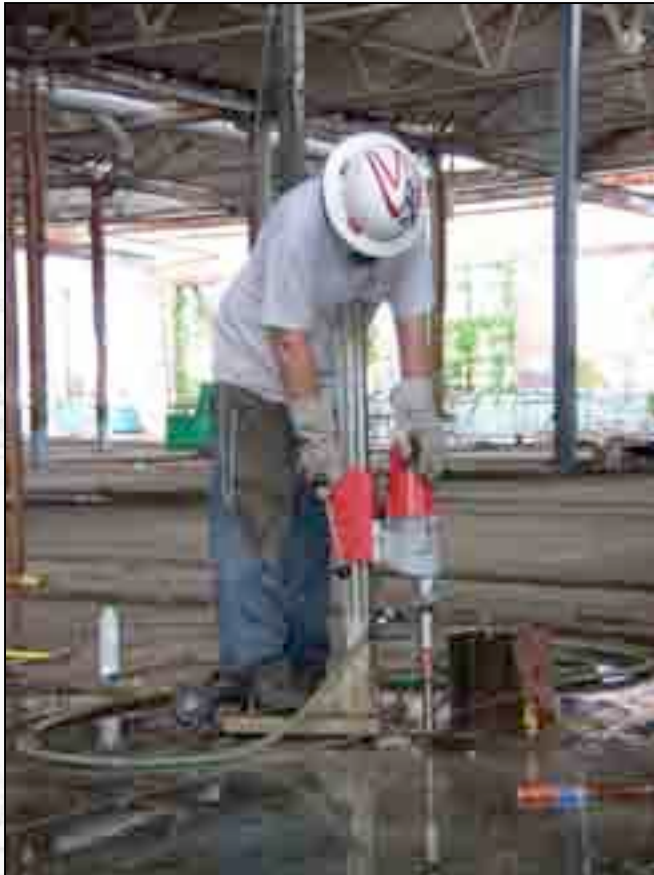
The CHS Preservation Team continues to work on structural steel repairs and door restoration in the Coach Shop.

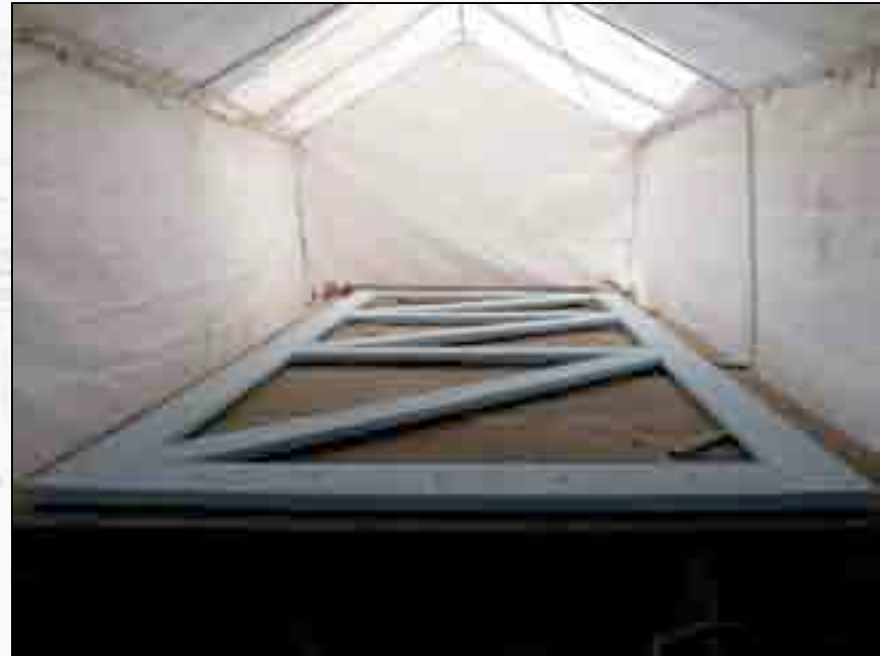
Bill Hersch inserted shims between each newly installed woodblock before filling the spaces with expandable cork. After cork was inserted, the shims were removed.

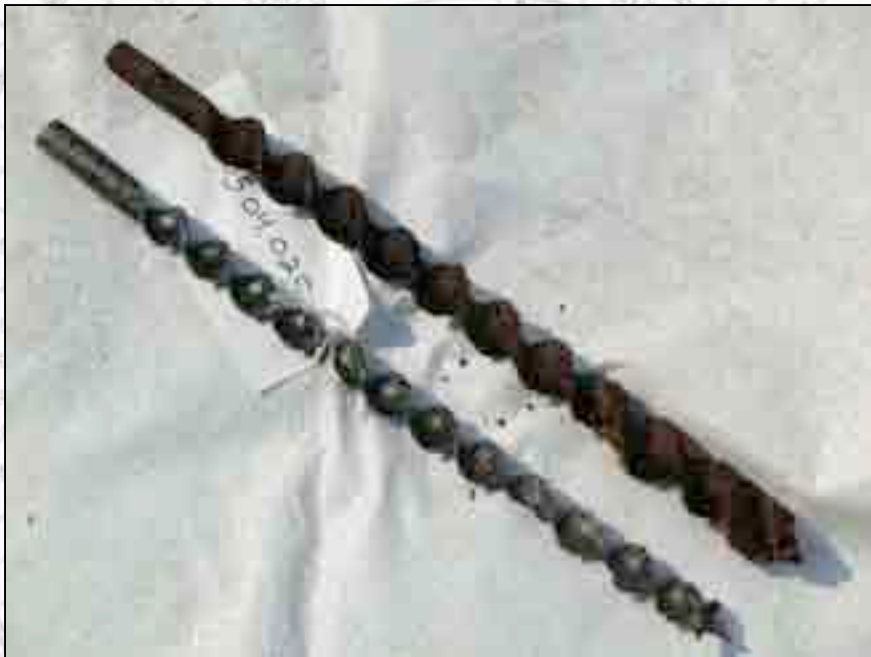
View of two drill bits that have been found on site. The bottom one has been cleaned of rust.

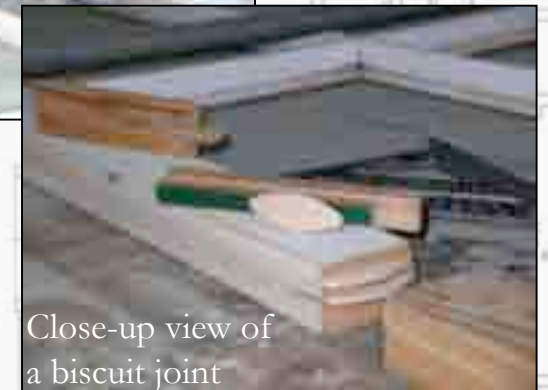
Close-up view of a biscuit joint
